Rosenbauer America, LLC. Technical Service Bulletin

| Date: 7/2/2025 | Form ID: TSB25002 | Update Required on IFM Digital Instrument Cluster TSB25002 | |
| Component | IFM CR1203 Display/12"/8:3/Touch (Digital Instrument Cluster) | | |

1 Production Programming Procedure for 3050819 – Rosenbauer Digital Instrument Display

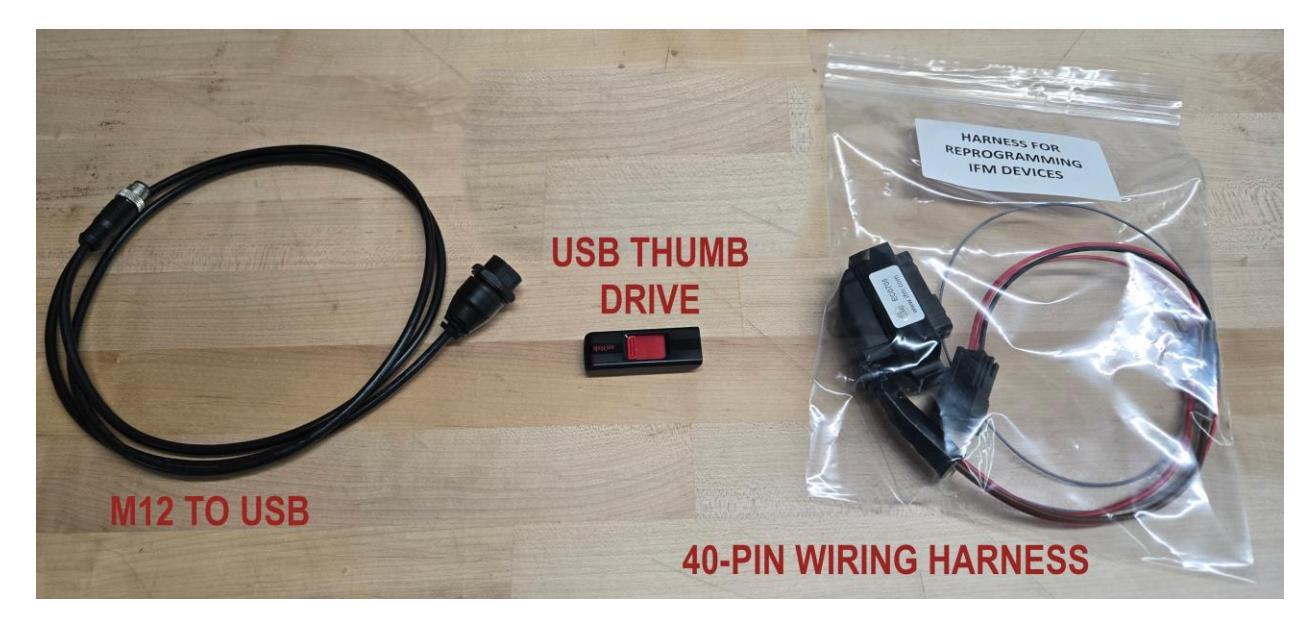
Figure 1 – Equipment Required to Reprogram Digital Instrument Cluster

Equipment required for this procedure is shown in Table 1 below:

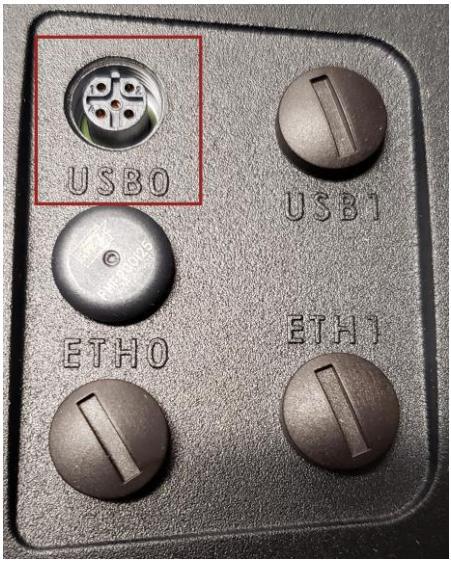
Figure 2

1) Unscrew the plug labeled "USB0" (Figure 2).

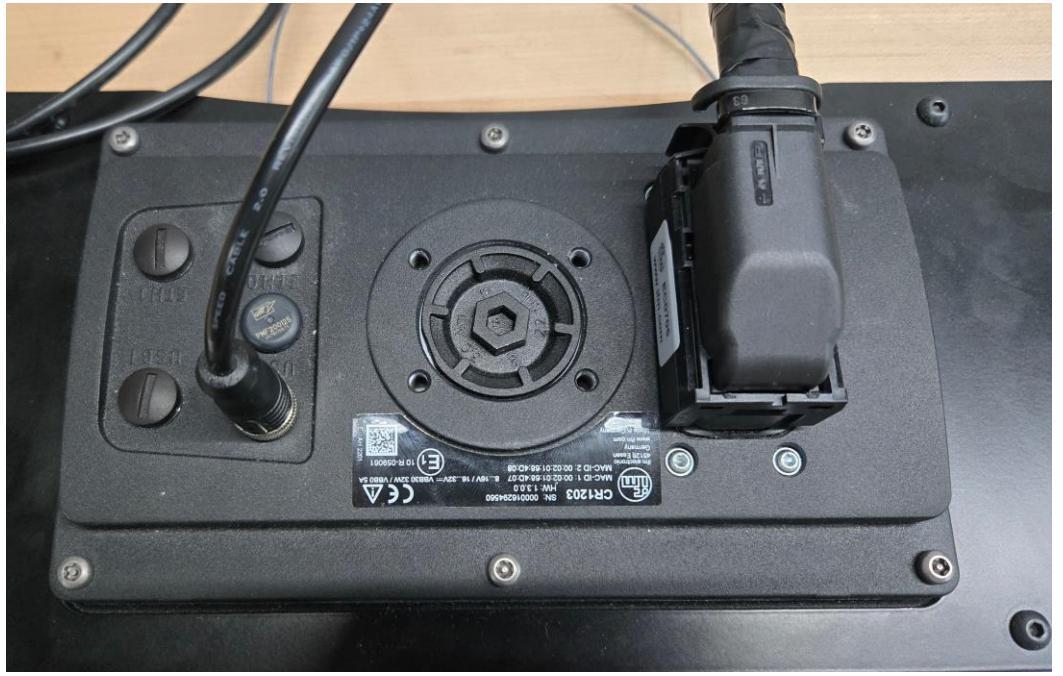
Figure 3

2) Plug the USB to M12 cable (EC2099) with thumb drive inserted into USB0 and the 40-pin reprogramming wire harness (do **NOT** apply power yet) (Figure 3).

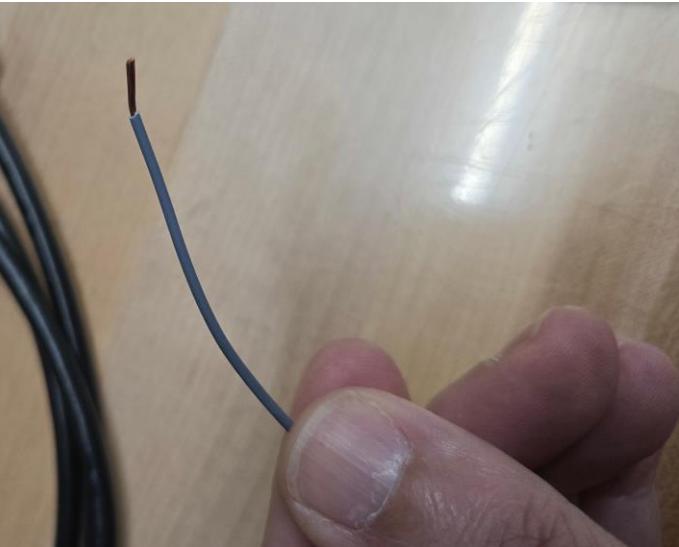
Figure 4

Attach the service line (grey wire) to battery positive (+) (Figure 4). Can be master switched or battery direct.

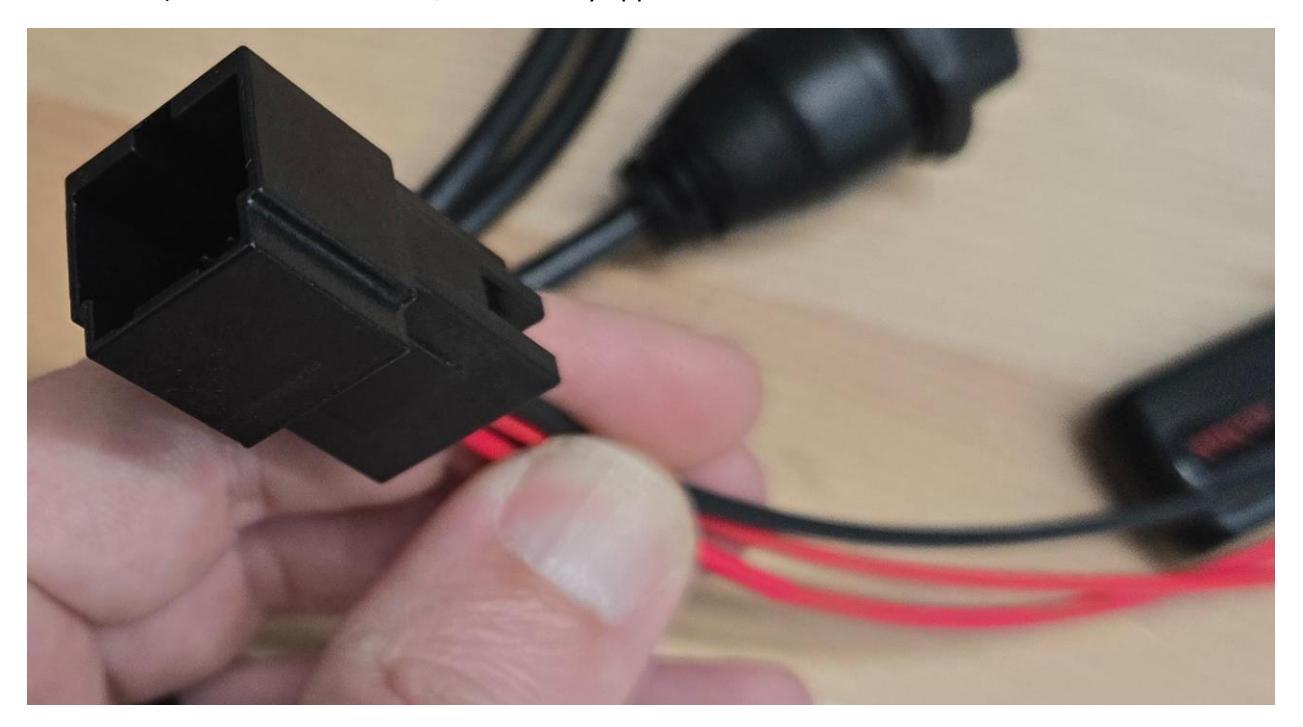
Figure 5

- 4) Plug Molex connector into existing vehicle harness (Figure 5).
 - a) Turn on vehicle power and ignition
 - b) IFM splash screen should appear.
 - c) After a few seconds, the recovery application will start.

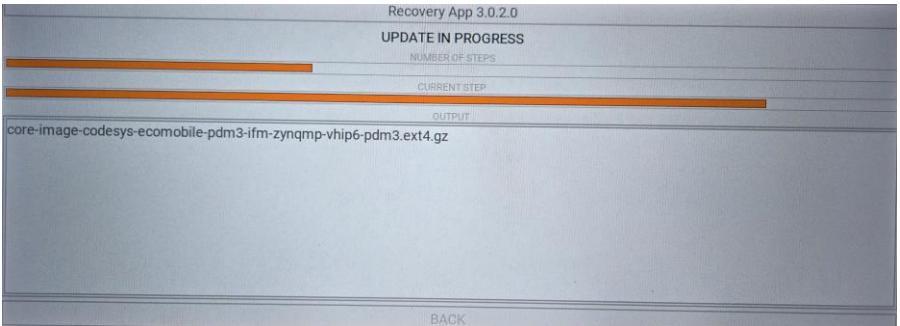
Figure 6

- 5) Once the recovery application has started, **remove service line** connection from battery positive (+).
- 6) The recovery application *should* start automatically (Figure 6). If it does not automatically start after 5 seconds, follow steps 7-10. Otherwise, go to step 11.

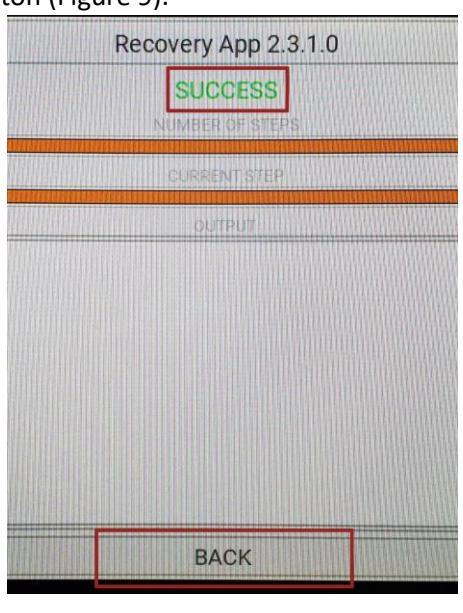
9) Once the programming process is complete, "SUCCESS" will remain on the screen.a) Press the back button (Figure 9).

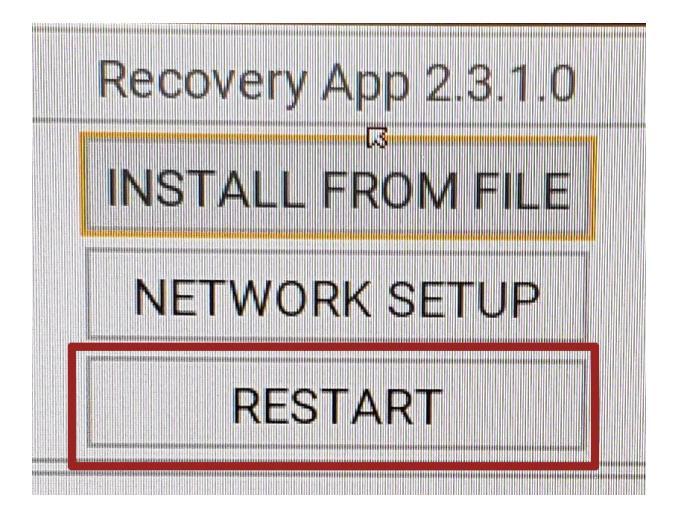
Figure 10

10) Press the button labeled "restart" (Figure 10).

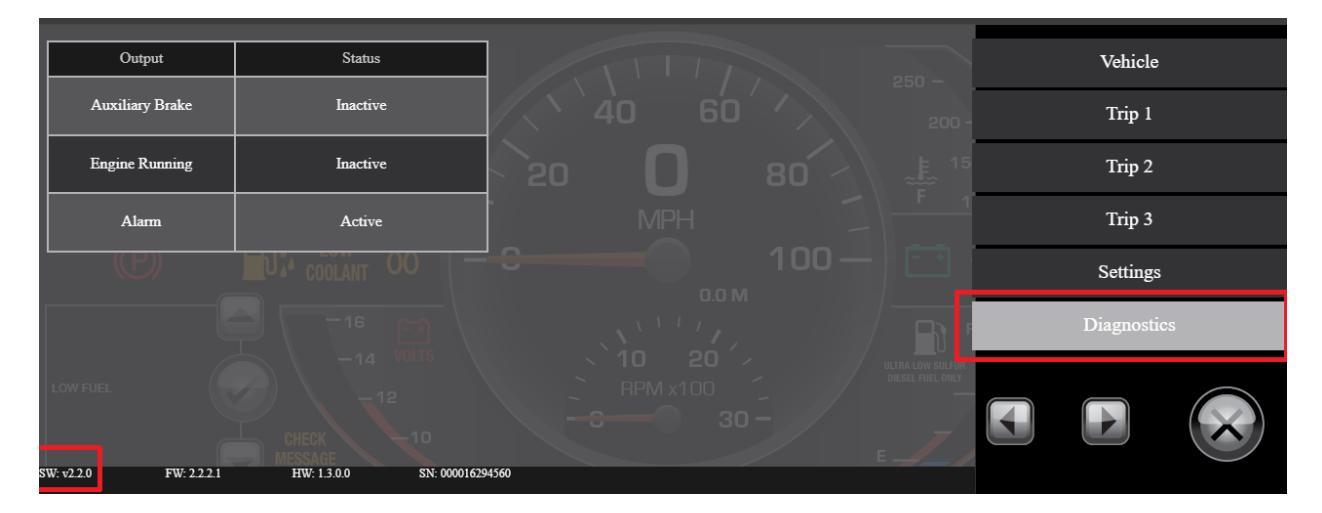
Figure 12

- 13) Remove the temporary harness, M12 to USB, and return the USB0 plug that was removed previously.
- 14) Reconnect vehicle harness and turn power and ignition on to verify instrument cluster function.
- 15) Verify the software version from the diagnostic menu matches your expected software version (Figure 12).
