Service Bulletin

## Safety Recall: 2007–11 CR-V Passenger Airbag Inflator Harness

Incorrect wire harnesses were supplied in a very small number of 2007–11 CR-V passenger airbag inflator kits intended for use in recall repairs. An incorrect harness may prevent the front passenger airbag from deploying as designed.

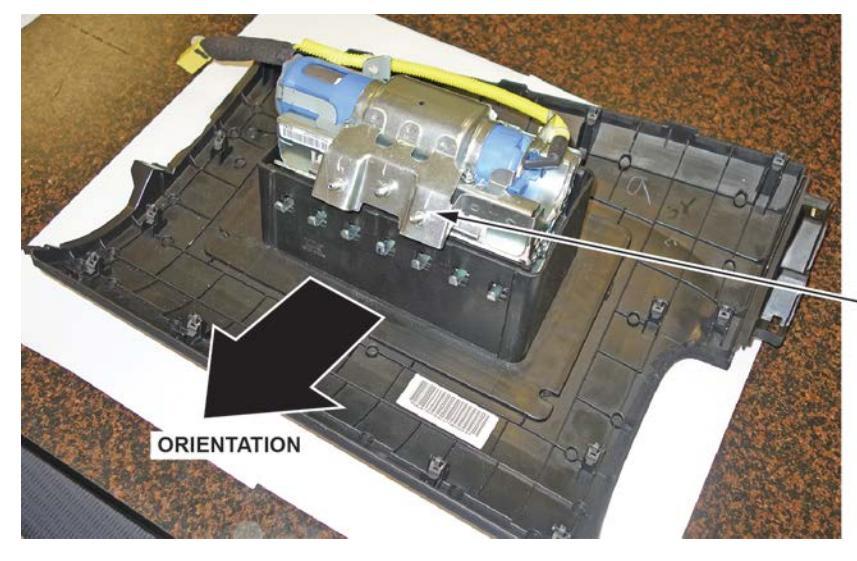
NOTE: The orientation of the airbag is critical because if you need to replace the inflator, and you install it incorrectly, the harness will be too short when you reinstall the airbag.

Place the airbag with the mounting stud facing you.

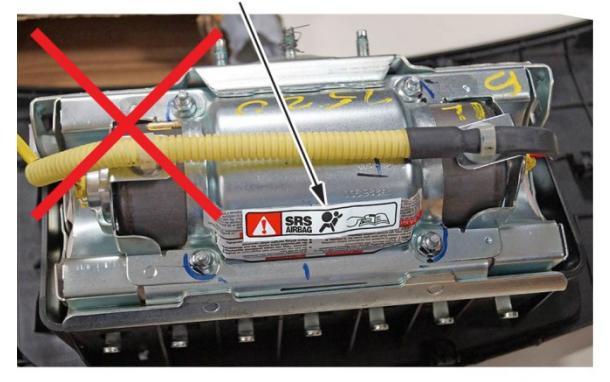
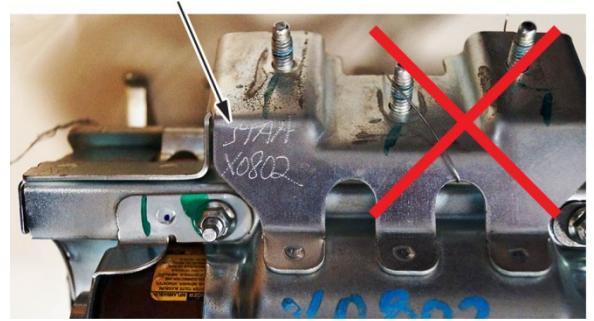
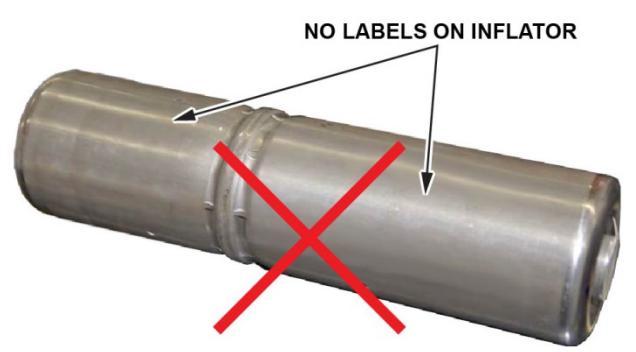
- 5. Visually inspect the airbag and the inflator for any unusual writing or markings.
  - If there is nothing unusual about the airbag or the inflator, go to step 6.
  - If there are any unusual markings, like an incorrect label or a model year written in marker, the airbag and inflator may not be the correct airbag and/or inflator for the vehicle or it may be a counterfeit part. For more information about counterfeit airbags, you can refer to *safercar.gov*, enter keywords **MANAGING** COUNTERFEIT, and select Recommended Dealer Guidance for Managing Counterfeit Air Bags from the list. If you suspect that the airbag or inflator is counterfeit, do not continue this procedure. Contact your DPSM for assistance.

NON-STANDARD SAFETY LABEL

**GREASE PENCIL OR PAINT MARKINGS**

HAND ENGRAVING

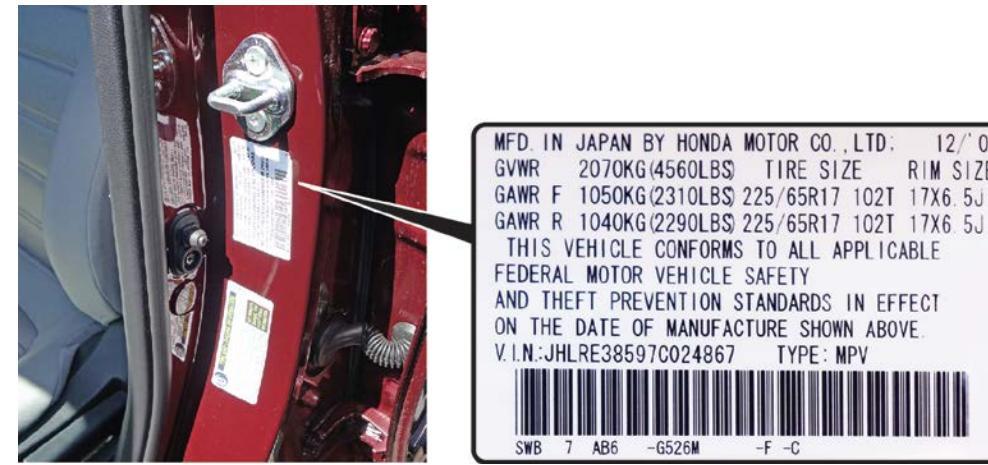
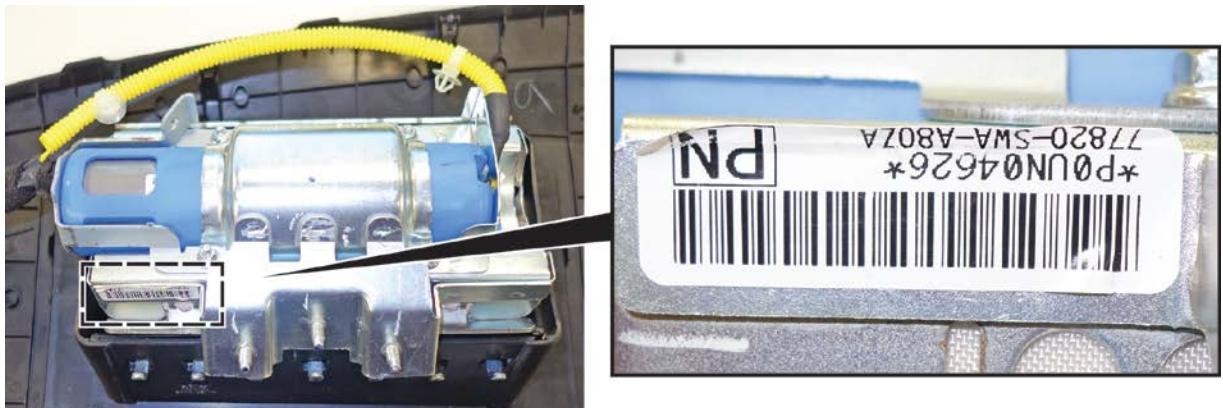
6. Take photos of the VIN on the doorjamb, serial number on the airbag assembly, and every inflator harness (good or no good).

Inflator Harness (color of the long wires inside the corrugated tube)

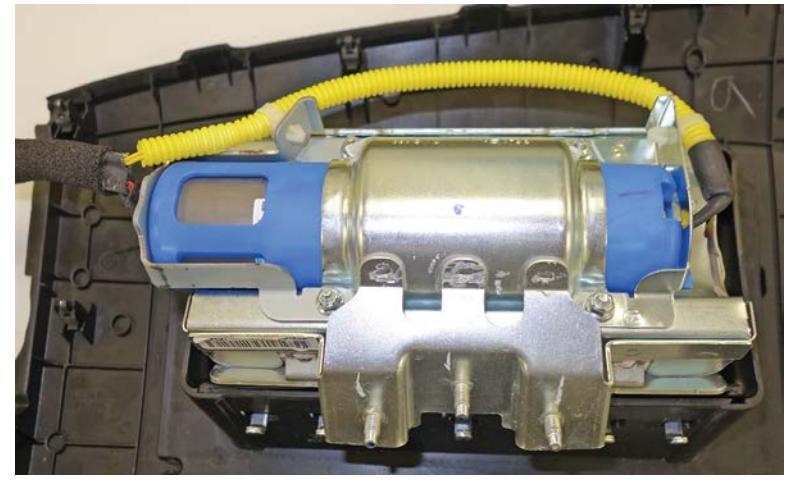
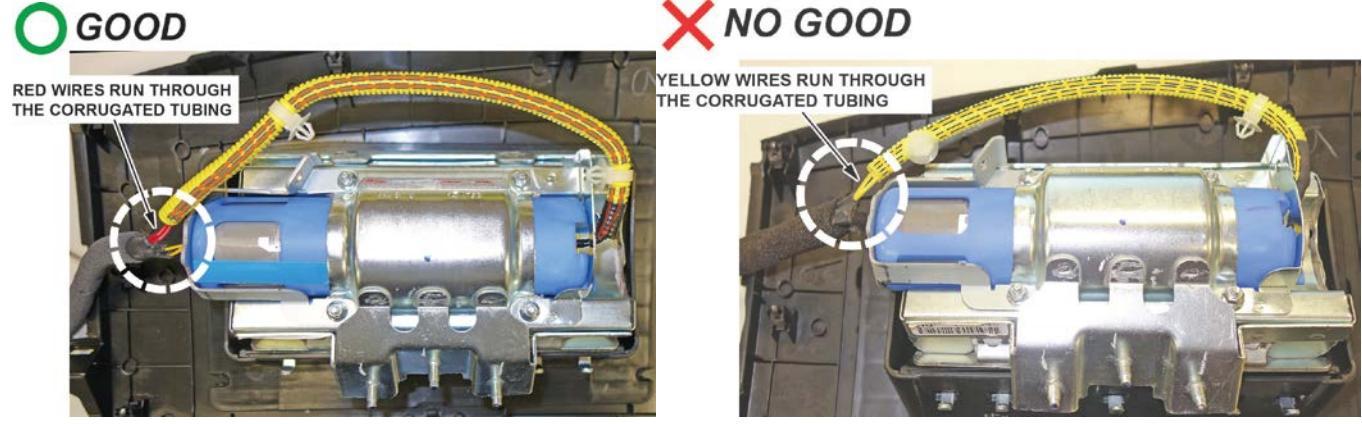
- 7. Inspect the inflator harness by sliding the corrugated tube up so you can see the color of the long wires that are inside the corrugated tubing.
  - If there are **red wires inside the corrugated tubing**, the harness is **good**. Follow steps 19 thru 23 to reinstall the airbag module.
  - If there are yellow wires inside the corrugated tubing, the harness is no good. Go to step 8.

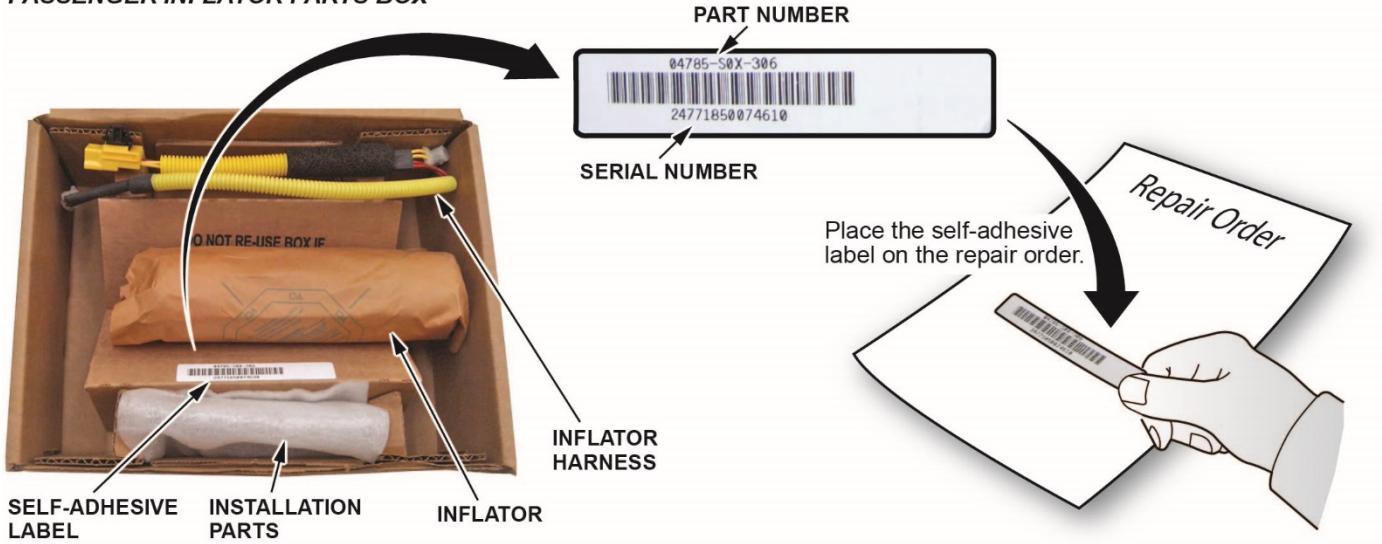
#### PASSENGER INFLATOR PARTS BOX

8. Peel the label located inside the inflator box from its backing and attach it to the RO. For the warranty claim to be paid, the replacement inflator part number that you received must be included in the warranty claim.

- The replacement part number is printed on the top part of the label and the serial number is printed on the bottom. Make sure you attach the label to the RO and give it to the warranty clerk.
- There may also be a colored sticker located in the kit ignore it because it is not used.
- Not all inflator kits include a label. In those cases, write the serial number and part number from the side of the inflator box on the RO.

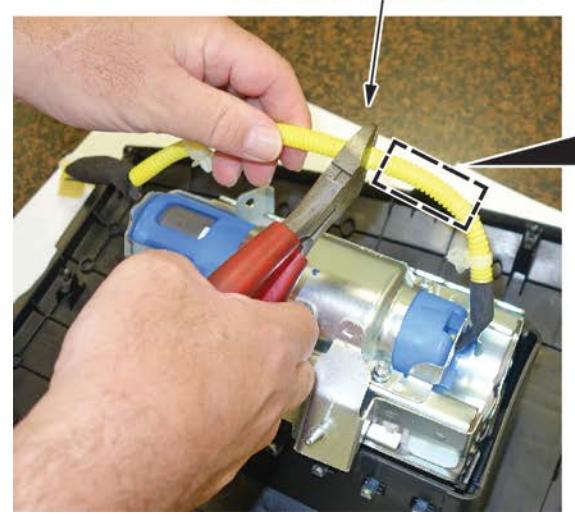
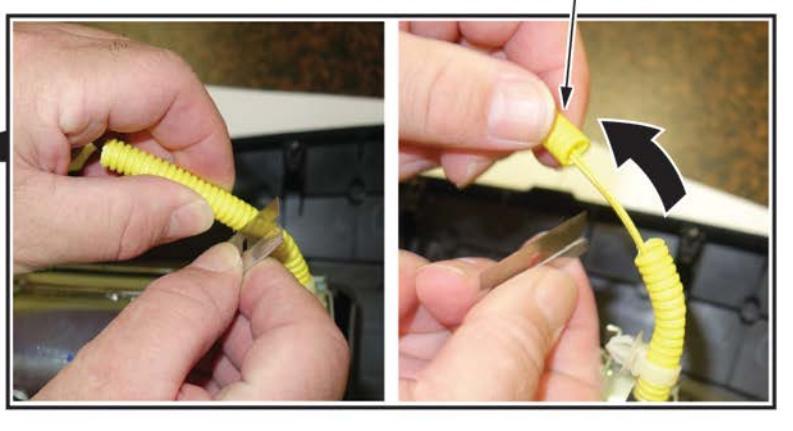
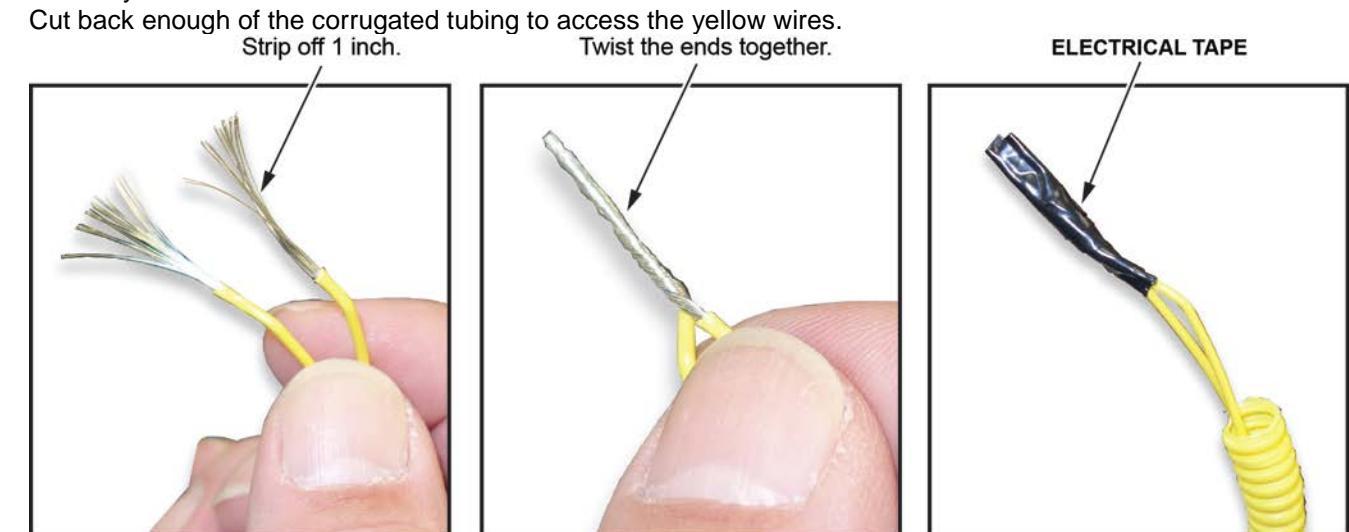
- 9. Unclip the harness from the inflator bracket.
  - Short the yellow (long) wires. You must cut the yellow wires for inflator removal and short the yellow wires on the inflator side as indicated to prevent accidental deployment.
  - Do not cut the red wires because the airbag connector shorts these inflator wires.
    Cut the harness in the center.
    Remov

Remove some of the corrugated tubing.

• Cut the yellow wires as shown.

- Strip away about 1 inch of the yellow wire insulation, then twist the wires together.
- Tape the twisted ends with electrical tape.

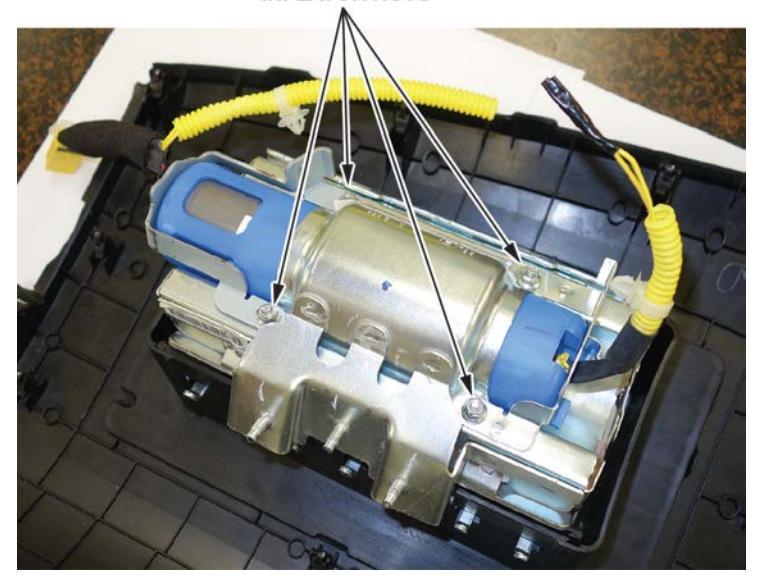
# 10. Remove the four inflator nuts.

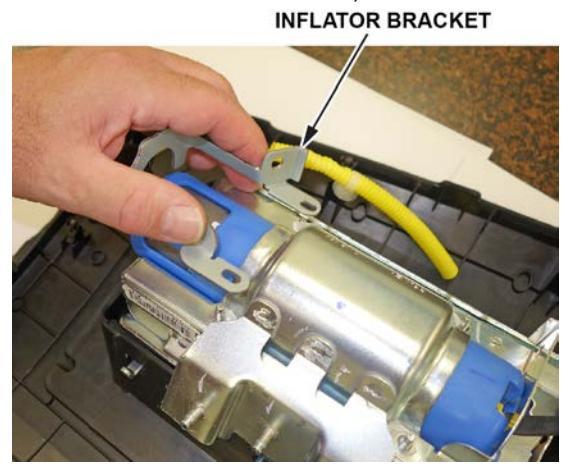
11. Remove the inflator bracket.

- You can only remove one of the brackets, as the other is welded to the airbag housing.
- Do not reuse the bracket; use the new one that came in the inflator kit.

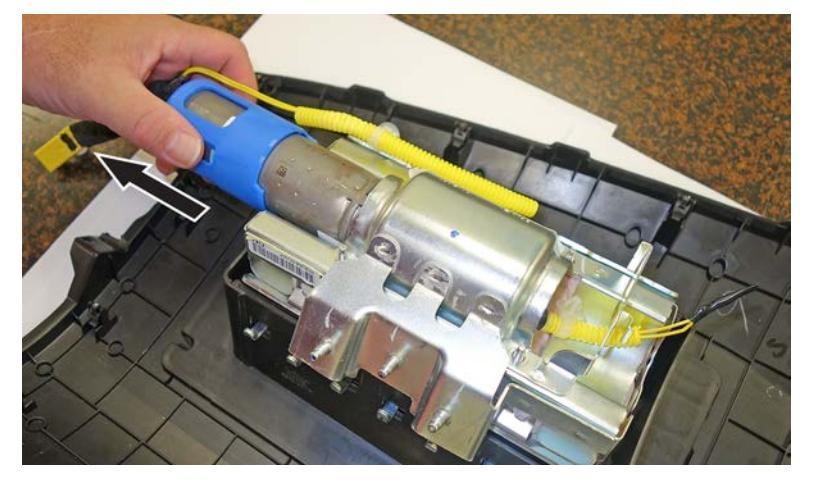
12. Remove the inflator by pulling it out.

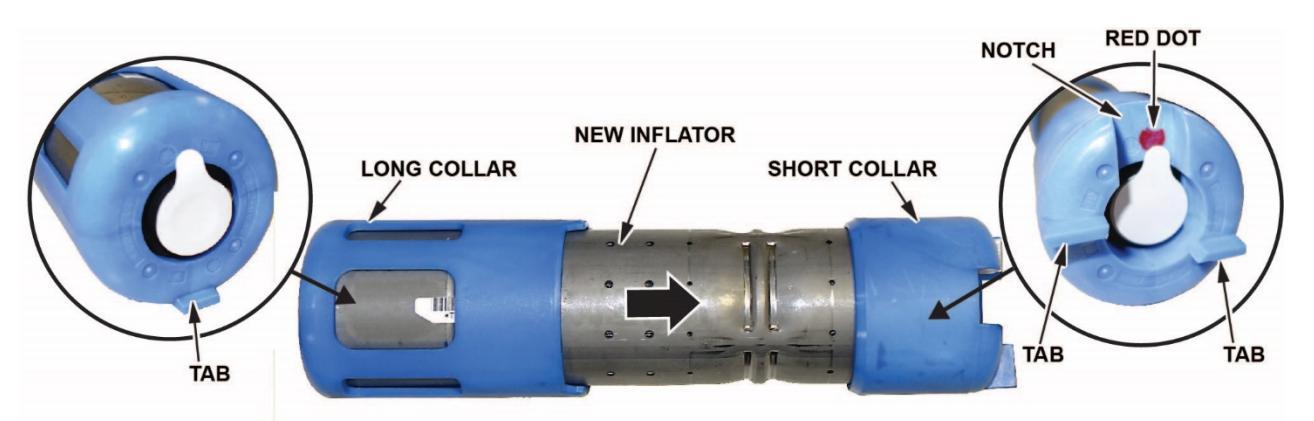
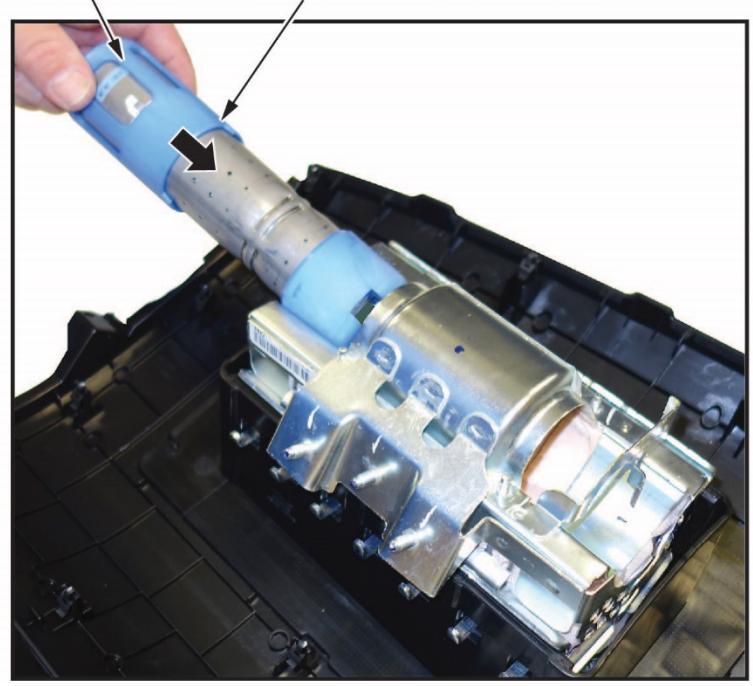
#### P/N 06790-SWA-305

• One side of the inflator has a longer collar, a single tab, a plastic cutout, and a small flat spot on the connector. The other side of the inflator has a shorter collar, two tabs, and a red dot. Make sure you insert the end with the shorter collar into the airbag first.

LONG COLLAR The inflator installation is directional.

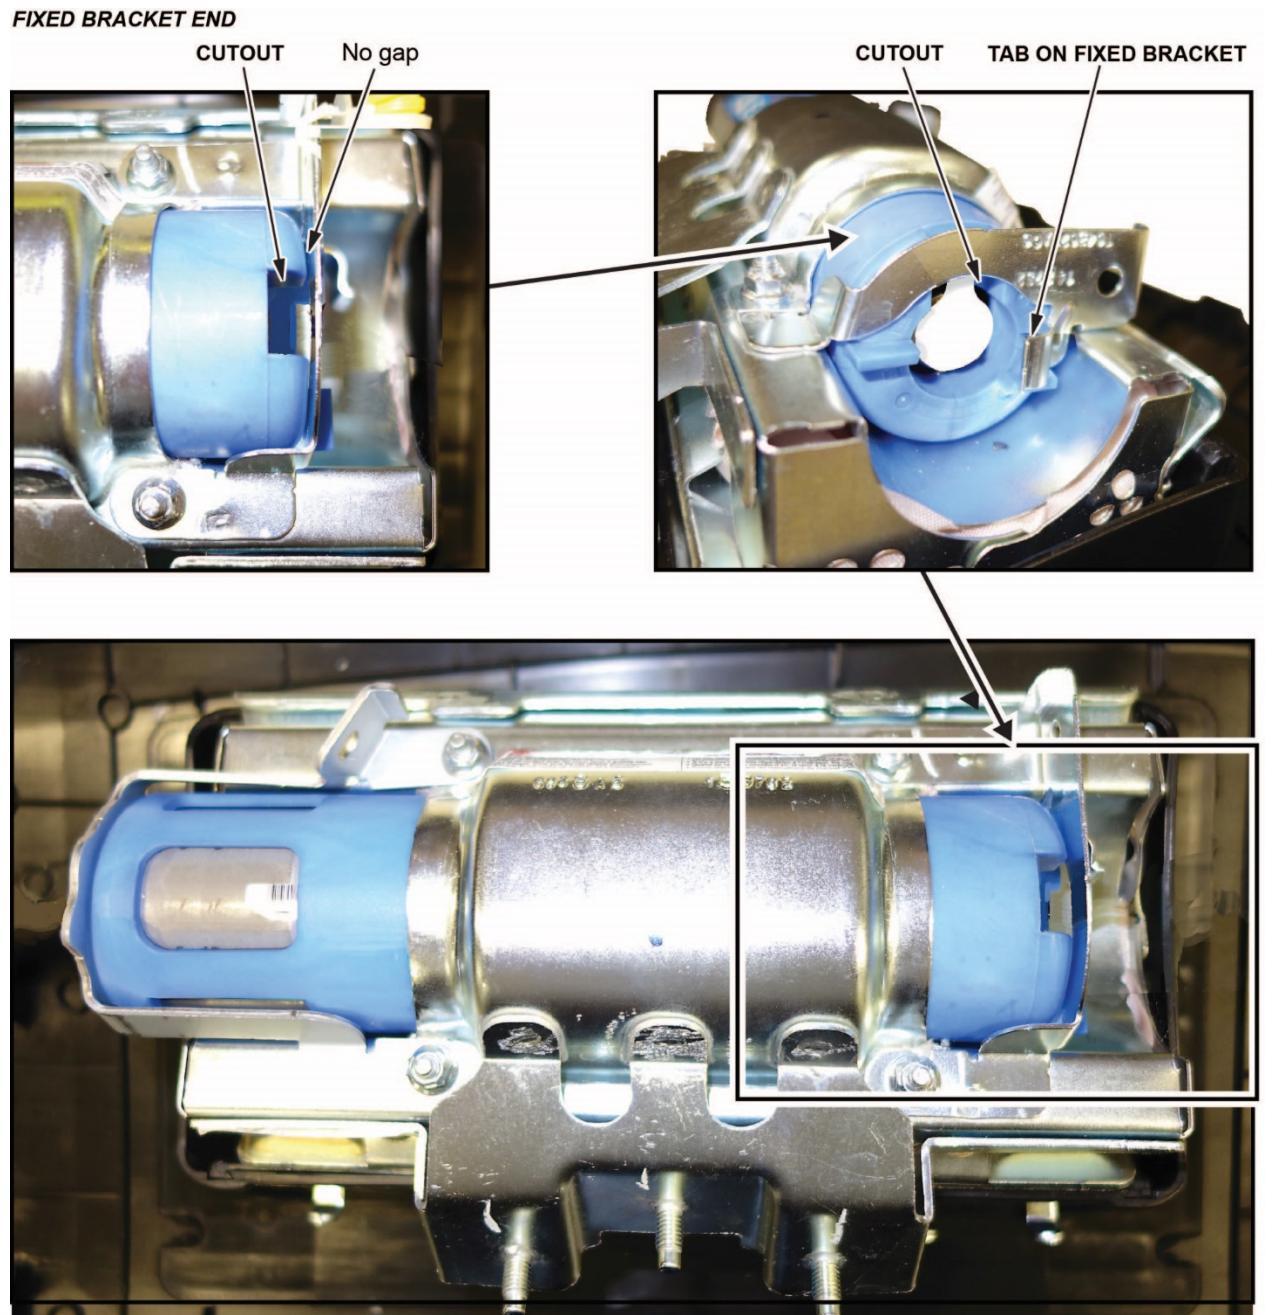
• Slide the inflator in until the plastic collar contacts the bracket. The two tabs should align with the side of the airbag module and the metal tab as shown. There should be no space or gap between the inflator and bracket.

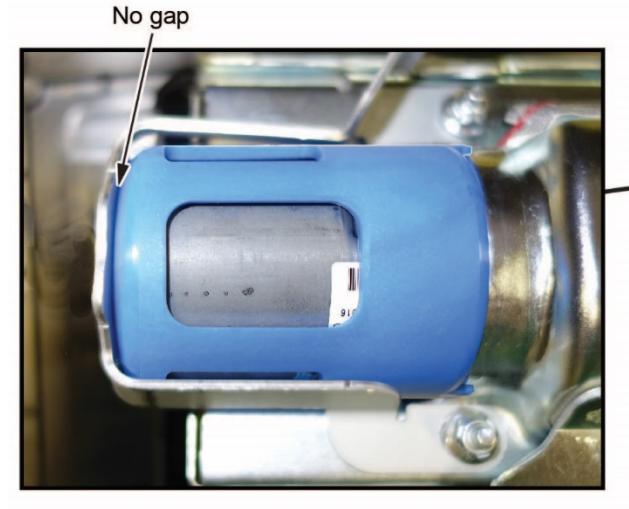
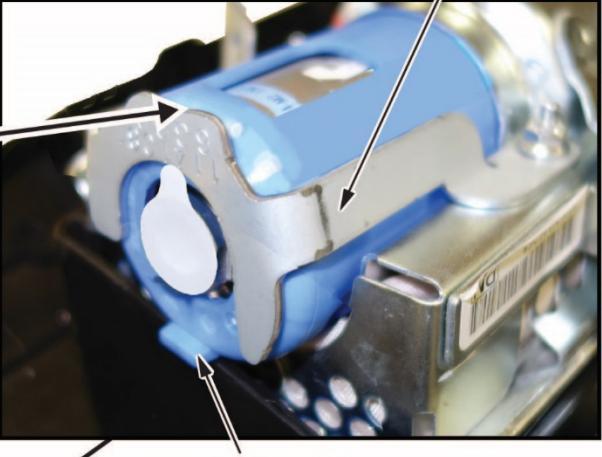
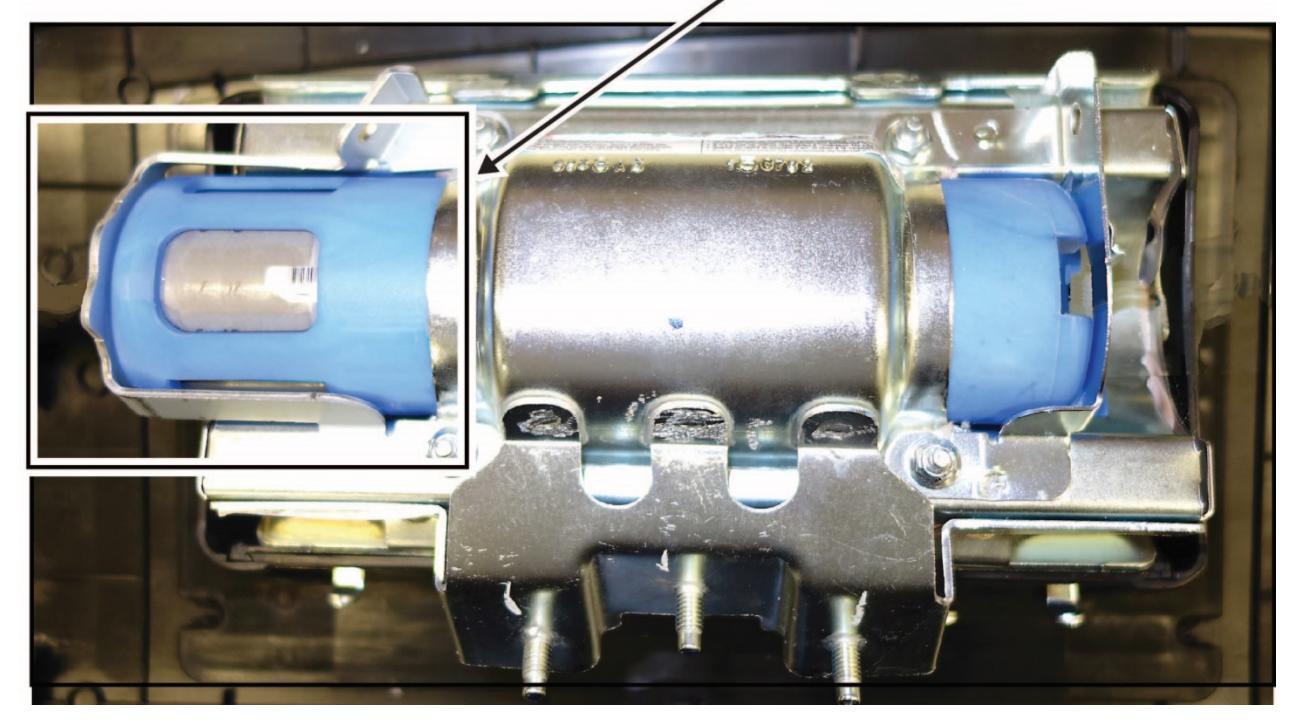
Install the new bracket included in the kit onto the airbag module. Check there is no space or gap between the inflator and bracket by pushing the bracket against the inflator. ٠

NOTE: The bracket may have a little bit of play before you install the new nuts. ADJUSTABLE BRACKET END

ADJUSTABLE BRACKET

TAB ON INFLATOR

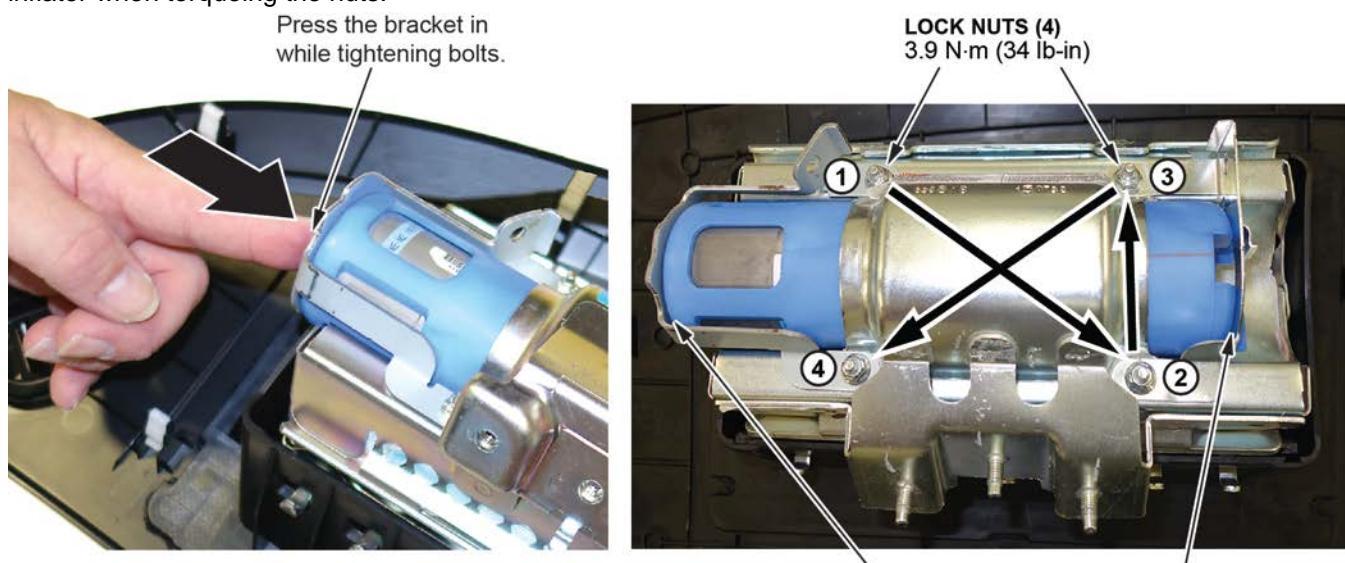
14. Hold the bracket against the inflator, then install the new 5 mm locknuts and torque them in sequence to **4.0** N•m (34 lb-in).

NOTE: Make sure you push the bracket against the inflator to ensure there are no gaps between the brackets and inflator when torqueing the nuts.

Be sure there are no gaps between the inflator ends and the inflator brackets.

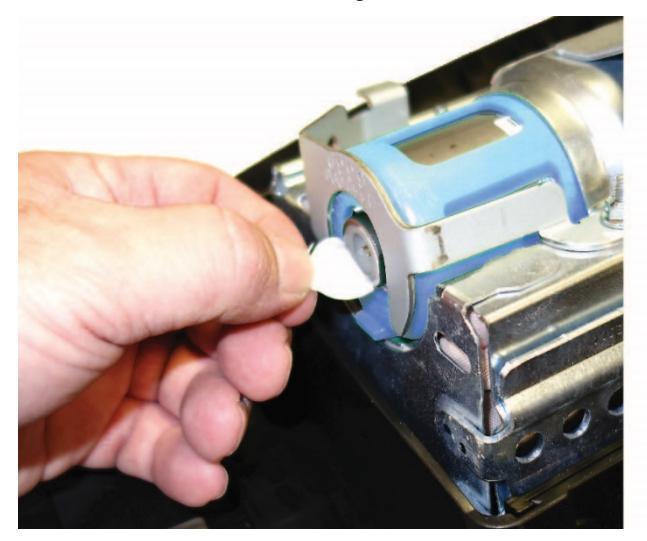
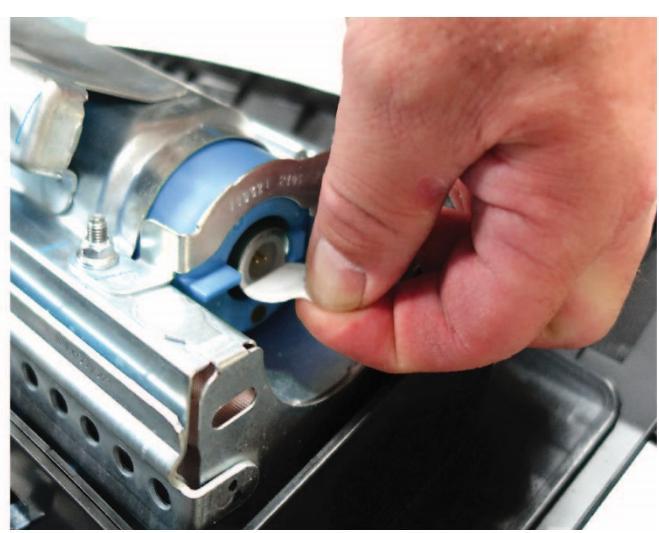
15. Remove the stickers covering the terminals on both sides of the new inflator.

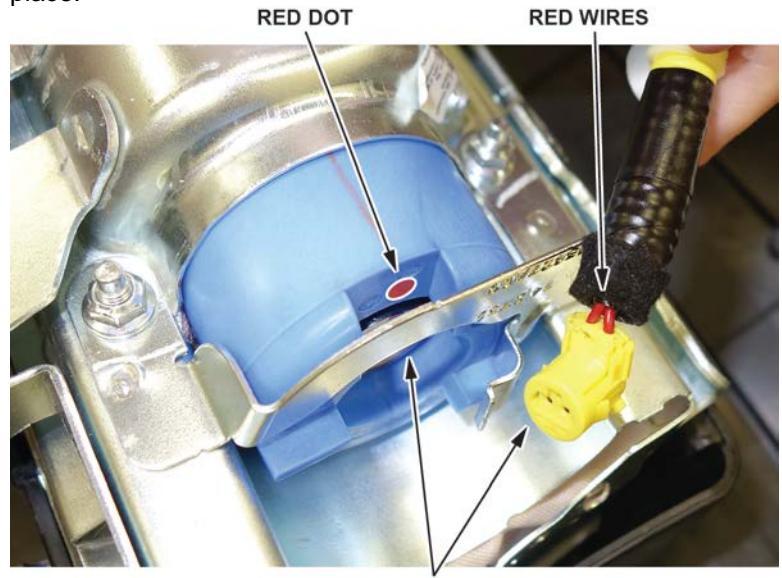
- 16. Install the new inflator harness.
  - Make sure the airbag and harness are aligned as shown.
  - Connect the red wire connector to the connector on the side with the red dot on the plastic cap. Align the "T" shape in the inflator harness connector with the T-shaped inflator connector, then press the connector into place.

The red wire end of the harness connects to the red dot side of the inflator.

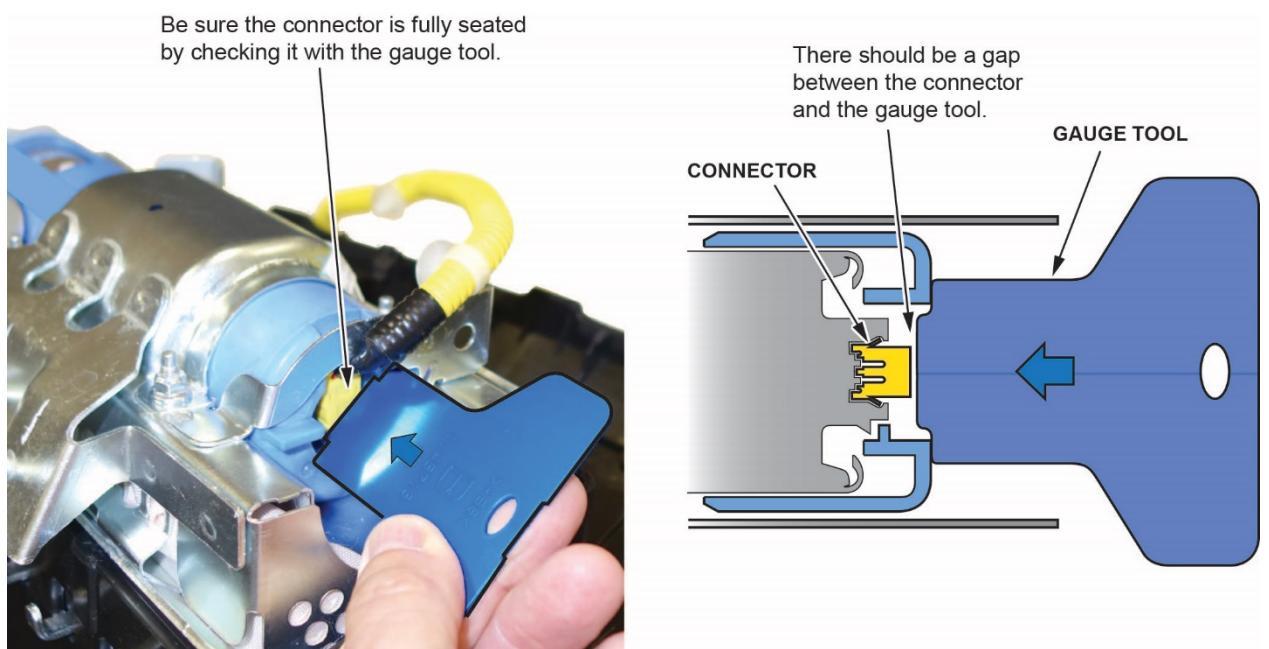
- Connect the yellow wire connector to the connector on the side with the long plastic cap.
- After you hear each connector click, wiggle it to make sure it is secure. NOTE: If the connector is not properly aligned, it will come out.
- 17. Make sure the connector is secure and in place by using the gauge tool. (PSPI6 Gauge Tool: P/N 070AJ-TA00A00 or 07AAJ-TA0AA00)

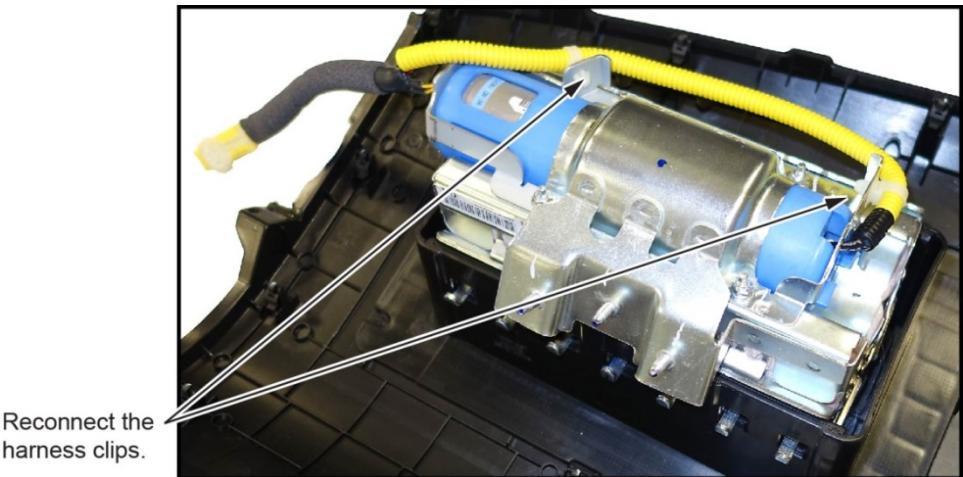
18. Connect the harness to the inflator brackets as shown.

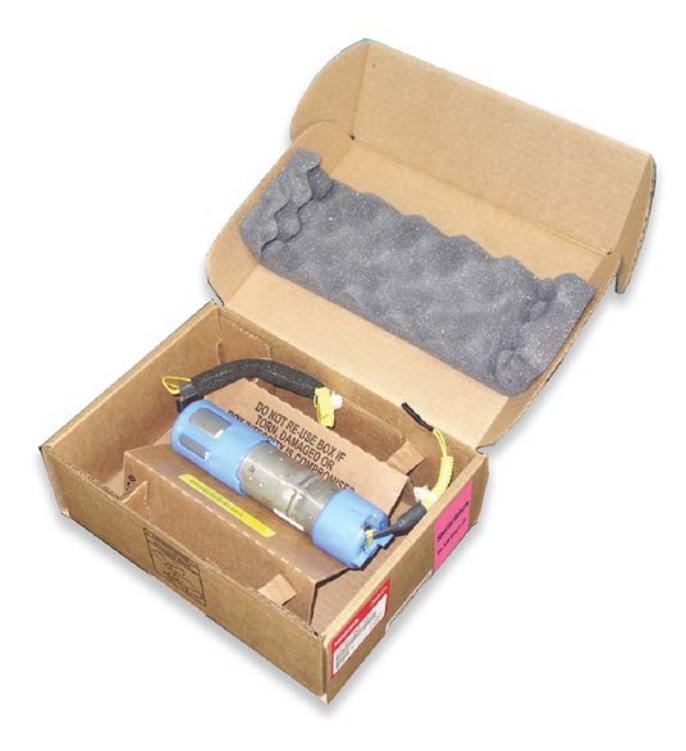
- 21. Turn the ignition to ON and make sure the SRS indicator comes on for about 6 seconds, then goes off.
- 22. Set the clock (for vehicles without navigation) and enter the anti-theft code for the audio and navigation system (if applicable).
- 23. Give your warranty clerk the digital photos and RO. If the inflator was replaced, submit the digital photos and RO that includes the replacement inflator serial number and replacement part number. For the warranty claim to be paid, the photos and the replacement inflator part number (if applicable) must be included in the warranty claim. See ATTACHING PHOTOS TO A CLAIM for information about attaching photos to warranty claims.
- 24. Put the original inflator into the box the new one came in. Make sure there is no other hardware in the box because if the package rattles, it will not be accepted by the courier.

NOTE: These boxes will have a pink label on the side.
