Э нүрлоаг			chnical Servic	Group TRA	Group TRANSAXLE		
				07-	40-012		
ject				Date			
A		EMPERATURE SE	NSOR - DIAGNOSTIC	OCTO	BER, 2007		
TROUBLE CODES P			11, P0712 & P0713	Model 2007	~ ELANTRA		
This (Ava	TSB req ilable at	uires Kent-Moore 800-345-2233).	e J-36850-A Transmissi	on Assembly Lu	be		
DES	CRIPTIO	N:					
Incor	rect oper	ation of the oil tem	perature sensor may res	ult in the followin	g symptoms

07-40-012

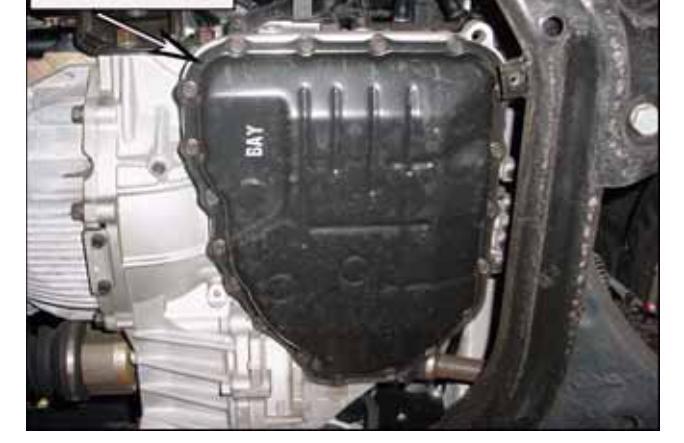
- Remove all except 2 bolts to the oil pan. Loosen the remaining 2 bolts 1/8~1/4 inch.
- 7. Use a rubber hammer to tap the oil pan at the corner until the pan separates from the case.

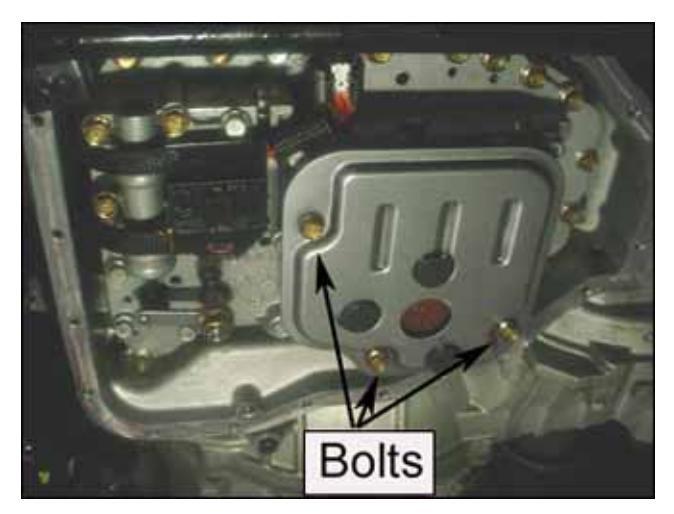
8. Remove the 3 bolts that retain the oil filter and remove the oil filter.

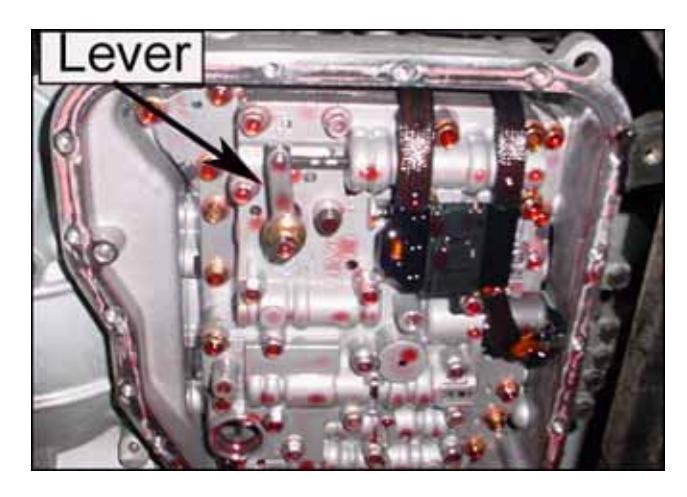
9. Remove the 14 mm nut and remove the manual valve lever.

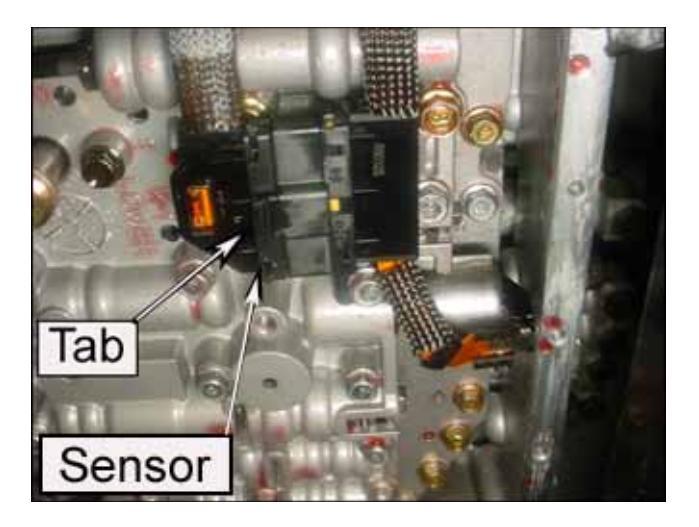
10. Press the tab and disconnect the fluid temperature sensor from the solenoid connector.

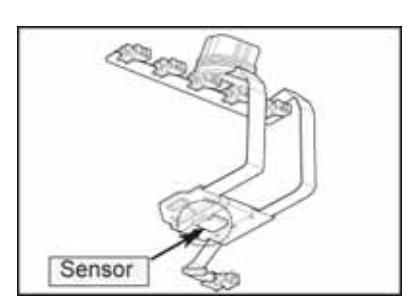
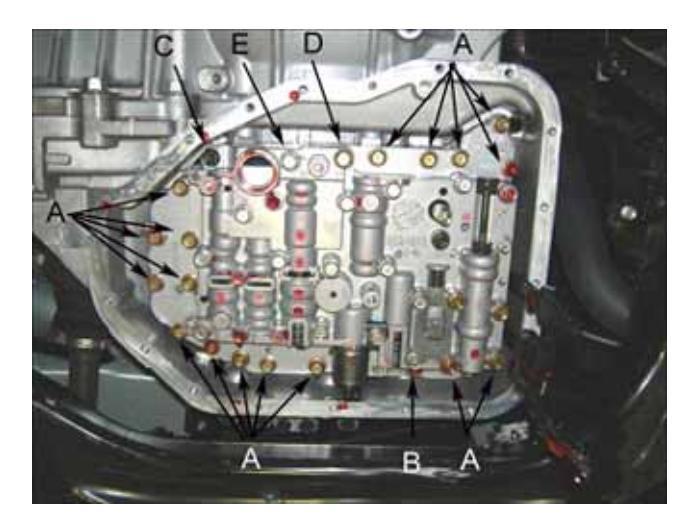
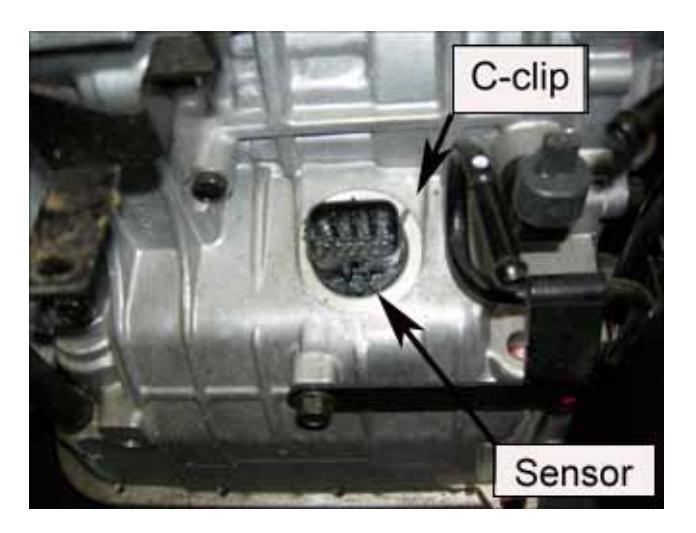
- 11. Remove the bolts that secure the valve body and carefully lower the valve body.
- CAUTION: The accumulators and springs may fall out of the transaxle case.
- 12. Carefully lay the valve body on a clean **paper** towel.
- CAUTION: Do not use a shop rag. Cloth rags contain lint that may cause a valve to stick in the valve body.
- 13. Remove the C-clip from the solenoid connector and remove the fluid temperature sensor.
- 14. Install a new temperature sensor and insert the c-clip.

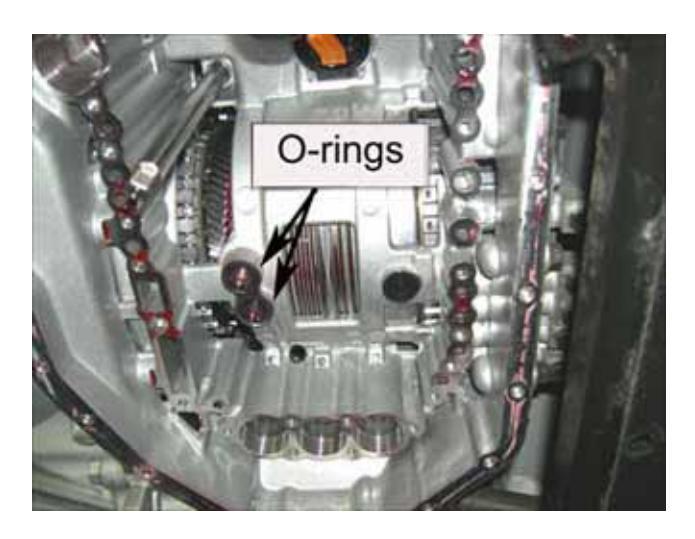
15. Apply assembly lube and install two o-rings in the locations shown.

NOTE: The o-rings are available in 45010-23A01, ATA overhaul seal kit.

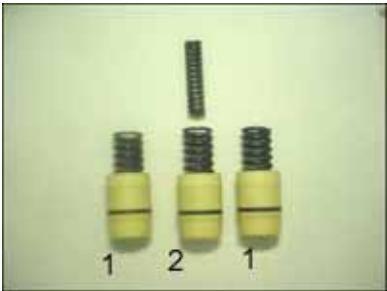
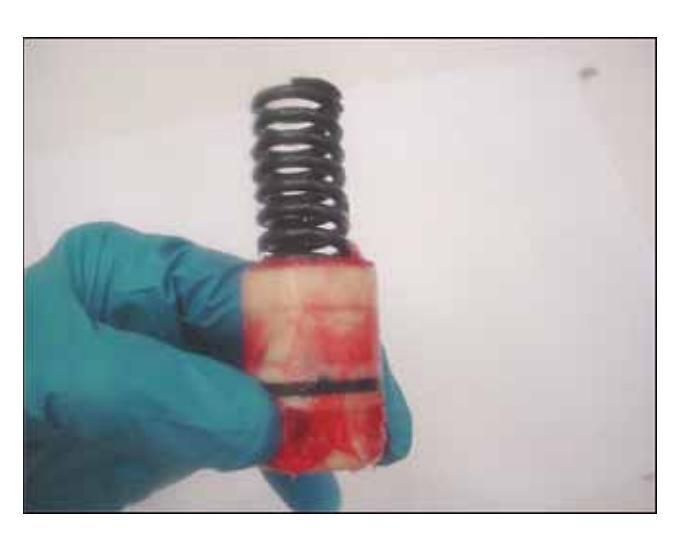
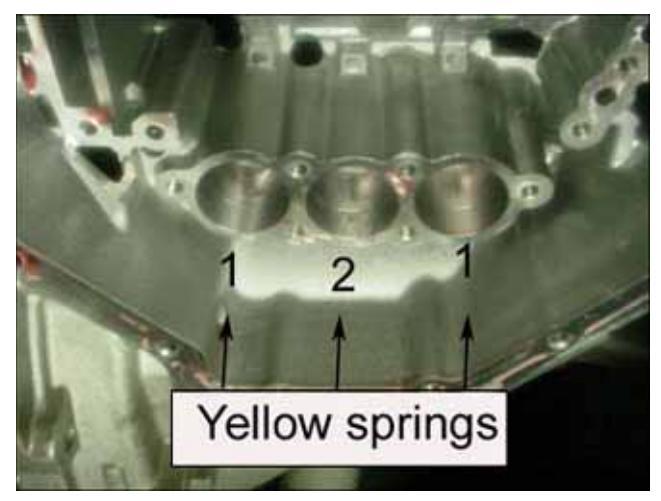
- Apply Kent-Moore Assembly Lube, P/N J-36850-A (available at 800-345-2233) to the accumulator and bore in the case.
- CAUTION: Other assembly lube products may not hold the accumulators in place during assembly.
- NOTE: An assistant may be required to hold the accumulators in place until the valve body is installed in the case.
- 17. Install the yellow springs in the location shown.

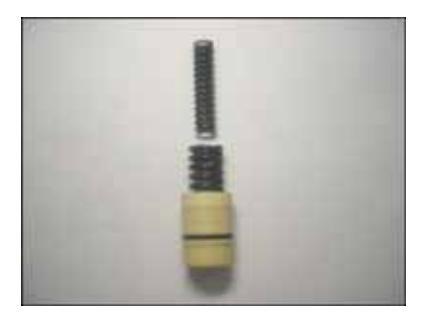
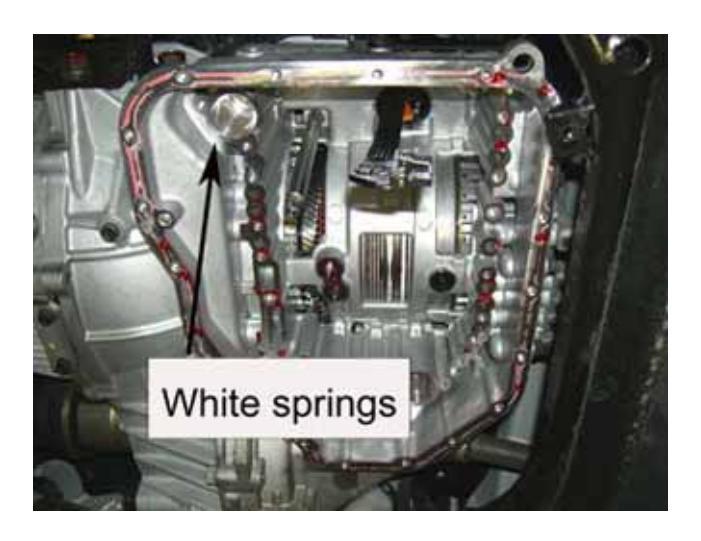
18. Install the 2 white springs in the location shown:

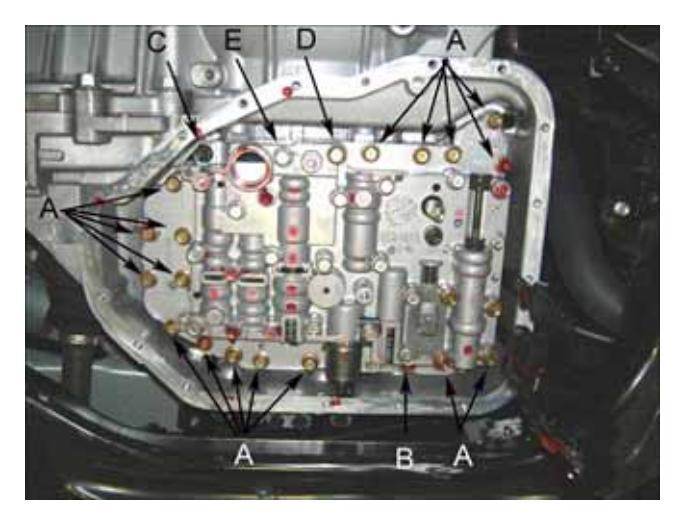
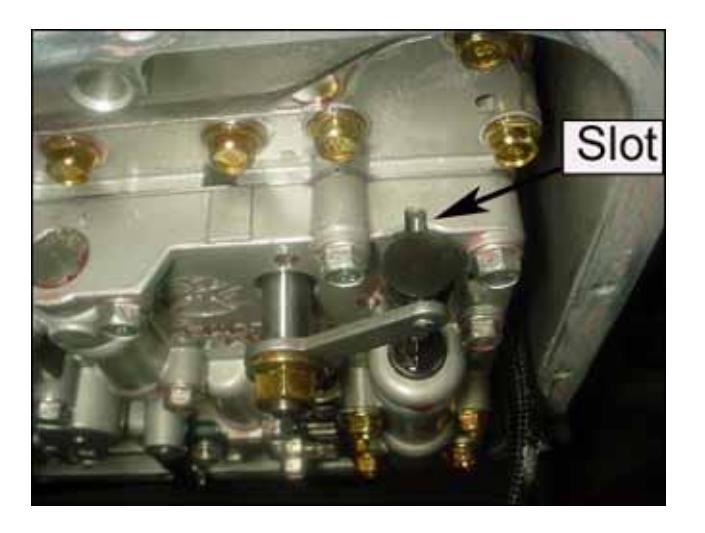
19. Install the valve body and torque the bolts to specification.

Torque: 7~8 lb-ft (100~120 kgf.cm)

Bolt	Qty.	Length	Color
A	17	6x30 mm	Brass
В	1	6x35 mm	Silver
С	1	6x40 mm	Black
D	1	6x55 mm	Brass
E	1	6x60 mm	Silver

20. Confirm the manual valve is inserted into the slot.

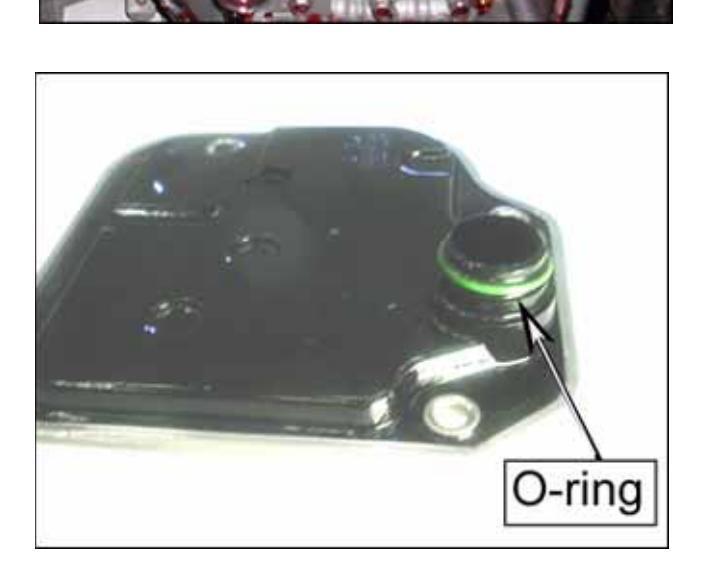
21. Install the manual valve lever to the manual valve and torque the nut to specification.

Torque: 7~8 lb-ft (100~120 kgf.cm)

- 22. Reconnect the fluid temperature sensor connector to the solenoid harness connector.
- 23. Install the o-ring on the oil filter.

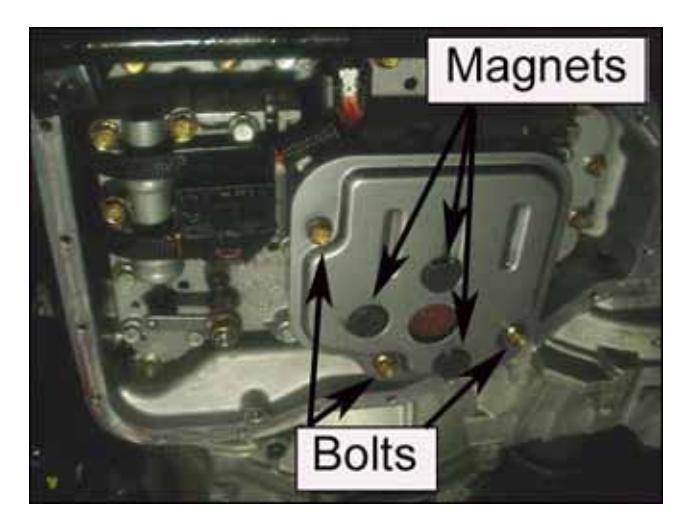
- 24. Install three magnets on the oil filter.
- 25. Install the oil filter with 3 bolts and torque to specification.

Torque: 7~8 lb-ft, 100~120 kgf.cm)
