# **Service Bulletin**

## Subject: Diagnostic Tip for Fuel System Contamination, Malfunction Indicator Lamp (MIL) Illuminated - DTC P026D, P2A00, P0171, P0172, and/or P0300

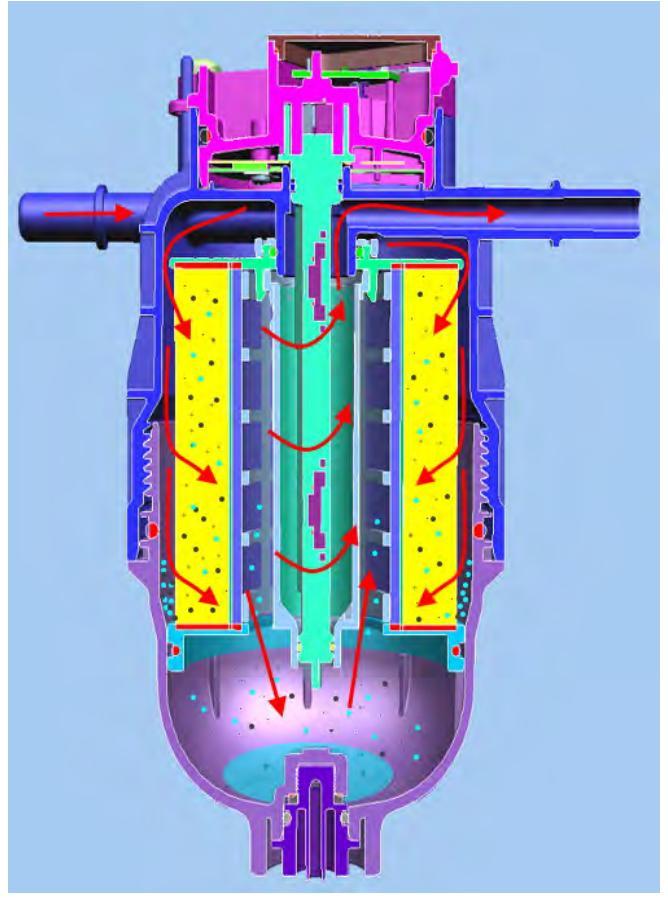
5417311

Water or other like contaminates in the fuel will create drivability concerns and loss of engine power. If water and/or debris is present in the fuel system, the fuel cannot cool and lubricate the components properly, causing overheating, rust and corrosion. This can result in component failure. Water and debris can enter the fuel system in several ways, either through a contaminated refueling source, plugged venting or through long term condensation in the vehicle fuel tanks.

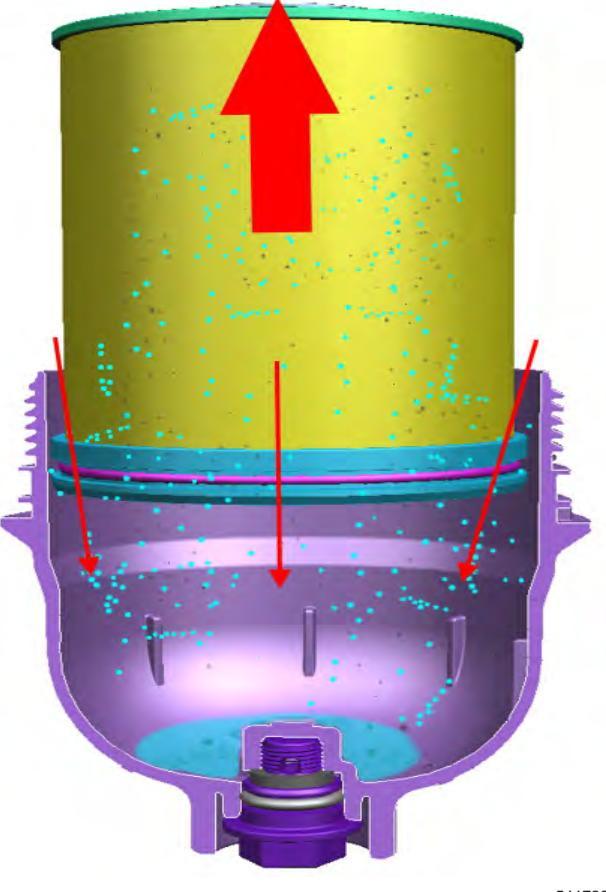
5417283

- If the filter is facing upwards, debris left on the sides of the filter may escape past the O-ring seal during removal and settle in the fuel/water separator reservoir.

- Water and/or debris left in the fuel/water separator reservoir will flow past the filter, directly in to the fuel system when re-started.
- Debris that is allowed past the filter and into the fuel system can cause fuel injection issues that may set DTCs P2A00, P026D, P0300, P0172.
  Replacement of fuel injectors without a complete cleaning of the fuel system will only be a temporary fix until the debris gets into the new injectors.

- 3. Inspect the fuel/water separator reservoir and filter for heavy debris.
  - If heavy debris is found in the filter, clean the fuel/water separator reservoir and continue to the Fuel System Flushing Procedure.

- If no signs of debris are found, clean the fuel/ water separator reservoir, install new filter and refer to SI for further diagnostics.

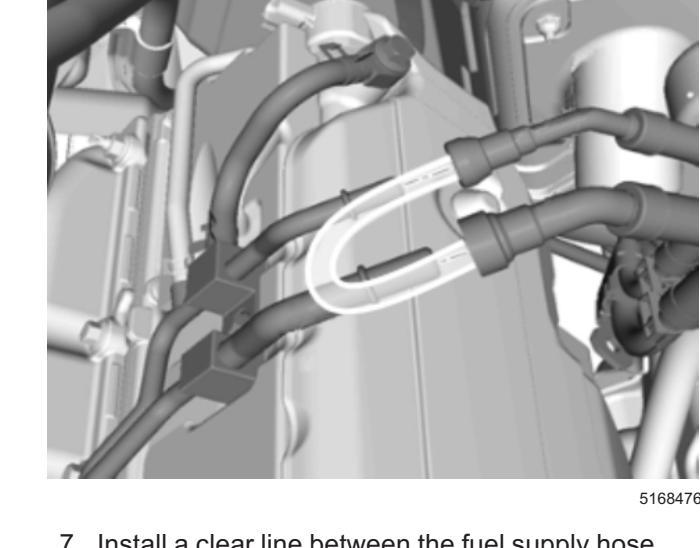
**Note:** The white "Tubing" shown in the graphics below depict the route of the clear line, not the length.

- 7. Install a clear line between the fuel supply hose and the fuel return hose.
- 8. Run the fuel pump until the fuel runs clear in the line.
