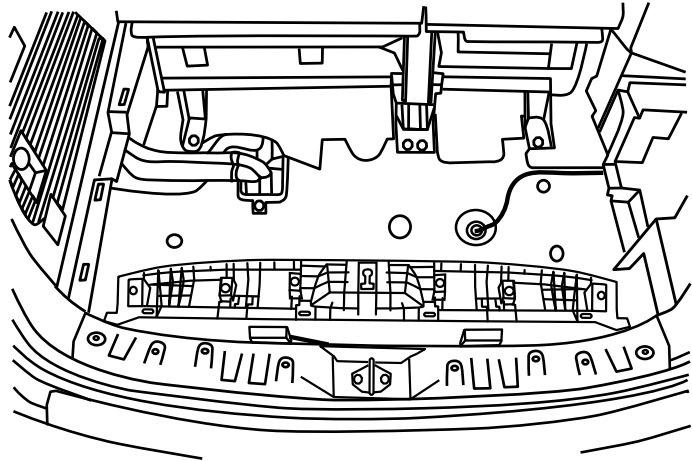
5. Remove the (4) clips to move the rear scuff panel ASSY.

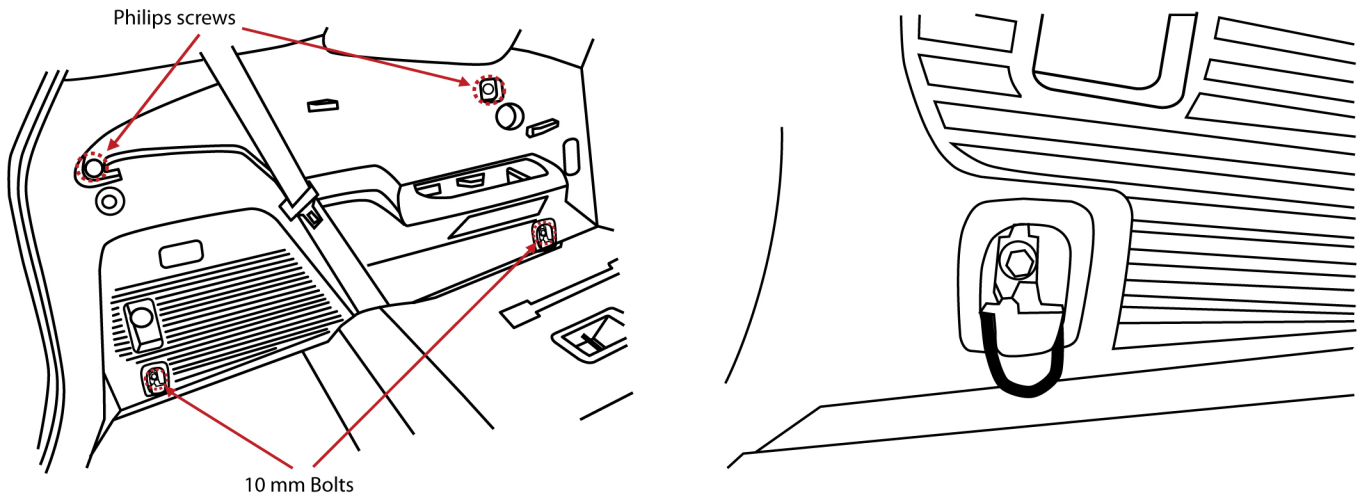
8. Remove (2) Philips screws (hidden under caps) and (2) 10mm bolts from trim panel apron.

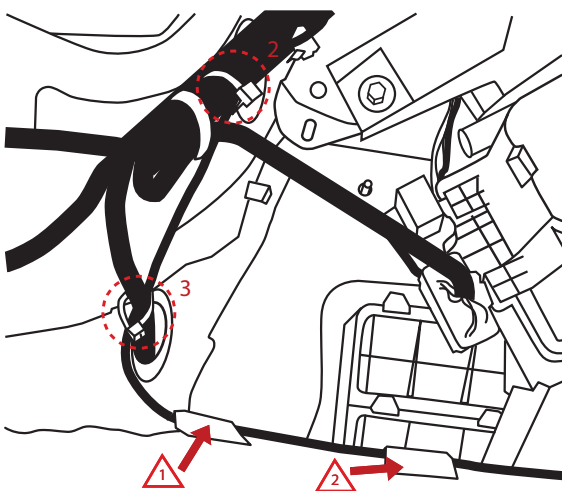
14. Route the harness as shown. Secure the harness with (4) wire ties at the white tape mark locations as shown (circles). Use (4) foam tapes to secure the harness to the floor as shown (arrows).

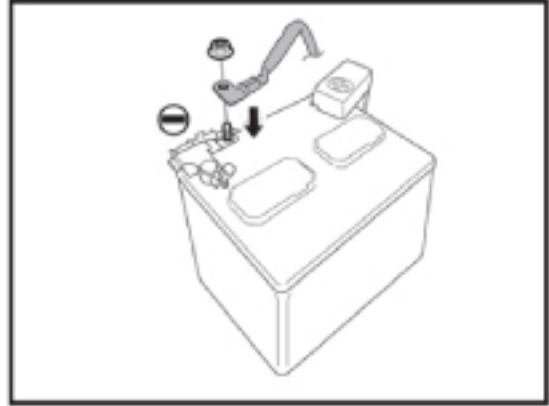
18. Re-install all panels and reverse order of removal. Reconnect negative battery terminal.

Note: Make sure LH apron trim is properly re-installed to vehicle and all clips are fully engaged.
