General Service Bulletin (GSB):	Proper Seating of Connector C2280G to the Body Control Module
GSB Overview:	GSB Showing how to verify a proper connection of connector C2280G to the Body Control Module (BCM)
NOTE: This information is not intended to replace or supersede any warranty, parts and service policy, Work Shop Manual (WSM) procedures or technical training or wiring diagram information.

Connector C2280G Proper Connection GSB

2011- 2014 F150

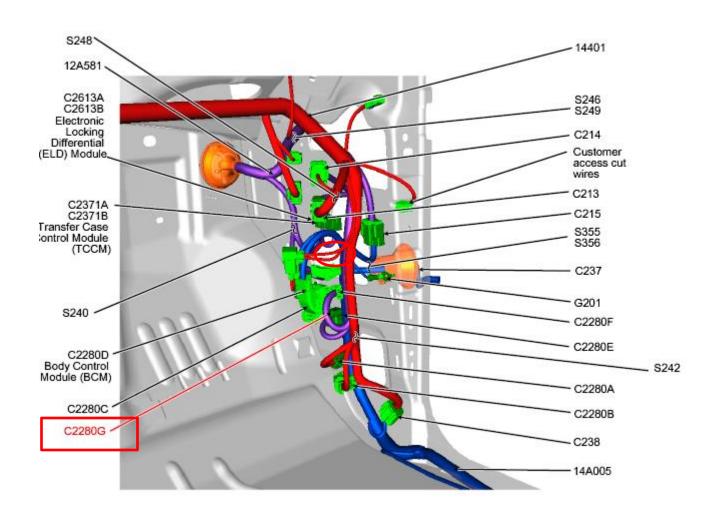
Location of BCM Connector C2280G

(as shown in Wiring Diagram)

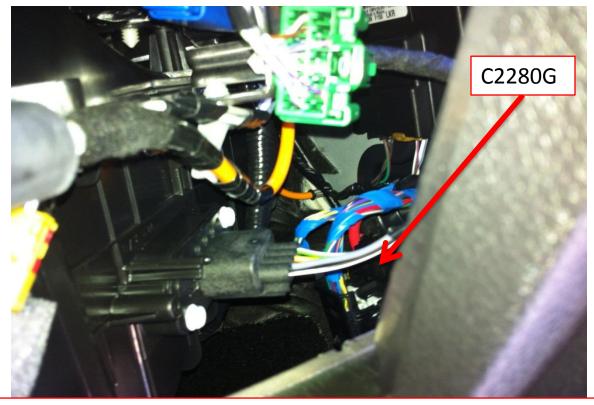
Location of BCM Connector C2280G (in vehicle)

C2280G Is located on the right hand side of the vehicle, behind the glovebox

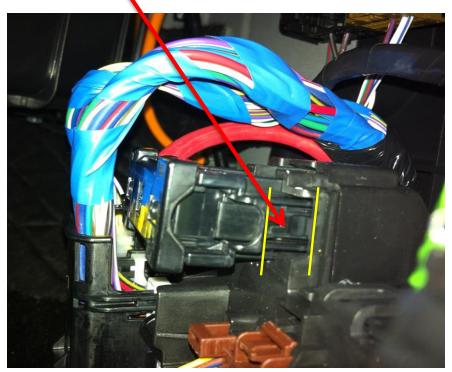
NOT CONNECTED, NOT FULLY SEATED

Notice space between connector and module.

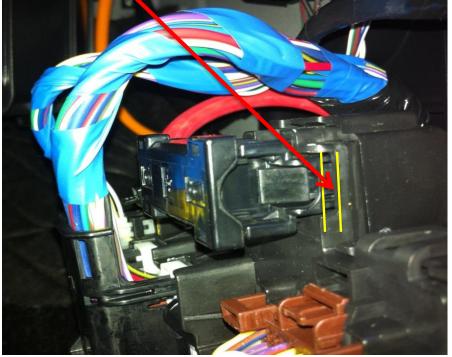
CONNECTED BUT NOT FULLY SEATED

Notice space between connector and module.

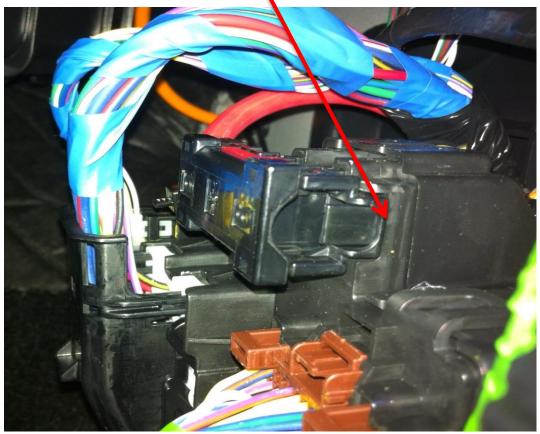
CONNECTED AND FULLY SEATED

Example of a "Good" Connection

No space between the module and connector.
