# MULTI-MODEL (EQUIPPED WITH AUTO-DIMMING MIRROR)

## *AUTO-DIMMING MIRROR IMPROPER OPERATION*

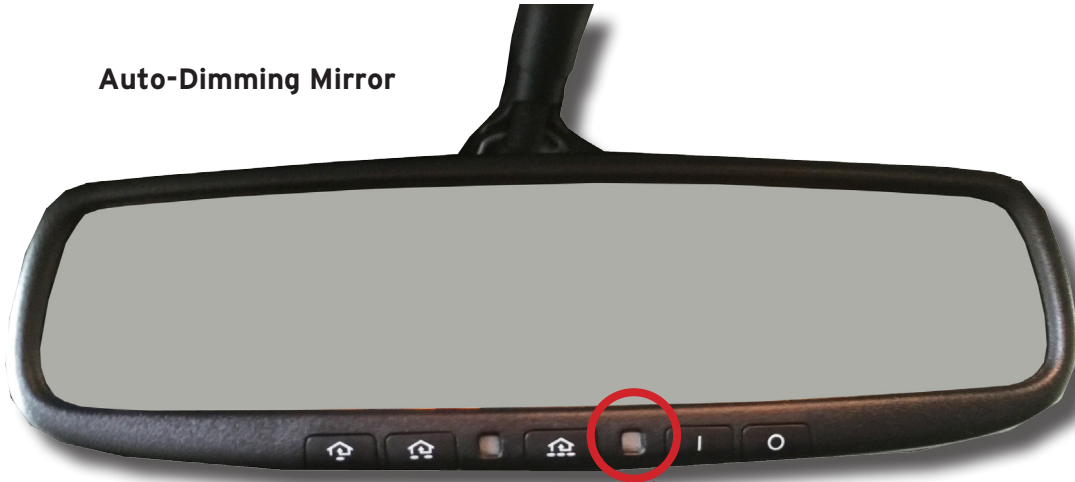
**Auto-Dimming Mirror**

**Front Light Sensor**

Some customers may complain about improper operation of the auto-dimming mirror. This may be caused by an obstruction of the front and/or rear light sensor(s) (e.g. hanging a parking permit from the mirror). Use a soft cloth with mild detergent to clean the mirror. Harsh detergent may damage the front and/or rear light sensor(s).

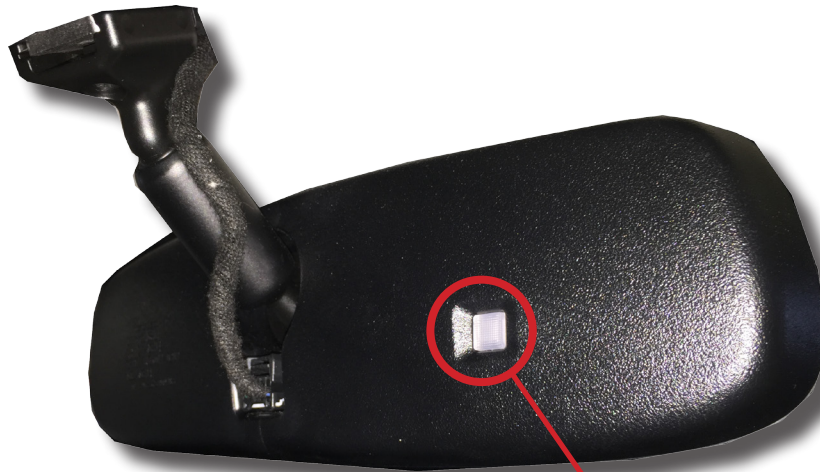
**Rear Light Sensor**
