GENERAL MOTORS  
DCS 7510  
URGENT - DISTRIBUTE IMMEDIATELY

Subject: REVISION: N262552010-01 – Customer Satisfaction Program  
Incorrect Power Seat Switch  
Revised Parts Table

Models: 2026 Cadillac OPTIQ

## N262552010 Incorrect Power Seat Switch

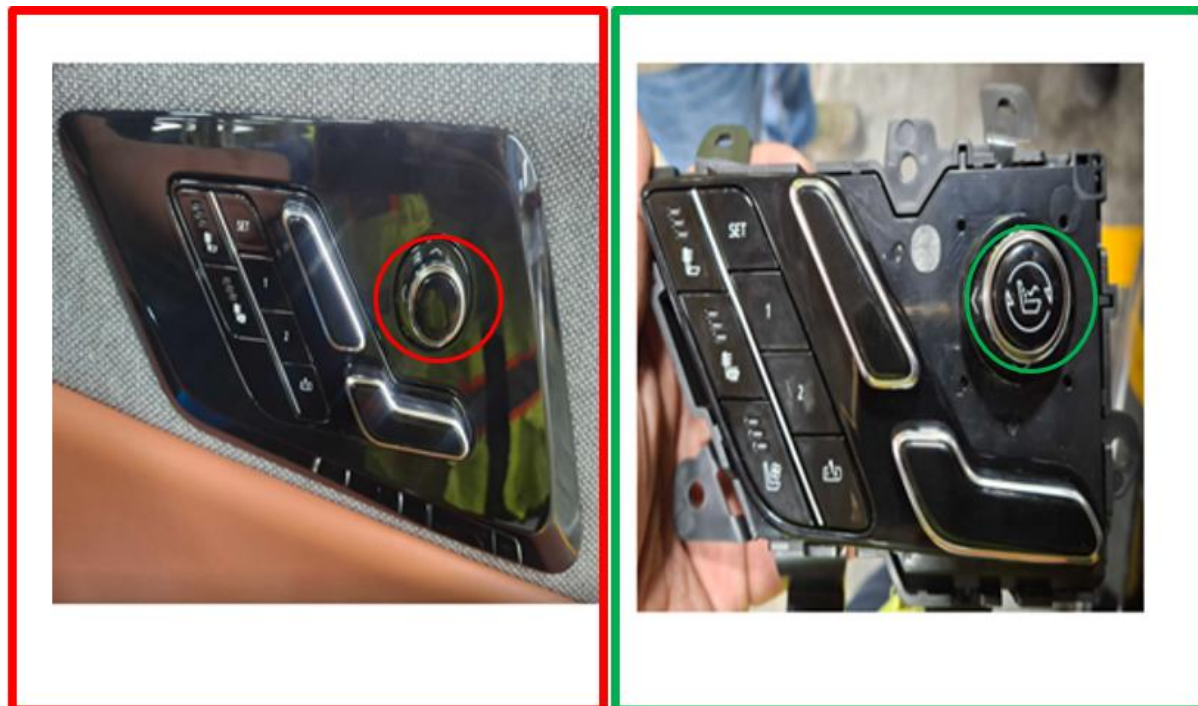
7135950

| <b>Condition</b> | Certain vehicles listed above may have been built with the incorrect power seat switch on the Driver's door panel. |

1. Inspect the Driver's side Front Seat Adjuster Switch. If the switch looks like the switch pictured on the left (red) the switch **MUST** be replaced, please proceed to step 2.

**Note: The suspect switch assembly will also be missing the ventilated seat button.**

If the switch looks like the switch on the right (green), no further action is required.

| <b>Correction</b> | Dealers will inspect the Driver's side power seat switch and replace it with the correct assembly, if necessary. |

2. Replace the Driver's side Front Seat Adjuster Switch. Refer to *Front Seat Adjuster Switch Replacement* in SI.
