| | | <b>MODEL I and Ix</b><br><b>DINETTE DRAWER FRONT REPAIR</b><br><b>INSTRUCTIONS</b> | | | <div><div>4</div><div>3</div><div>2</div><div>1</div><div>0</div></div> <div>1</div> <div>Difficulty Level</div> |
| WI: | WI-089-2026 Model I and Ix Dinette Drawer Front Repair Instructions | | | | |
| PRODUCT: | Model I and Ix | VIN Range: | 000001 - 003366 | REVISION: | REV-A |

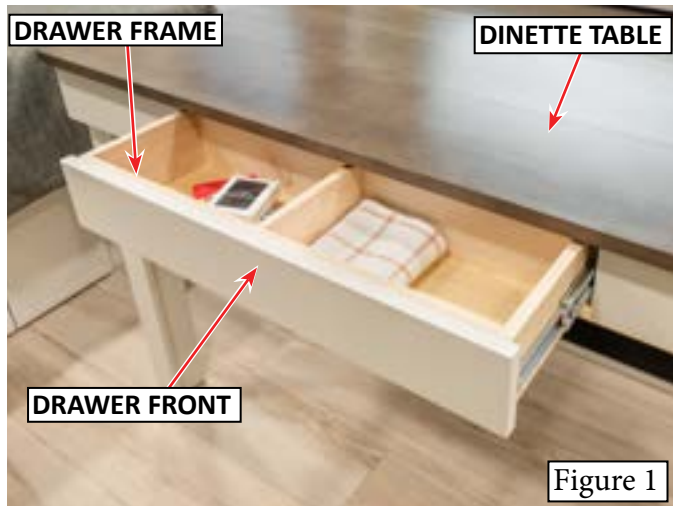
1. READ AND UNDERSTAND ALL INSTRUCTIONS PRIOR TO BEGINNING WORK.
2. Inspect the pull-out dinette silverware drawer to see if the drawer front is loose against the drawer frame (Figure 1). If it is, be sure the drawer front is centered on the drawer frame before proceeding to step #3.
3. Use a screw gun with a #2 square drive bit to install two (2) additional #8 X 1-1/4" wood screws (P/N 114379) through the drawer frame into the drawer front (Figure 2b and 2c). Position the screws offset as shown - one approximately 1" above the center line, and one approximately 1" below the center line.
4. Remove the original screws and replace them with new #8 X 1-1/4" wood screws (Figure 2c).
