## Recall Campaign 8026C – Battery Label Concern

| Model | Plant | Subject VIN range | Production date range |
|---|---|---|---|
| 2025 CX-50 (Hybrid) | MTM | 7MMVA****TN142667–145555 | From September 8, 2025 to September 25, 2025 |

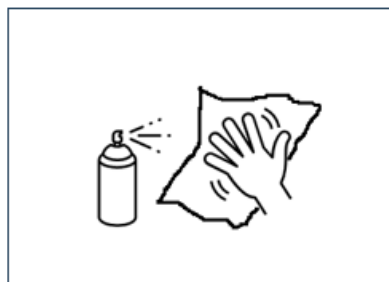
1. Remove Battery Label attached to the following location.

**NOTE:** Before removing Battery Label, clean and degrease body surface to prevent scratches using a clean shop cloth or microfiber cloth. \*Cleaning area is in light blue:

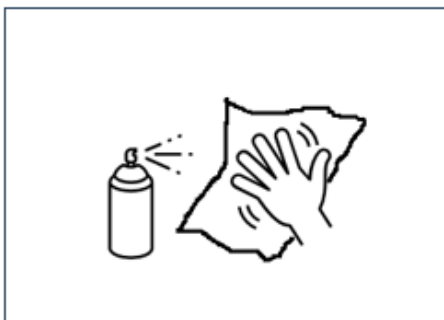
2. Clean the surface vehicle body where the Battery Label was attached.

- a. Apply parts cleaner(main ingredient: ethanol, isopropyl alcohol) to a microfiber cloth.
- b. Clean the body surface where the Battery Label was attached (remove residue 100%)

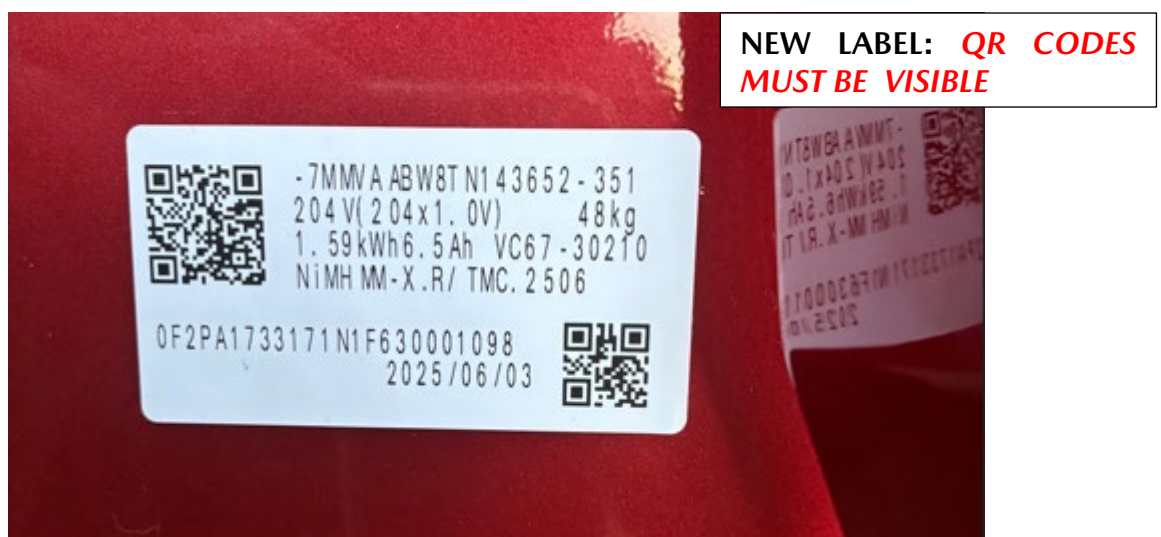
4. **PHOTO #1 – Installation of NEW label on B-Pillar**

- Take a picture of the area where the new Battery Label was placed.

**NOTE:** The printed contents (VIN and QR code) on the photographed battery label must be readable.

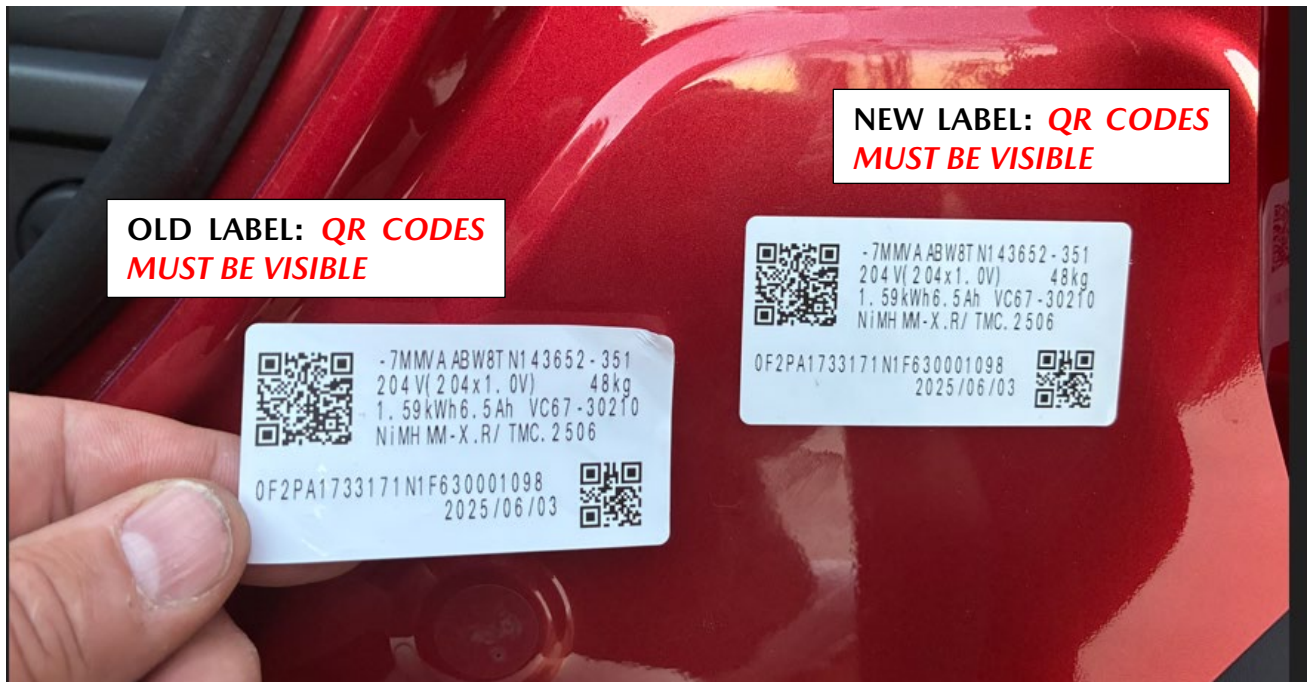
PHOTO #2 example: OLD and NEW label – clear photo – do not use black & white or pdf.

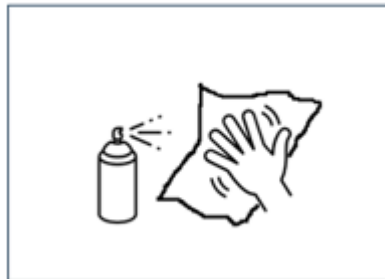
5. Remove the rear seat cushion according to procedure in Workshop Manual. ([See REAR SEAT CUSHION REMOVAL/INSTALLATION.](#))
6. Use a microfiber cloth to clean and degrease the area around the Battery label surface.  
\*Cleaning area is light blue as follows:

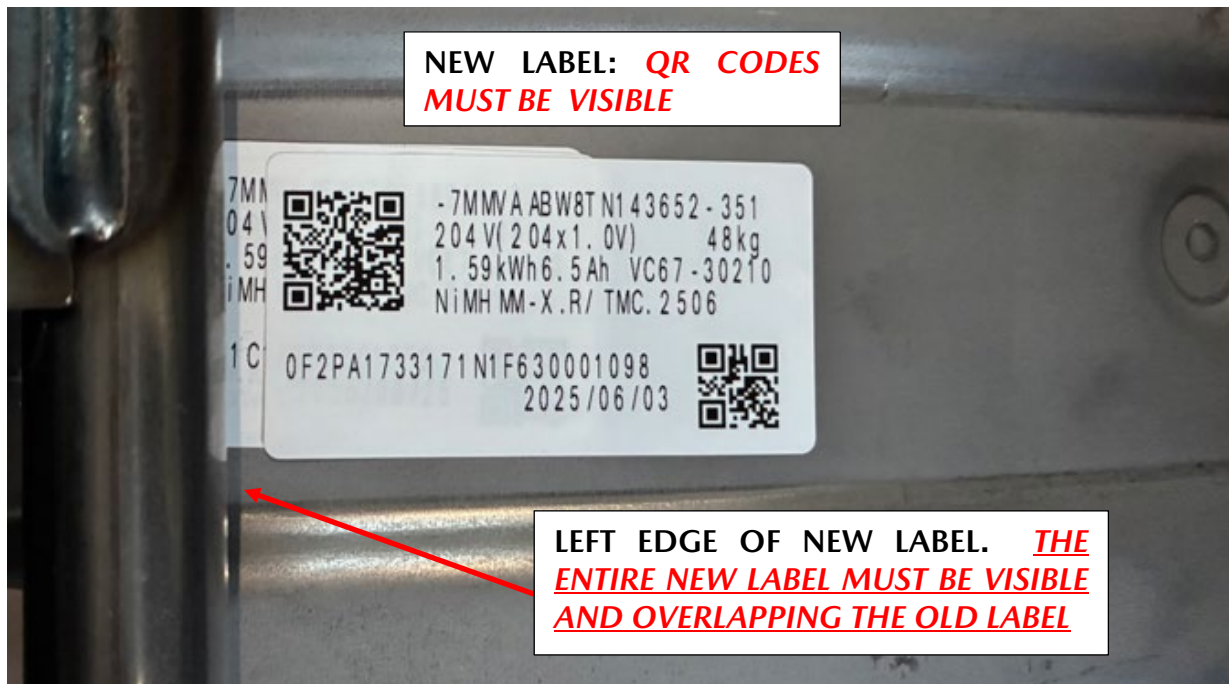
PHOTO # 3 example: Existing label – clear photo – do not use black & white or pdf

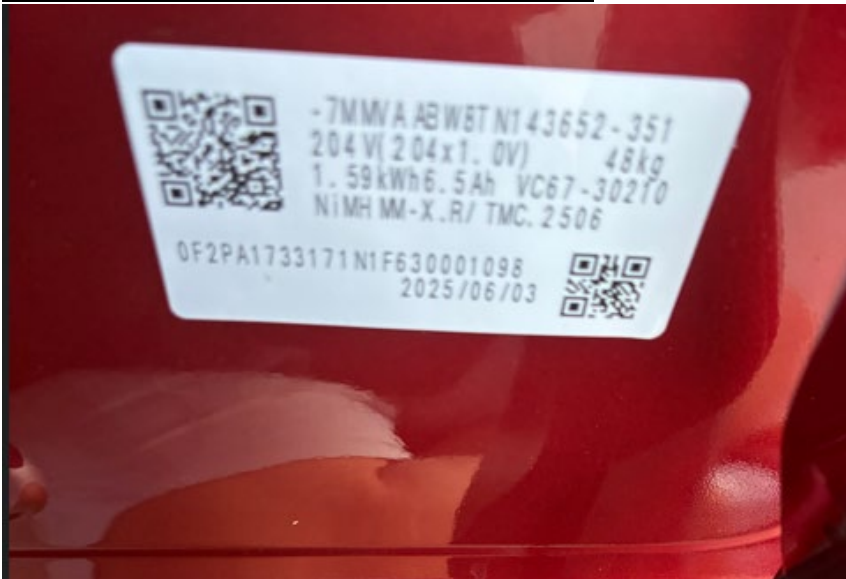
BLURRY AND OFF CENTER - UNACCEPTABLE

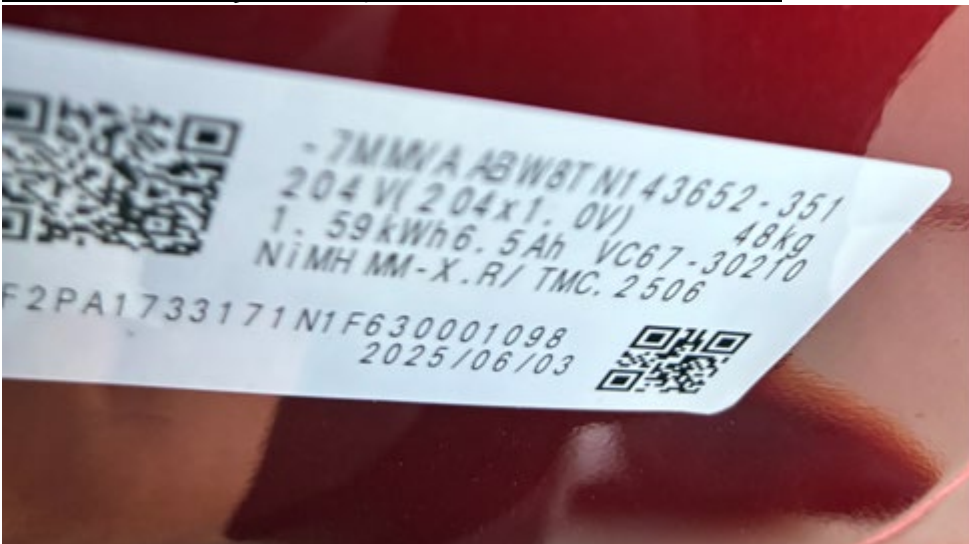
CANNOT READ QR CODES, TOO CLOSE - UNACCEPTABLE
