## Emissions Recall 8026C – Battery Label Concern - affecting 2026 CX-50 Hybrid vehicles

### CONDITION OF CONCERN

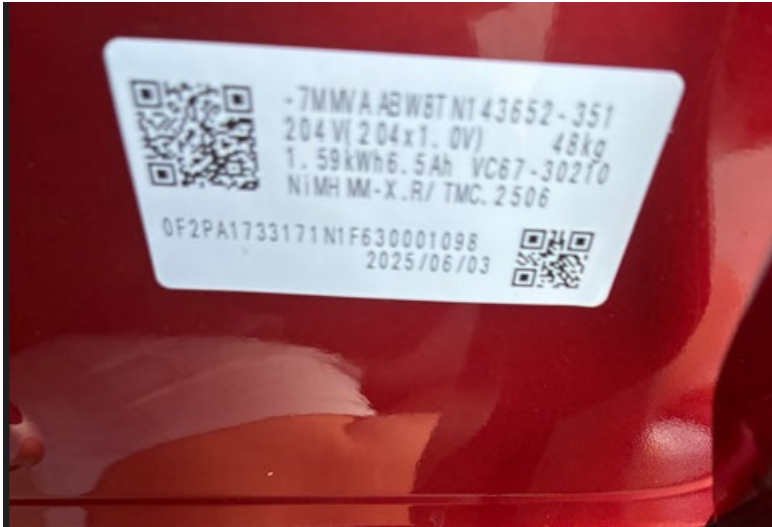
**BLURRY AND OFF CENTER - UNACCEPTABLE**

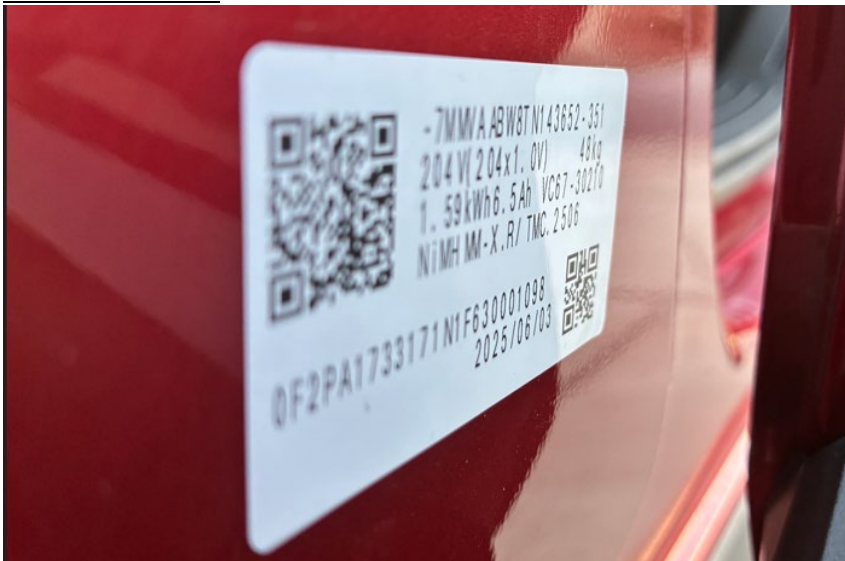
**UNACCEPTABLE**

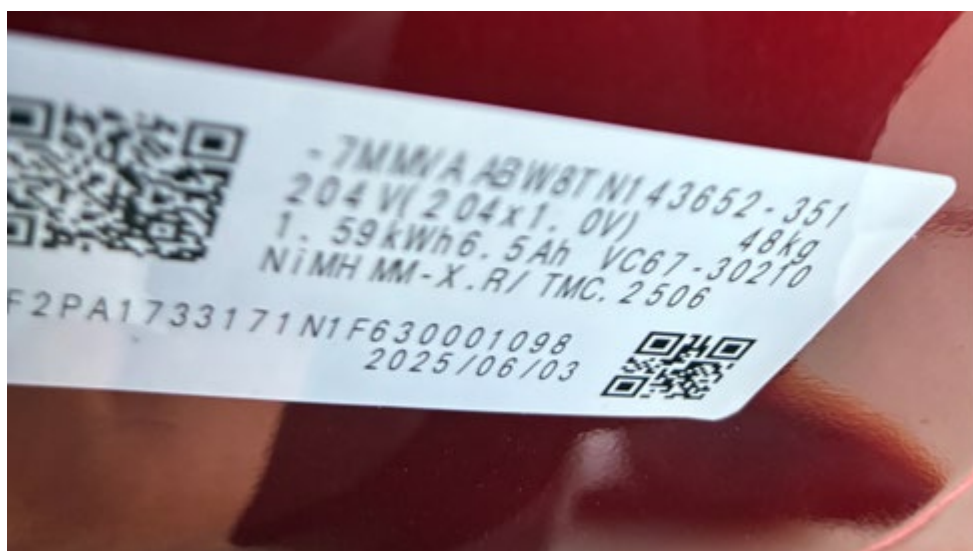
**CANNOT READ QR CODES, TOO CLOSE - UNACCEPTABLE**
