**Replacement Requirement for Wire Harness for Rear-View Mirror/Front Door or Front Main Wire Harness: Rework Signal Line for Mirror Camera (22/26)**

| Model Line: | <b>Panamera (YAA/YAB)</b> |
| Model Year: | <b>As of 2024</b> |
| Concerns: | <b>Plug contacts of the signal line for the mirror camera on the new mirror wire harness/front door/front main wire harness</b> |

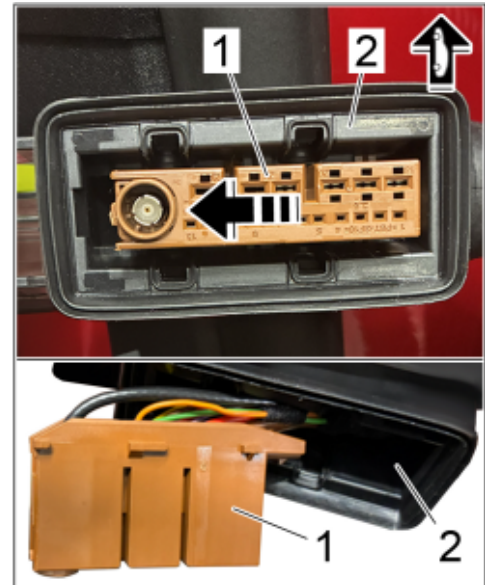
Example illustration of connector housing for door connection point

- 4 Release connector housing for door connection point  
 ⇒ Example illustration of connector housing for door connection point -1- in ⇒ Example illustration of connector housing for door connection point -Arrow direction- and pull it out of the mounting housing ⇒ Example illustration of connector housing for door connection point -2-.

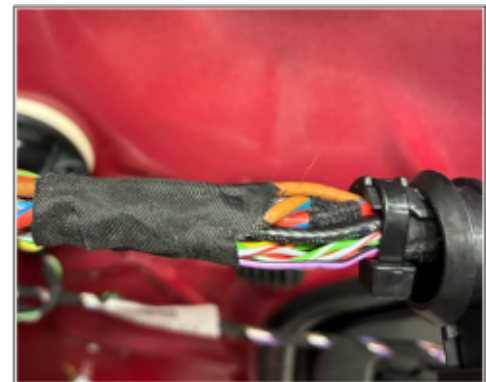
*Fabric tape*

If fabric tape has been opened or removed from the electric wire harness in the area below the grommet, re-attach it.  
⇒ *Fabric tape*
