Authored Date	14/05/2026	
Doc No.	IAMW0004502	
Title	Wheel Wrench Replacement	
Affected Vehicle(s)	Grenadier	PF000072 – PF009904 RF010491 – RF019001
Prior to starting any reworks, please make sure you check the vehicle is affected by checking the VIN using Vehicle Simple Search in the Warranty System.

Wheel Wrench – Remove and Install

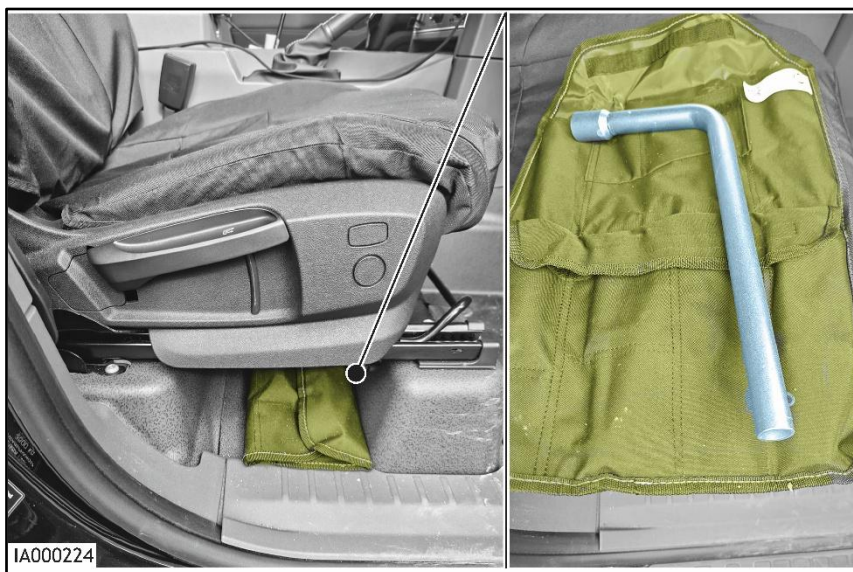
2.

- Remove the tool kit.
- Remove the wheel wrench.

- Install the new wheel wrench.

- Install the tool kit into its correct location.
