Service Bulletin

Bulletin No.: PIT6525

Subject: Drivers Seat Will Not Move

Brand:	Model:	Model Year:		VIN:		Engine:	Transmission:
		from	to	from	to		
Cadillac	XT5	2026		ALL	ALL	ALL	ALL

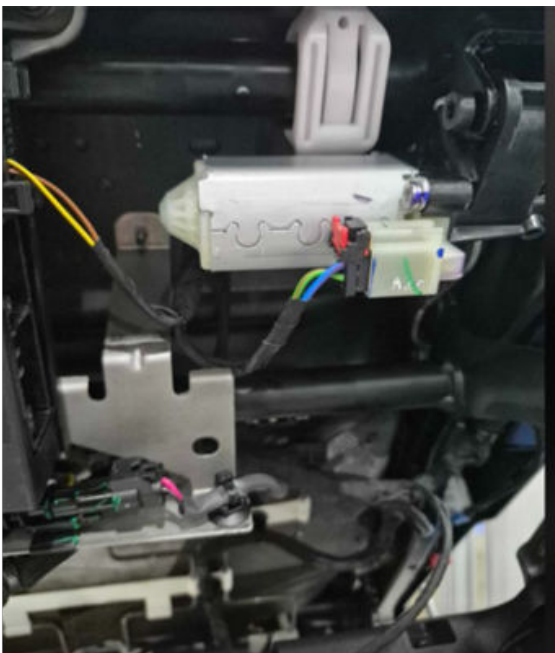
7149191

Involved Region or Country	North America
Condition	Driver's seat will not move.
Cause	Possible open fuse F33DA due to shorted circuits in driver seat.

Below is a photo from a Non- memory seat. Note the wire pinched below the bracket.

Inspect the circuits going to the vertical motor for being shorted together or shorted to ground.

Routing of the harness may be different on a memory seat. Repair damaged circuits following proper procedure in SI. Power and Signal Distribution>Wire and Connector Repair> Repair Instructions.
