GENERAL MOTORS
DCS7528
URGENT - DISTRIBUTE IMMEDIATELY

Subject: N262560510 - Service Update
Steering Column Fastener

Models: 2027 Chevrolet Bolt

N262560510 Steering Column Fastener

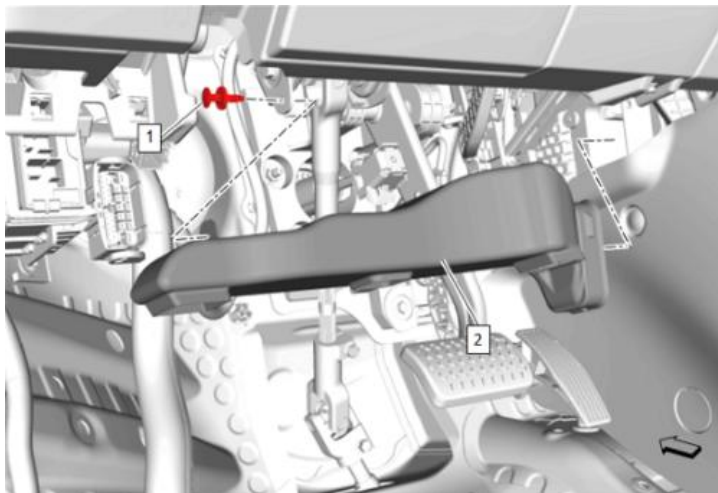
6962316

1. Remove the Floor Front Air Outlet Duct Retainer (1) and Duct (2).

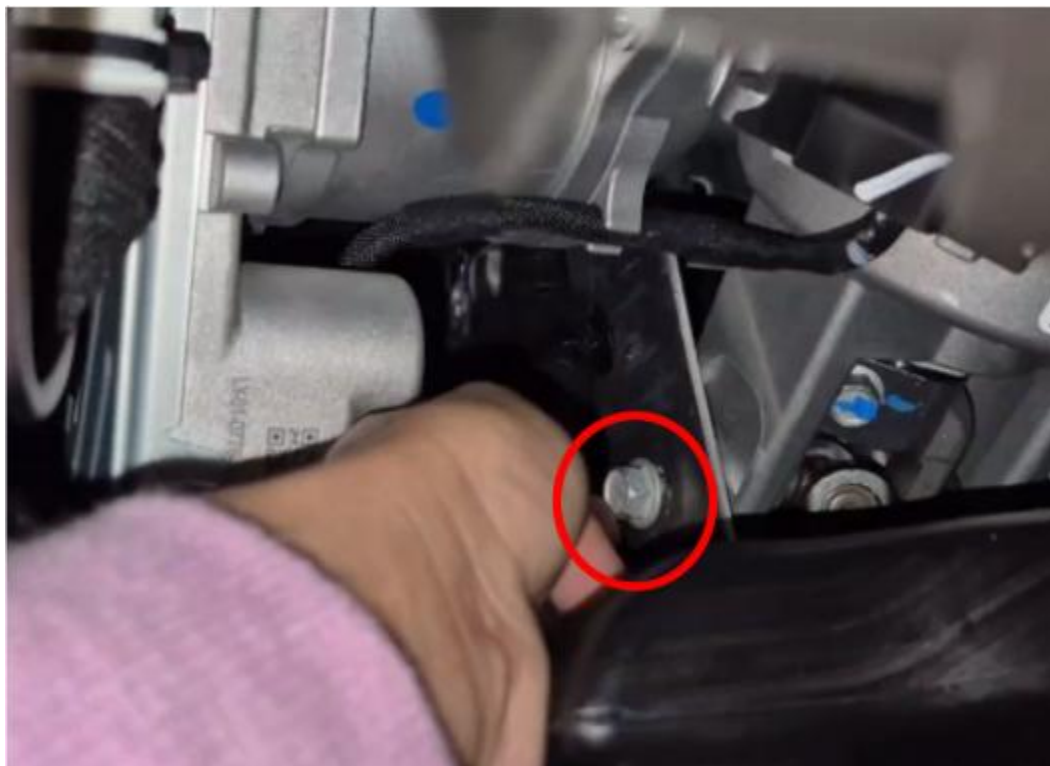
7165227

2. Looking up from the driver's side floor, locate the steering column bolt shown above.

Condition	Certain vehicles listed above may have a condition in which a fastener may be loose at the steering column to cockpit beam.
Correction	Dealers will inspect the fasteners and torque them to the proper value.

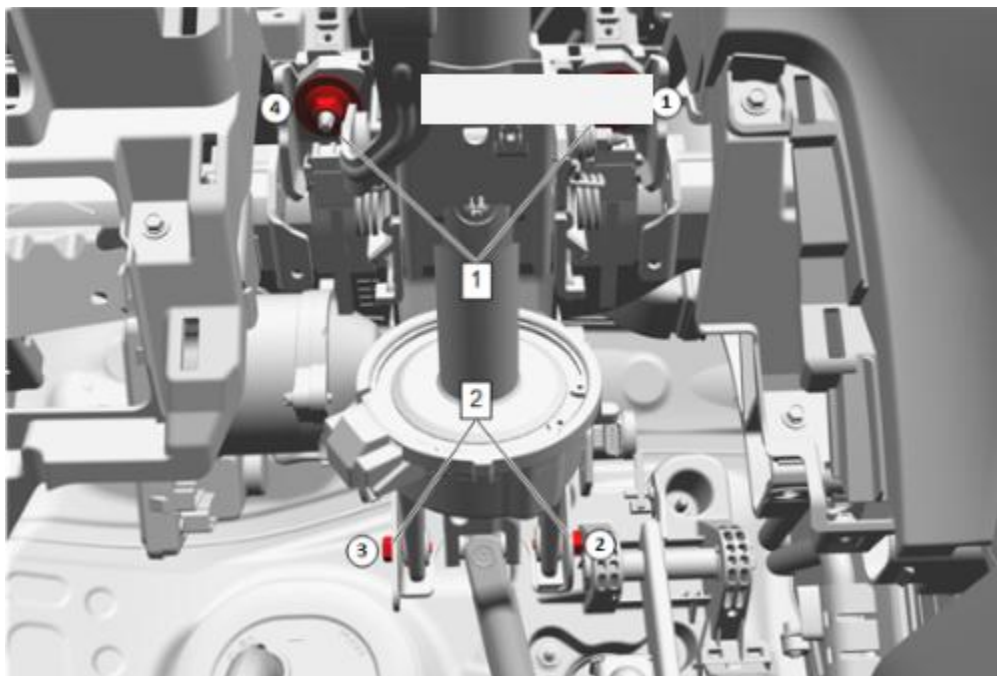
5699258

3. Slightly back off bolt number 3 shown above and then torque to **30 NM (22 lb ft)**.
4. Reinstall the Floor Front Air Outlet Duct Retainer.
