SERVICE BULLETIN

NUMBER: 09-74-21R
DATE: 05/06/21
REVISED: **06/25/26**

SUBJECT: Cleaning Procedure for Carbon Deposit Removal to Address Engine Misfire DTCs, Black Smoke from the Exhaust, Lack of Power, Knocking (Ping) and / or Rough Idle Concerns

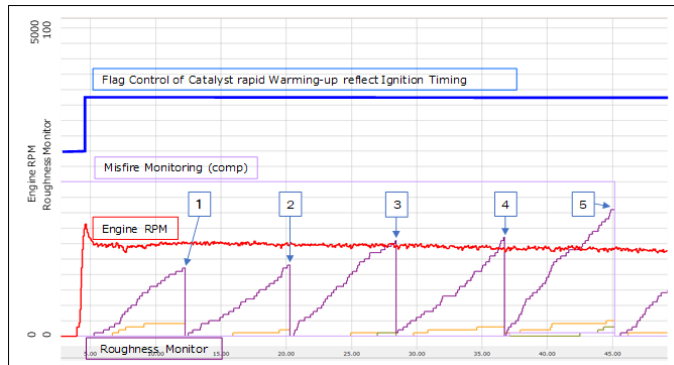
EXAMPLE 1:

Cylinder:	Peak 1	Peak 2	Peak 3	Peak 4	Peak 5	Total:
#1 (Orange)	4	2	1	3	5	169
#2 (Blue)	0	0	1	0	3	
#3 (Purple)	22	23	31	32	41	
#4 (Green)	0	0	0	0	1

- Flag control of Catalyst Rapid Warming-up reflect Ignition Timing
- Misfire Monitoring (comp)
- Engine RPM
- Roughness Counters #1, #2, #3 and #4.
- The roughness counter rises and resets (drops sharply) repeatedly which is the reason the signals form triangles. Read the peak values of each triangle on all cylinders until the “Misfire Monitoring (comp)” changes to “0” then, add all the values to get a “total” value. A **TOTAL** count of **34 or less** is to be considered acceptable.

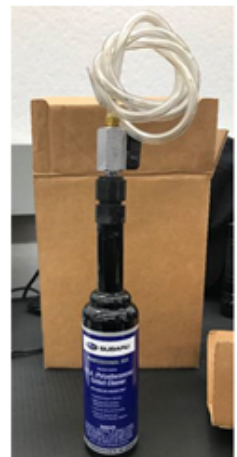
- **STEP 3 (all models):** Pour **ONE** full bottle of P.E.A. carbon cleaner into the vehicle's **FULL** fuel tank. **REMINDER:** The fuel tank **MUST** be **FULL**.
- **STEP 4:** With the valve **CLOSED** as shown below, remove the cap and thread the applicator tool onto the P.E.A. bottle. During use, try to keep the bottle vertical to insure all the contents are consumed.

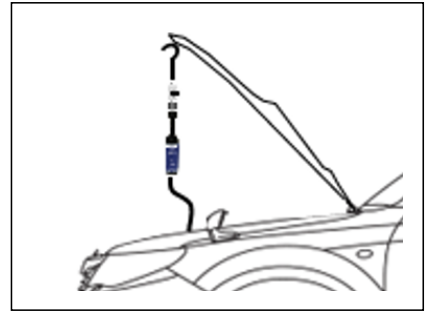
- **STEP 5:** Use the hanging hook to hold the assembled applicator tool on the hood striker as shown here.

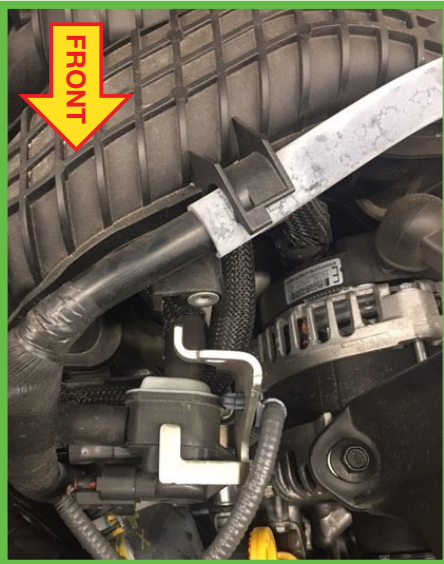
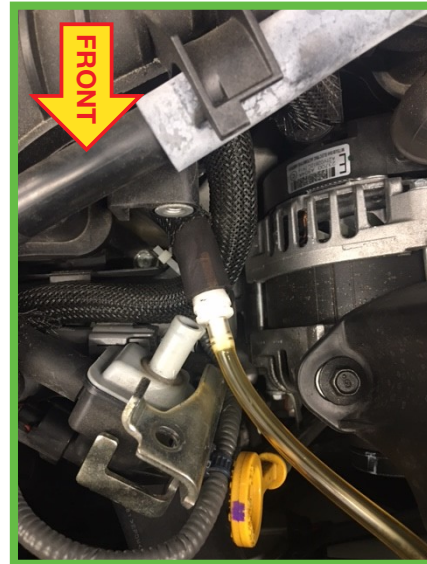
2.4 DIT

- **STEP 6:** Remove the purge hose and connect the hose from the applicator tool. Refer to the images below for the hose locations.
