SIB 52 04 26

BACKREST COVER COMES LOOSE BELOW APERTURE TRIM

2026-06-24

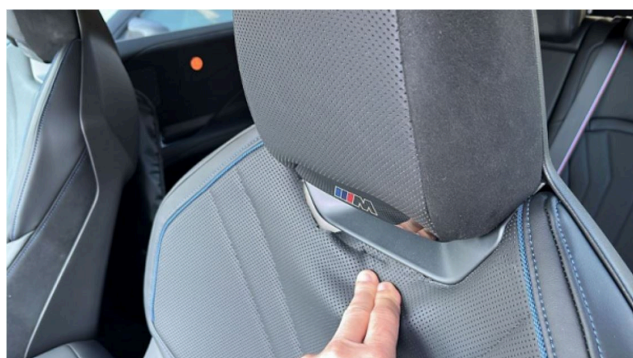
The backrest's front cover of the driver's seat is torn or too short. It does not stay in place under the upper plastic aperture trim.

This can also occur on the front passenger seat.

- 1-The trim hook of the seat backrest cover is not properly hooked to the seat.
- 2-The trim hook of the seat backrest cover is torn/damaged.

- 1-Correctly install seat backrest cover trim hook to the seat frame, or
- 2-Replace the damaged seat backrest cover.

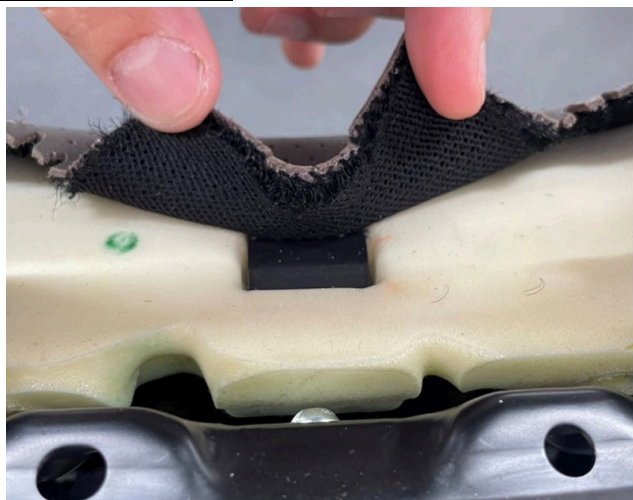
1. Raise the head restraint to its highest position.

Follow repair instructions 'Removing the front head restraint cover REP-TAT-P-5216-01' to remove the aperture trim.

Check whether the trim hook is present, and whether it is correctly hooked into the wire frame of the foam part.

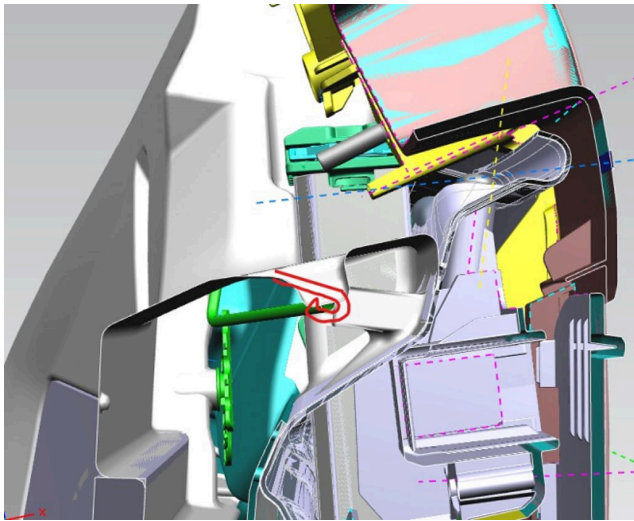
2. In this cutaway view the red hook must be clipped under the green metal frame to properly be retained under the seat aperture trim.

Reposition the trim hook as necessary, then reinstall the aperture trim.

3. If the trim hook of the seat backrest cover is torn/damaged, replace the seat cover.
