**Location:** Fuel Delivery System

**Topic:** DMTL 20 or 40 thou test not ok

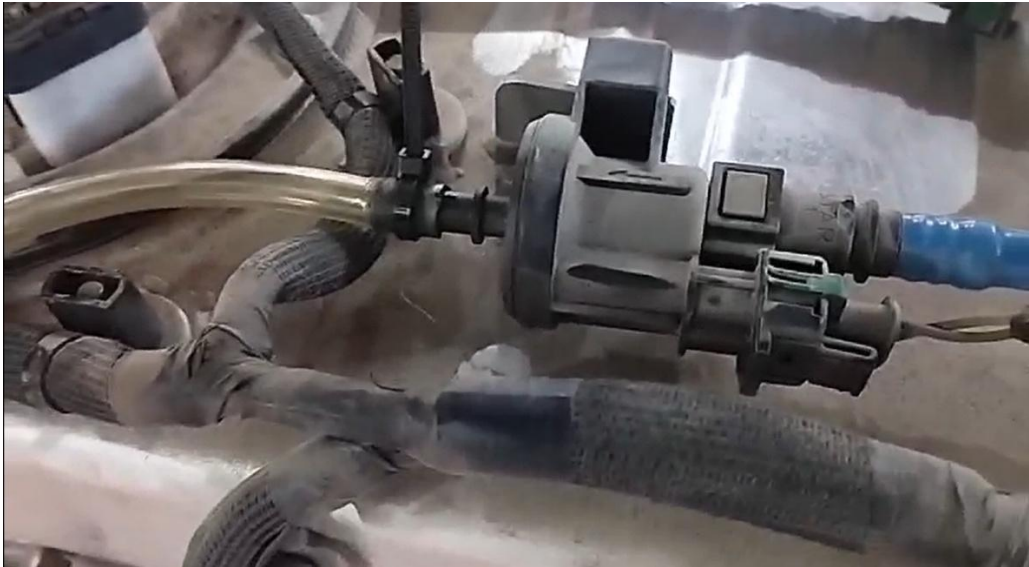
Therefore, check the purge valve is holding pressure by attaching Miti-vac tool in opposite direction to arrow (As per below image) and draw vacuum to test for leak.

**Care Point:** Check your Miti-vac gauge is not leaking internally by holding your finger against the end of the pipe and ensuring it holds a vacuum.

Remove the charcoal/carbon cannister and weigh it without the bracketry attached, compare to weight of new part, or confirm weight tolerance through TR. If found overweight, this may have been saturated because of leakage through the purge valve.
