JLRTB02149NAS2

**TECHNICAL BULLETIN**

310-01

Fuel Vapor Smell in Passenger Compartment - Further Enhancements

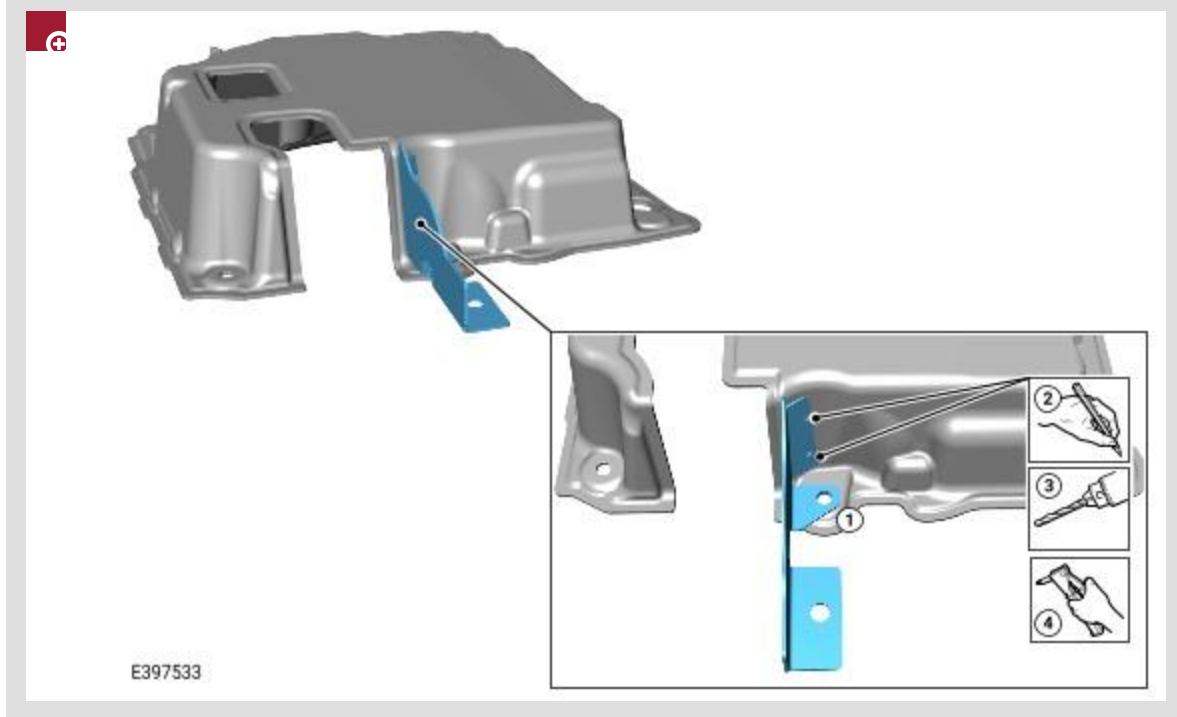
7.

Install the lower startup battery housing NVH outer deflector.

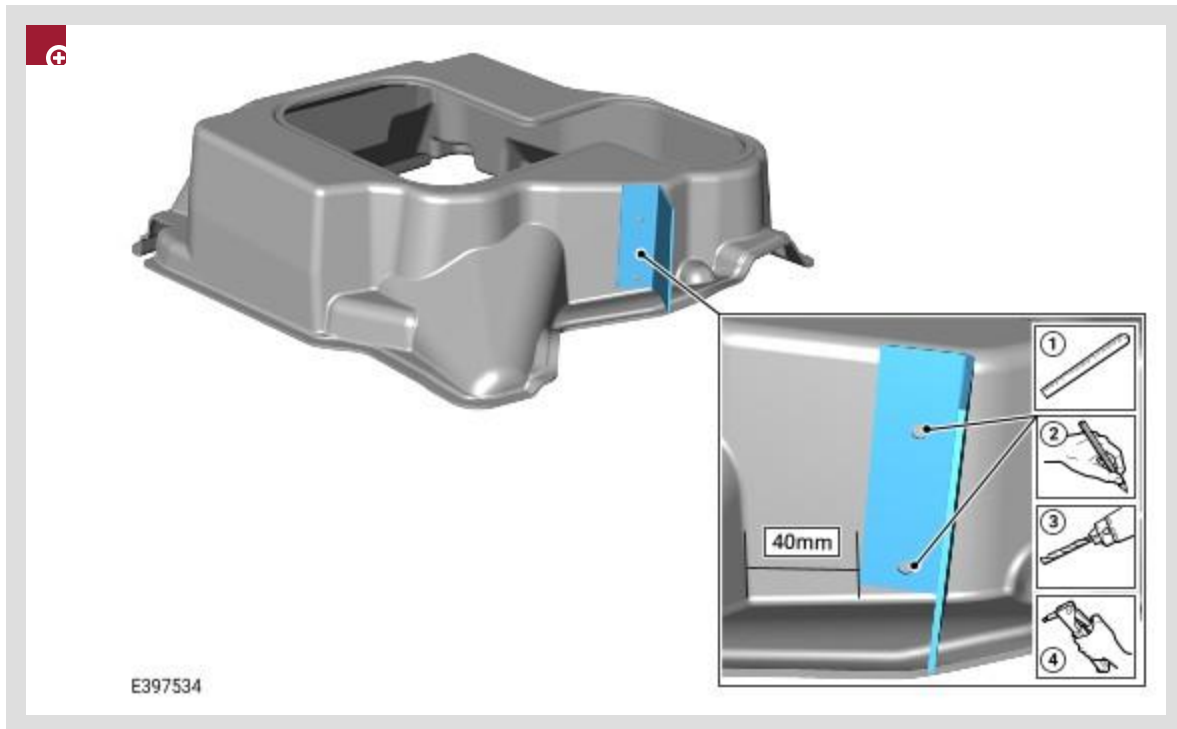
8.

Install the upper startup battery housing NVH inner deflector.

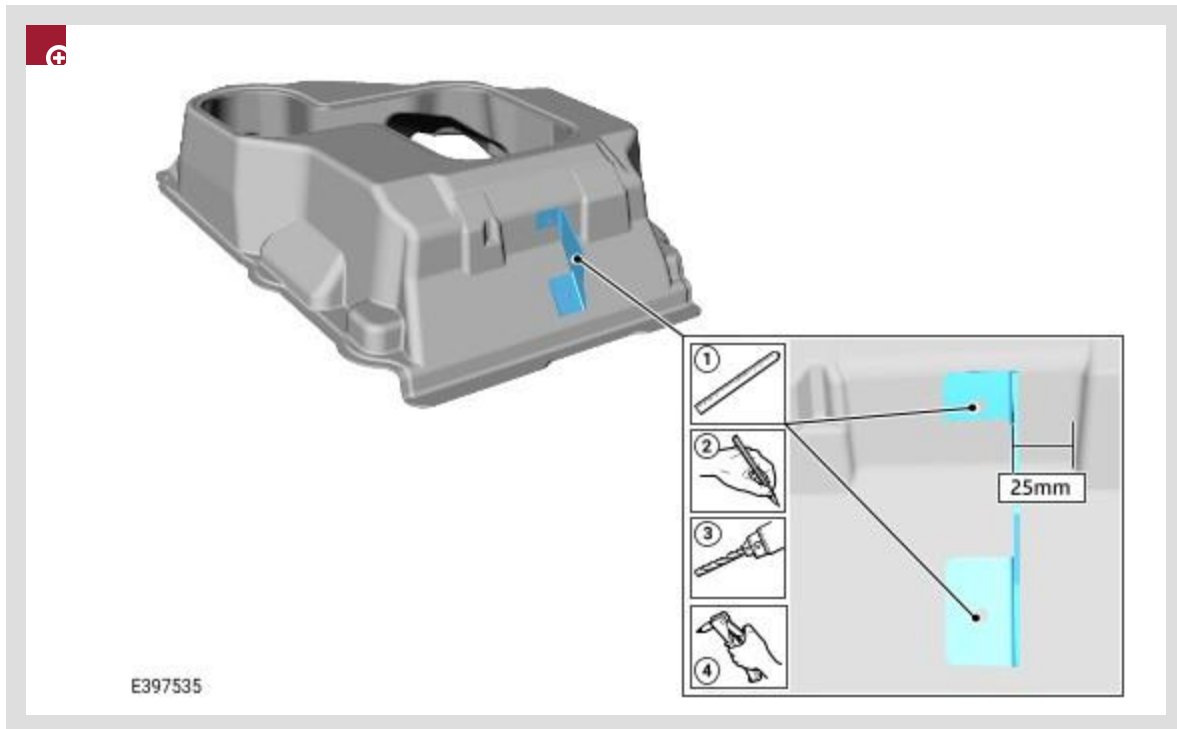
9.

Install the upper startup battery housing NVH outer deflector.

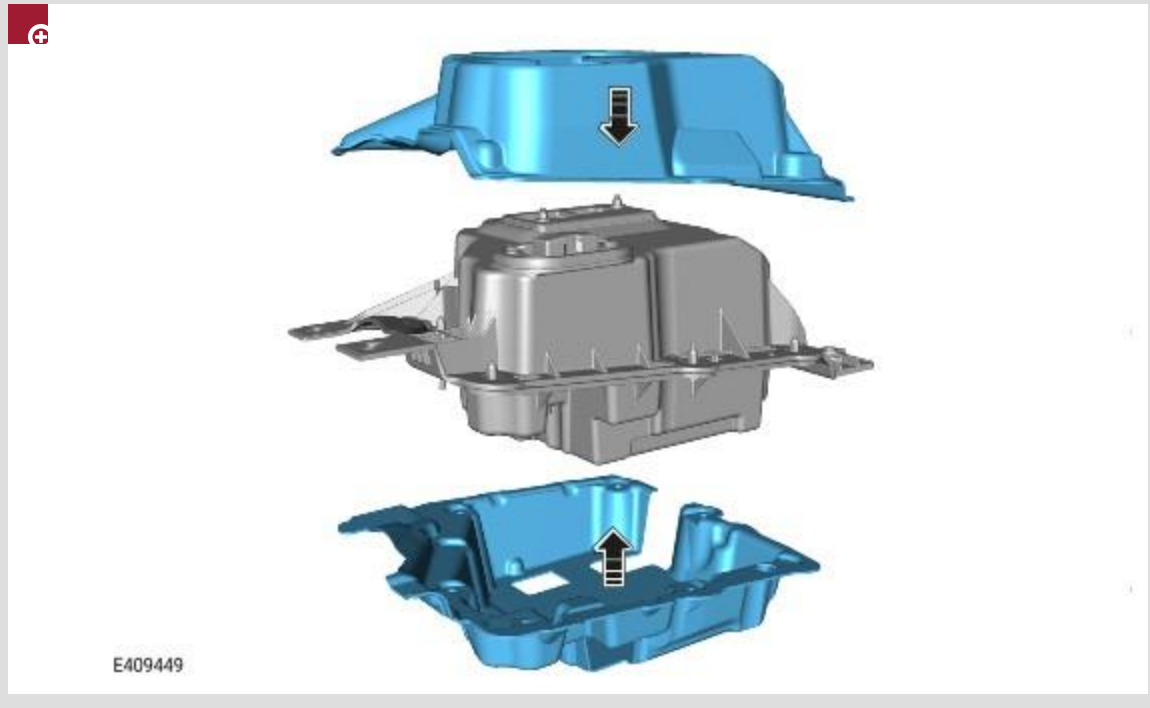
10.

Install the startup battery housing NVH cover.

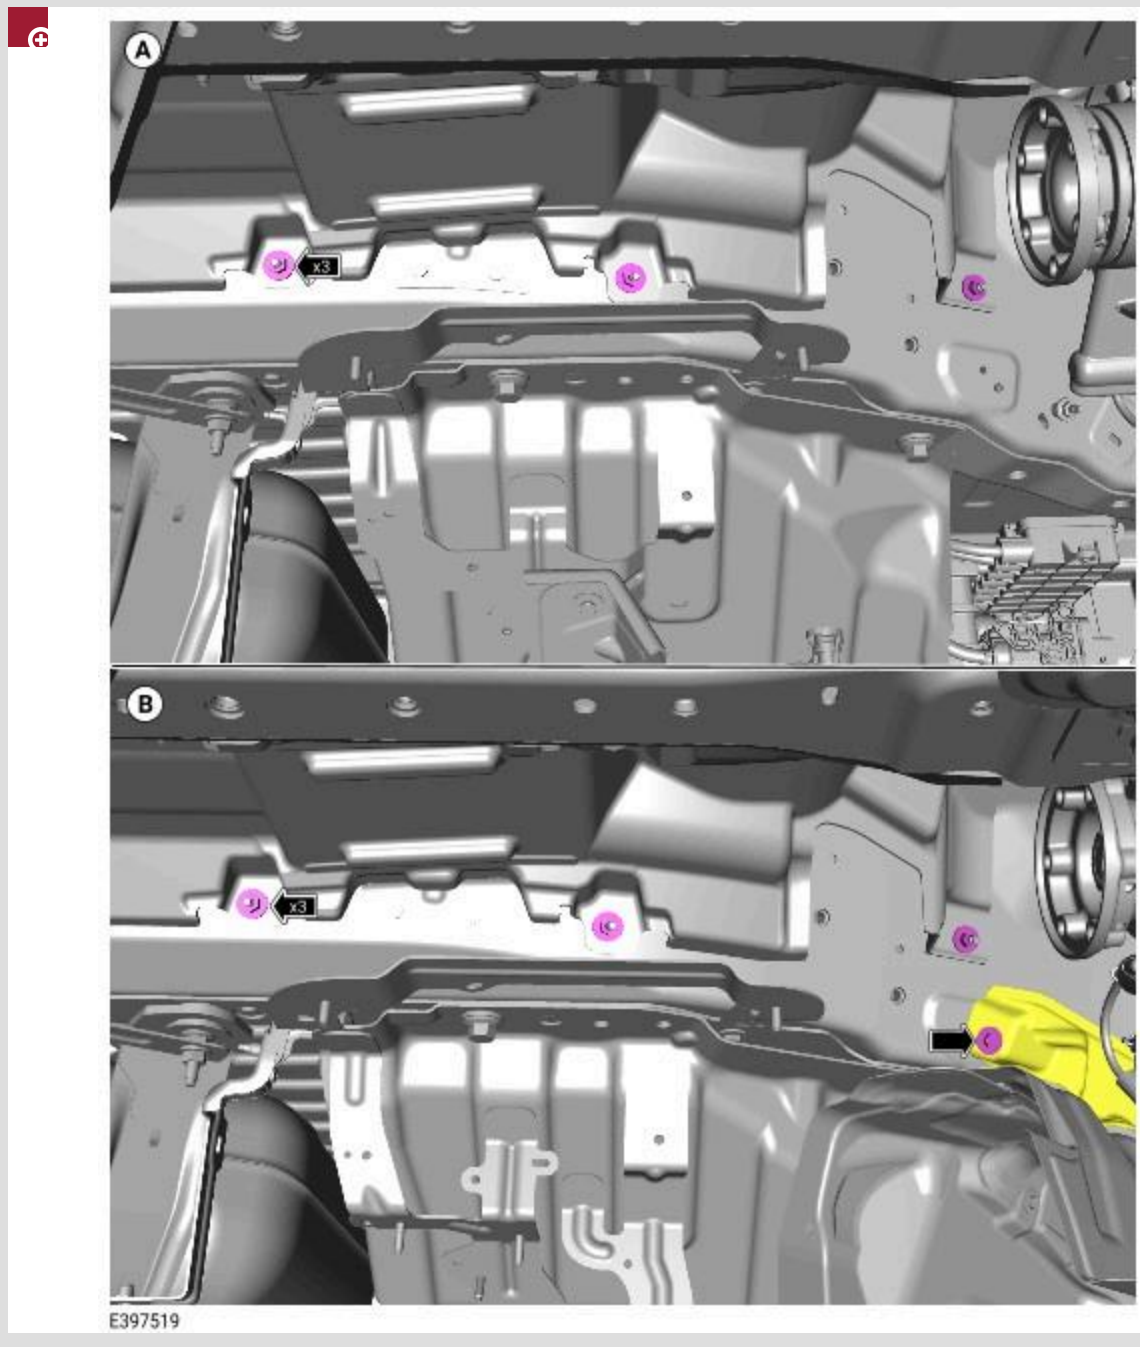
40.

Follow the instruction below that is applicable to the specification of vehicle.

- **(A) INGENIUM I6 3.0L Petrol / V8 T/C 4.4L Petrol NC10 vehicles** - Remove and retain the 3 nuts.
- **(B) V8 T/C 4.4L Petrol NC11 vehicles** - Remove and retain the 3 nuts and the bolt.

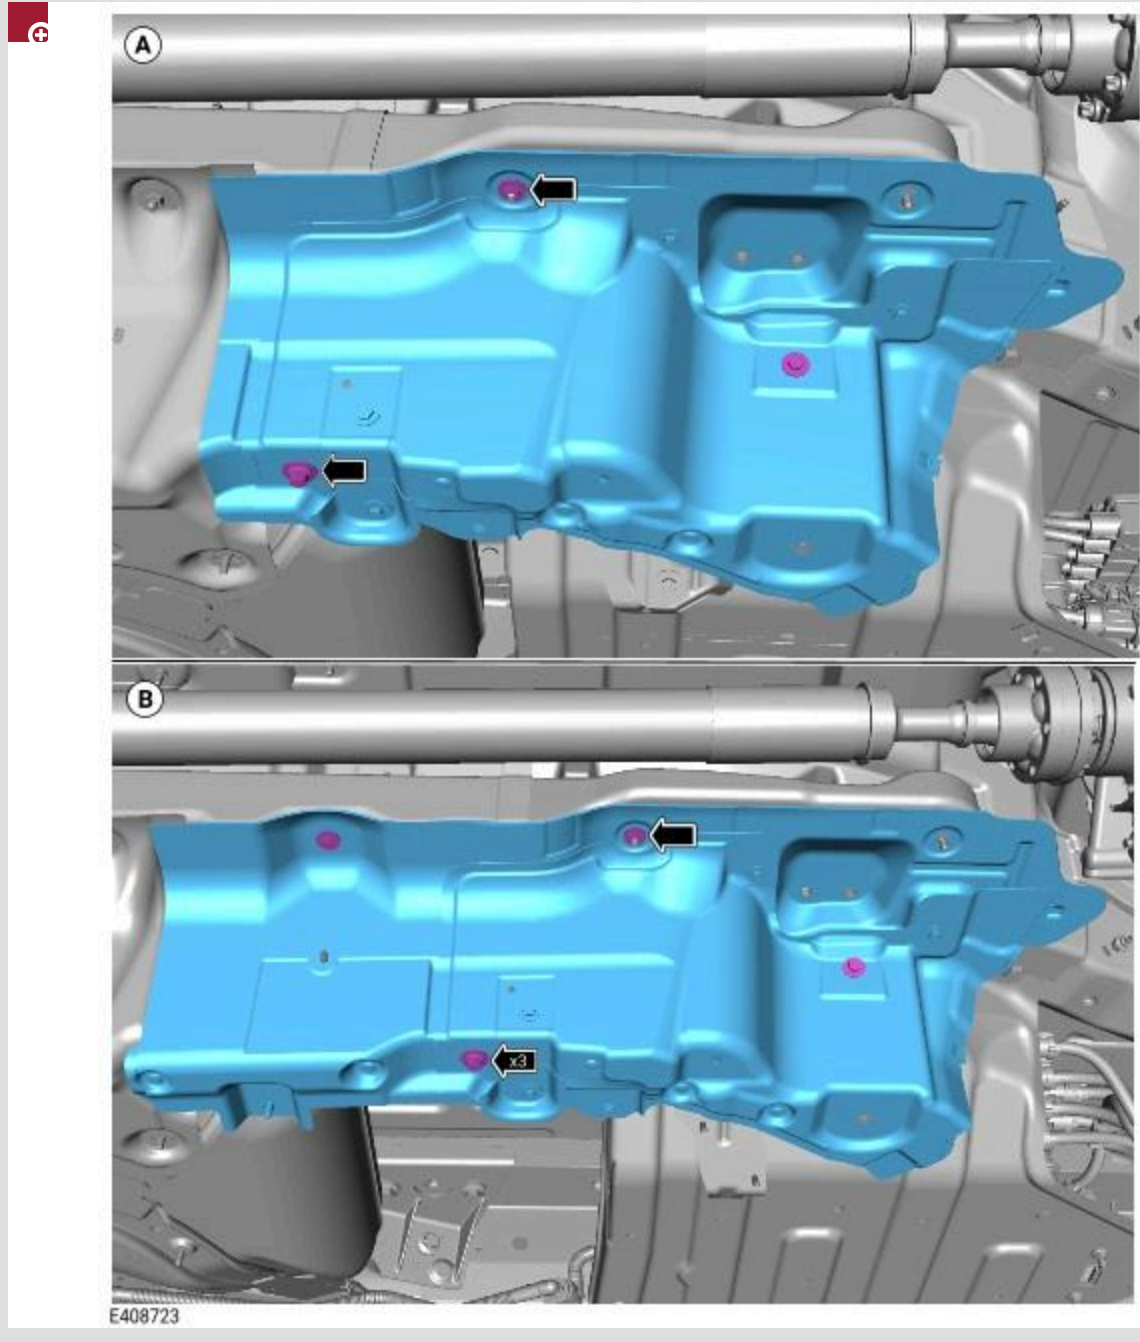
57.

Follow the instruction below that is applicable to the specification of vehicle.

- **(A) SWB INGENIUM I6 3.0L Petrol vehicles from 2025 model year -** Install the new left heatshield.
  - Install the nut previously removed.
    - Torque: **5Nm**
  - Install the bolt previously removed.
    - Torque: **5Nm**

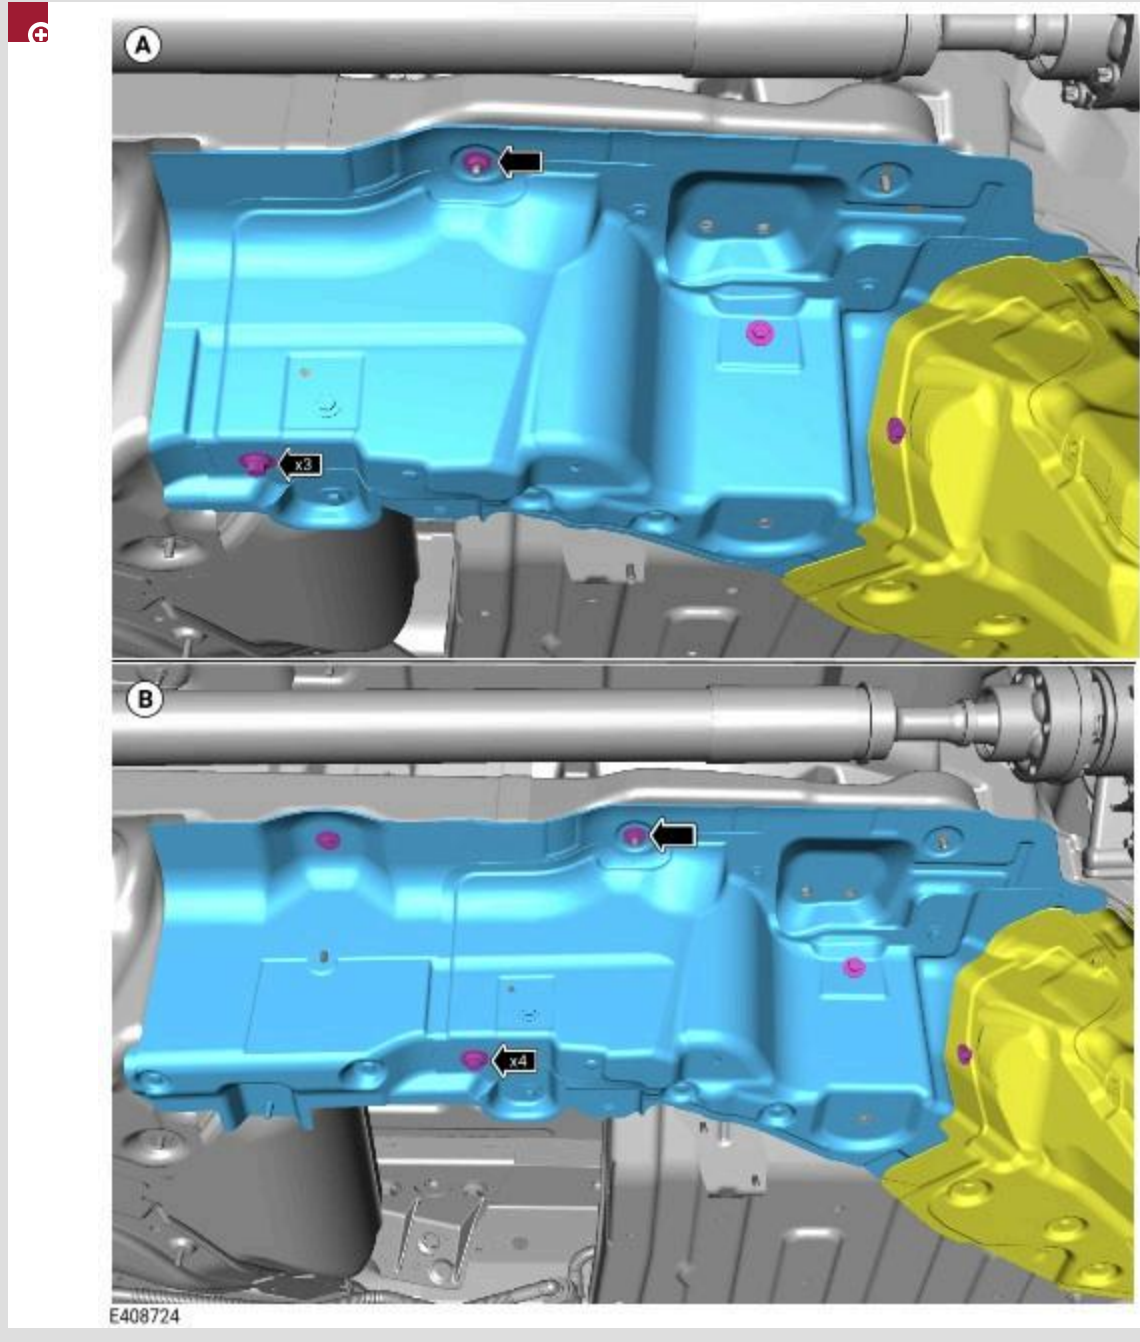
58.

Follow the instruction below that is applicable to the specification of vehicle.

- **(A) SWB V8 T/C 4.4L Petrol NC11 vehicles** - Install the new left heatshield.
  - Install the nut previously removed.
    - Torque: **5Nm**
  - Install the 3 bolts previously removed.
    - Torque: **5Nm**
- **(B) LWB V8 T/C 4.4L Petrol NC11 vehicles** - Install the new left heatshield.
  - Install the nut previously removed.

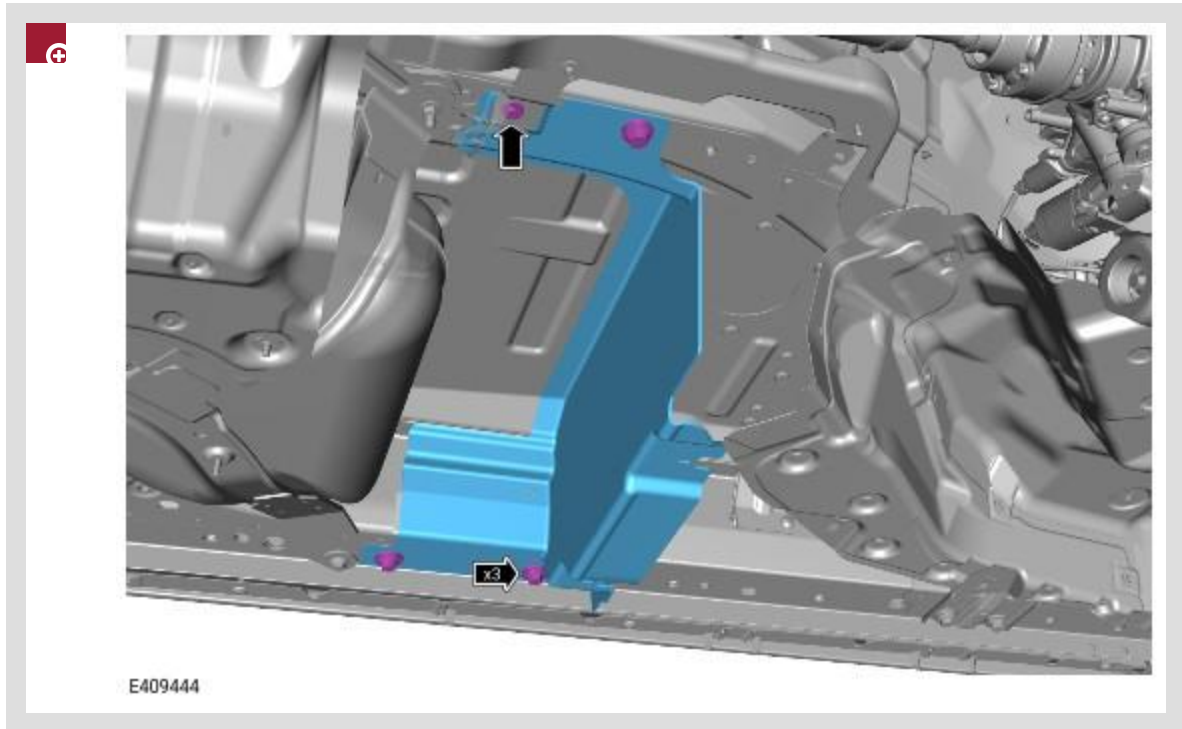
This step is required for ALL V8 T/C 4.4L Petrol NC10 vehicles.

Install the left fuel tank heatshield deflector in the location shown in the illustration.

- Install the bolt previously removed.
  - Torque: **5Nm**

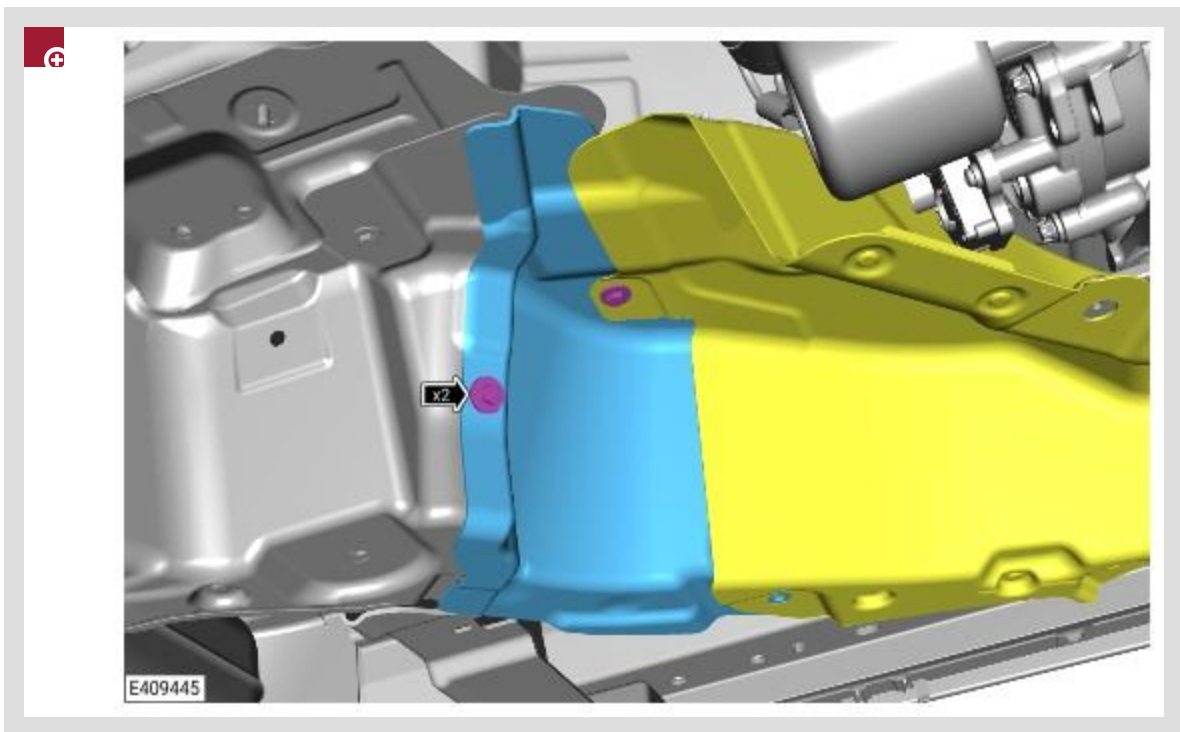
This step is required for ALL V8 T/C 4.4L Petrol NC10 vehicles.

Install the left in-fill heatshield.

- Install the 2 bolts previously removed.
  - Torque: **5Nm**

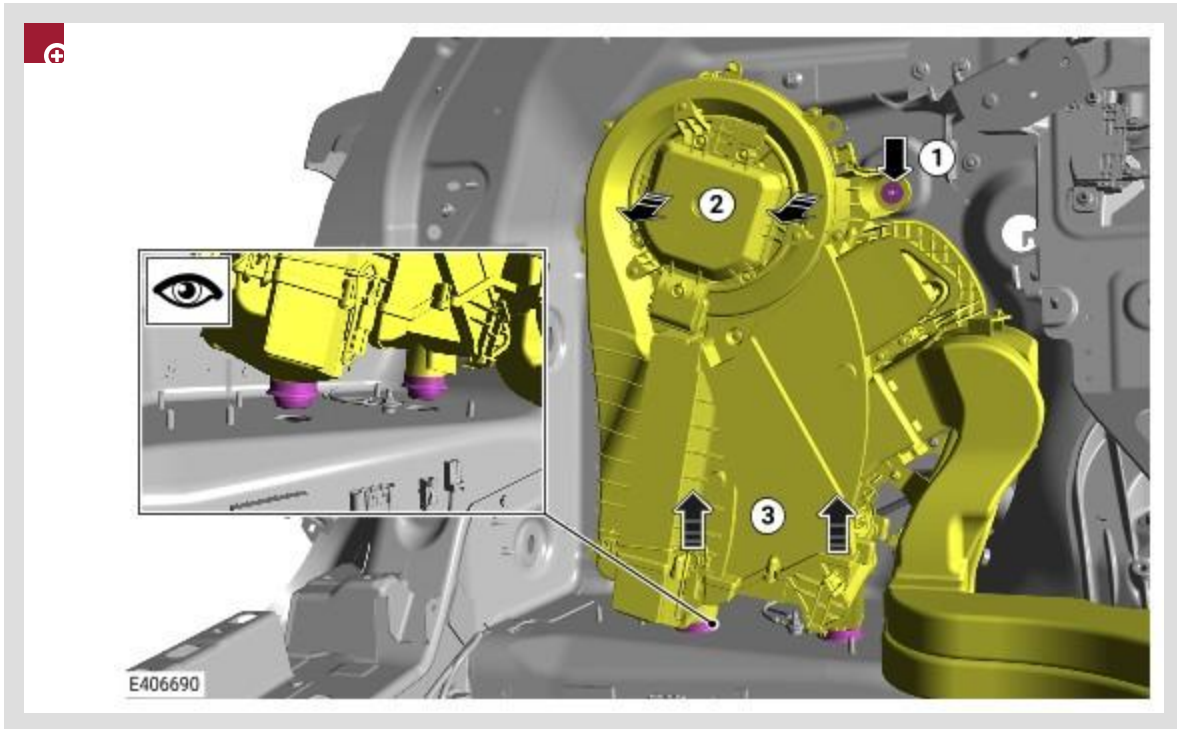
Only raise the auxiliary climate control assembly high enough to access the drain grommet (approximately 25 mm). Failure to follow this instruction may lead to damage to the component.

Raise the auxiliary climate control assembly to allow access to the drain grommet.

1. Remove the nut.
  - Torque: **5Nm**
2. Pull the top of the auxiliary climate control assembly forward to release it from the stud.
3. Raise the auxiliary climate control assembly.

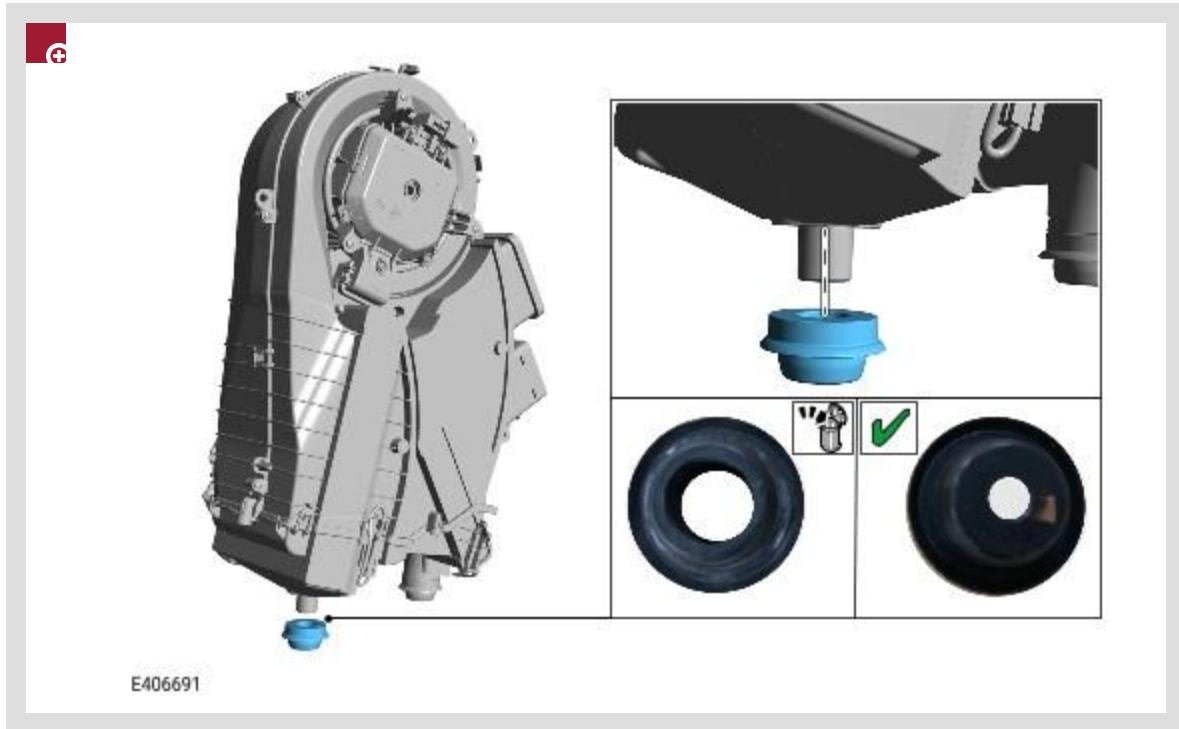
Only remove the drain grommet shown in the illustration. The grommet further forward on the auxiliary climate control assembly is for location purposes only.

Renew the drain grommet shown in the illustration.

- Remove and discard the drain grommet.
- Install the new reduced inner diameter drain grommet, shown with the **GREEN** ✓ in the illustration.
