BULLETIN NUMBER:  
**IB19-R-002C**

## **MOBILEYE TROUBLESHOOTING AND EXCHANGE PROGRAM**

- 2022MY to Present Isuzu N-Series Vehicles Equipped with RPO I4V and Mobileye 8
- 2023MY to Present Isuzu F-Series Vehicles Equipped with RPO I4V and Mobileye 8

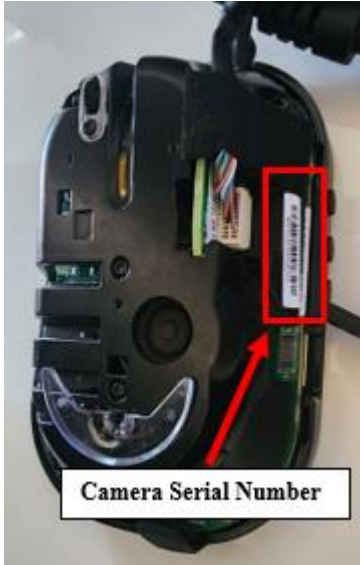
| <p><b>Figure 2 – Mobileye 8 Serial Number</b></p> | <p><b>Figure 3 – Mobileye 8 Camera Light</b></p> |

3. Diagnostic assistance is available directly from Mobileye by sending an email to [support-us@mobileye.com](mailto:support-us@mobileye.com). Include in this email pictures of any visible issue and the information listed below:
  - The Dealer name, address, and Dealer Code
  - Email address and phone number to receive confirmation of any Returned Merchandise Authorization (RMA)
  - The Vehicle Identification Number (VIN)
  - A description of the failure
  - The Mobileye Camera serial number (See Figures 2.)
  - Whether or not the blue light is illuminating on the camera (See Figures 3.) while the start (ignition) switch is turned to the On position.

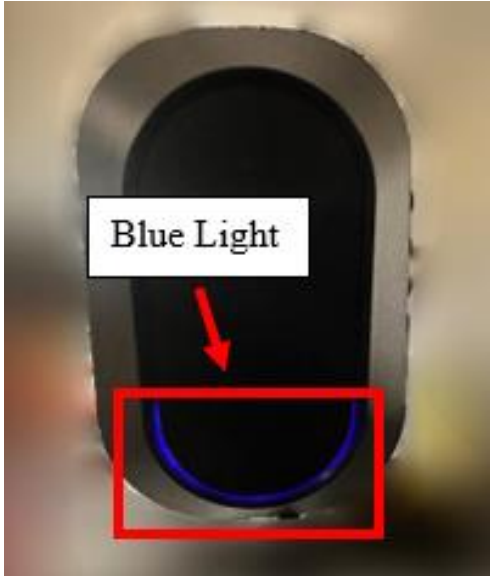
**NOTE: The blue light is an indication that the camera is receiving power and ground.**

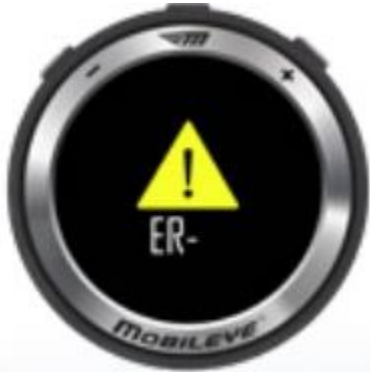
| <p><b>Figure 4 – Trouble Code</b></p> | <p><b>Figure 5 – Connection Error</b></p> |

- Any codes or errors that are present on the EyeWatch. (See Figures 4 and 5.)
