SWITCH - HEADLAMP : INTERRUPTEUR - PHARE : INTERRUPTOR - FARO DELANTERO

## Quality Inspection Request SWITCH – HEADLAMP Suspect Part Identification

**Part numbers:** 68156061AD, 68156064AC, 68156065AC, 68156066AC, 68401933AB, 68575999AA, 68401934AB, 68668430AA, 68669032AA, 68669033AA, 68469535AA and 68576206AA.

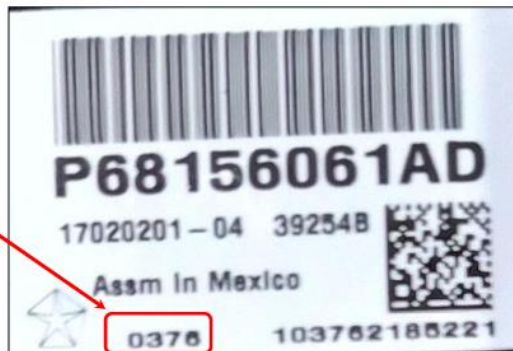
### Julian date code location:

Julian date code shown

0376: DDDY

37<sup>th</sup> Day of 2026

6<sup>th</sup> February 2026

Part in picture shown is suspect.

Part in picture below is suspect

**Suspect parts:** Parts built before Julian date code 1036 (13th April 2026) are suspect parts.

Please check and return suspect stock of part numbers: 68156061AD, 68156064AC, 68156065AC, 68156066AC, 68401933AB, 68575999AA, 68401934AB, 68668430AA, 68669032AA, 68669033AA, 68469535AA and 68576206AA. Please refer to QIR attachment.

Please return all parts back to your facing depot using Return Code 02, before 20th July 2026.

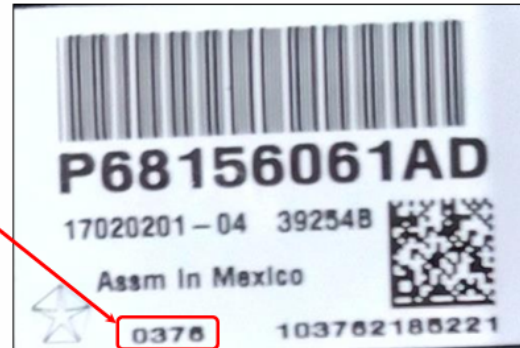
**Emplacement du code de date Julien:**

Code de date Julien affiché

**0376 : JJJA**

**37e Jour de 2026**

**6 février 2026**

La partie de l'image montrée est suspecte.

La partie de l'image ci-dessous est **suspecte**

**Pièces suspectes:** Les pièces construites avant le code de date julien **1036 (13 avril 2026)** sont des pièces suspectes.

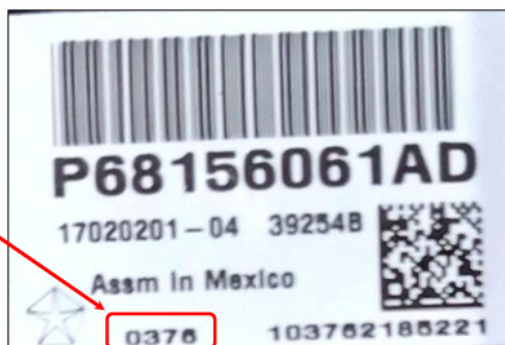
**Ubicación del código de fecha juliana:**

Se muestra el código de fecha juliano

**0376 : DDDA**

**Día 37 de 2026**

**6 de febrero de 2026**

Parte de la imagen del paquete que se muestra es sospechosa.

Parte en el paquete se muestra a continuación es **sospechoso**

**Piezas sospechosas:** Las piezas fabricadas antes del código de fecha juliana **1036** (**13 de abril de 2026**) son piezas sospechosas.
