**RAPID UPDATE**

# Rapid Update 831 Grecale GranTurismo and GranCabrio – Radiator Water Inlet Pipe Inspection

**VEHICLES INVOLVED:** (M182) Grecale MY26–MY27; (M189) GranTurismo and GranCabrio (M190) MY26–MY27

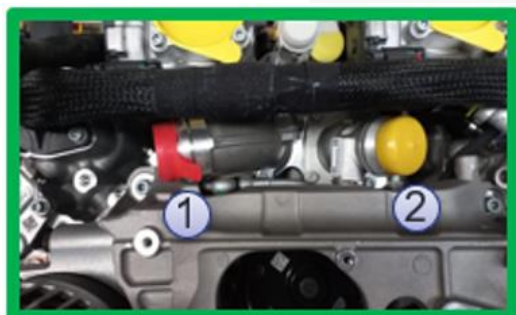
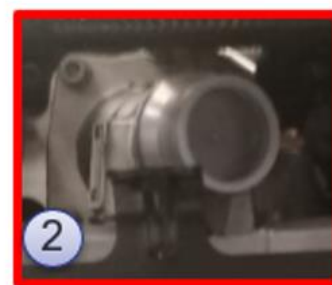
13. Inspect the cooling system circuit for **ANY** foreign material or obstructions, such as plastic plugs and/or residue.

12. Remove the sleeves connected to the thermostat body.
  - a. **1.71.008 RADIATOR WATER DELIVERY PIPE Detach-Reattach or Replace**
  - b. **1.71.009 RADIATOR WATER RETURN PIPE Detach-Reattach or Replace**

14. After the inspection is complete, restore the cooling circuit according to the official procedures.
15. Use only the fluid specified in the original equipment fluids table.
  - a. **00.AB.060 INITIAL LIQUID REFUELLING TABLE**
