CORE – HEATER : CORE – CHAUFFAGE : NÚCLEO – CALENTADOR

## Quality Inspection Request CORE – HEATER Suspect Part Identification

Part numbers: 68301874AA

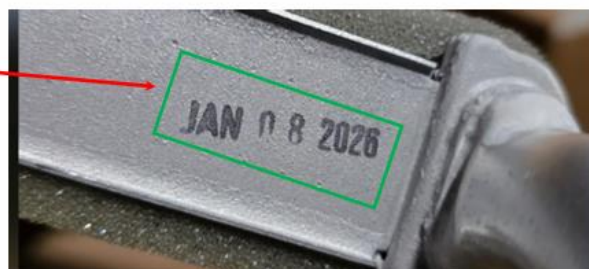
Built date code location:

Built date code shown

JAN 08 2026 : MON DD YYYY

8th January 2026

Part in picture shown is not suspect.

Part in picture below is not suspect

**Suspect parts:** Parts built before **JAN 01 2026** (1<sup>st</sup> January 2026) are suspect parts.

Please check and return suspect stock of part numbers: **68301874AA**. Please refer to QIR attachment.

Please return all parts back to your facing depot using **Return Code 02**, before 28th July 2026.

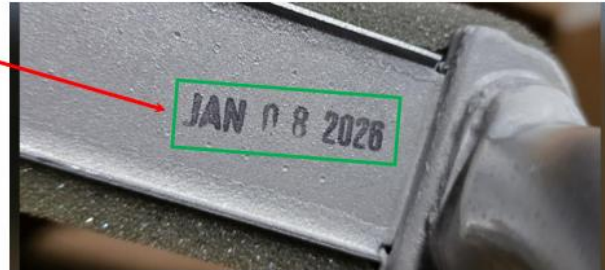
Emplacement du code de date de construction

Code de date de construction affiché

**JAN 08 2026 : MMM JJ AAAA**

8 janvier 2026

La partie visible sur la photo n'est pas suspecte.

La partie visible sur l'image ci-dessous n'est pas suspecte.

**Pièces suspectes:** Les pièces construites avant le **JAN 01 2026** (1er janvier 2026) sont des pièces suspectes

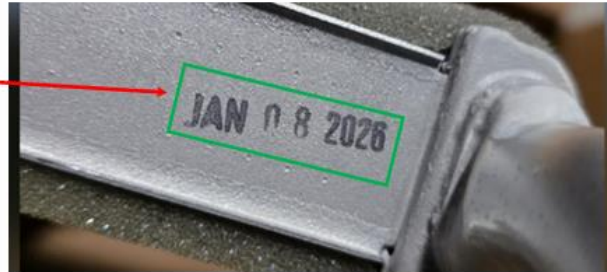
Ubicación del código de fecha de construcción:

Se muestra el código de fecha de construcción

**JAN 08 2026 : MMM/DD/AAAA**

**8 de enero de 2026**

La pieza que aparece en la imagen no es la sospechosa.

La parte que se muestra en la imagen de abajo no es sospechosa.

**Partes sospechosas:** Las piezas construidas antes de **JAN 01 2026** (1 de enero de 2026) son piezas sospechosas.
