**Pleasure-Way**

## Trustate 2.0 Retrofit Instructions.

### Start with the Trustate Monitor Replacement

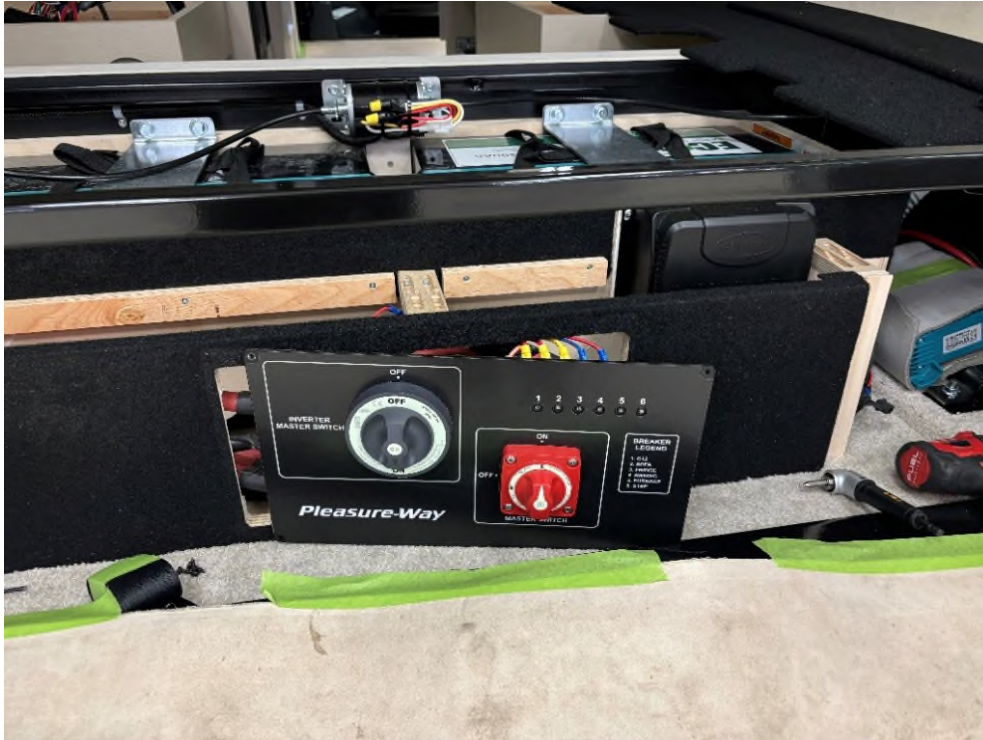
Remove the 4 screws in the DCD panel. Pivot the right side out and slide the assembly to the right while carefully guiding the wiring with it.

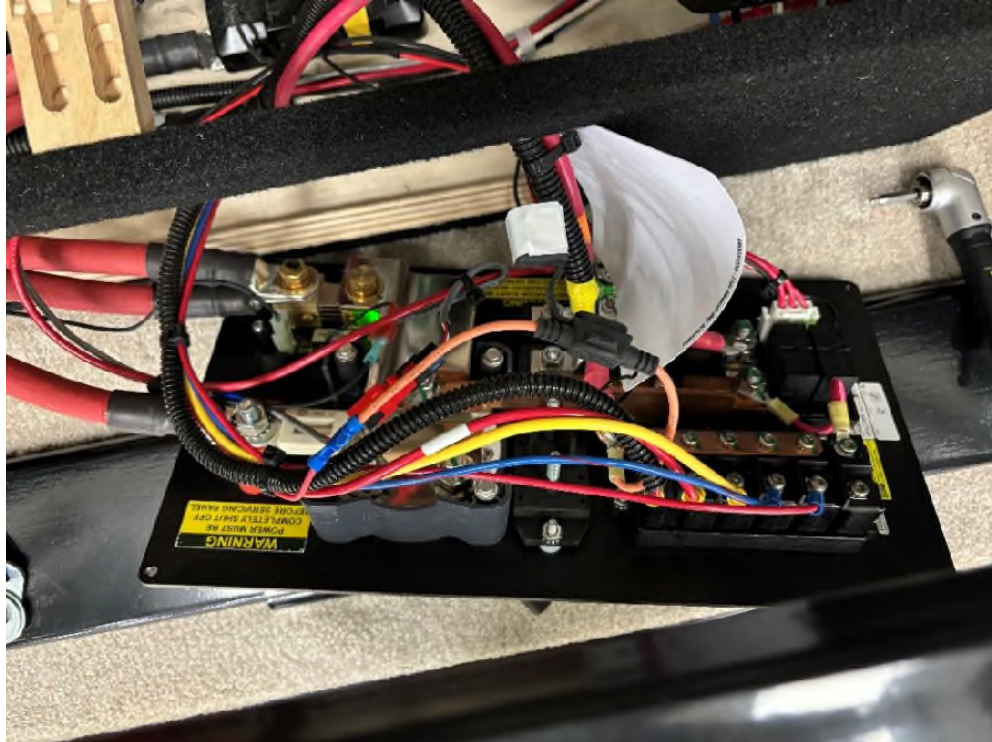
Lay the panel down flat, exposing the back side. The Trustate monitor is in the lower rear left hand corner.

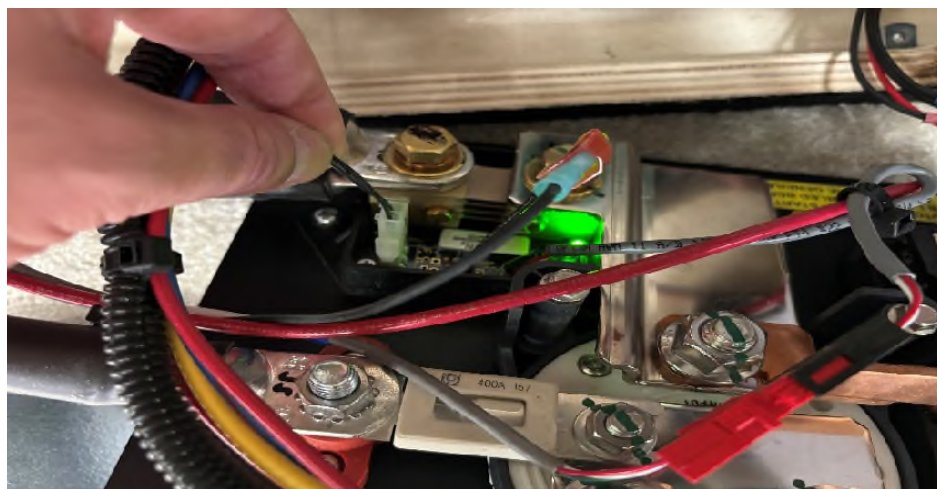
On the Trustate Monitor, disconnect the thermistor (white plug with 2 black wires):

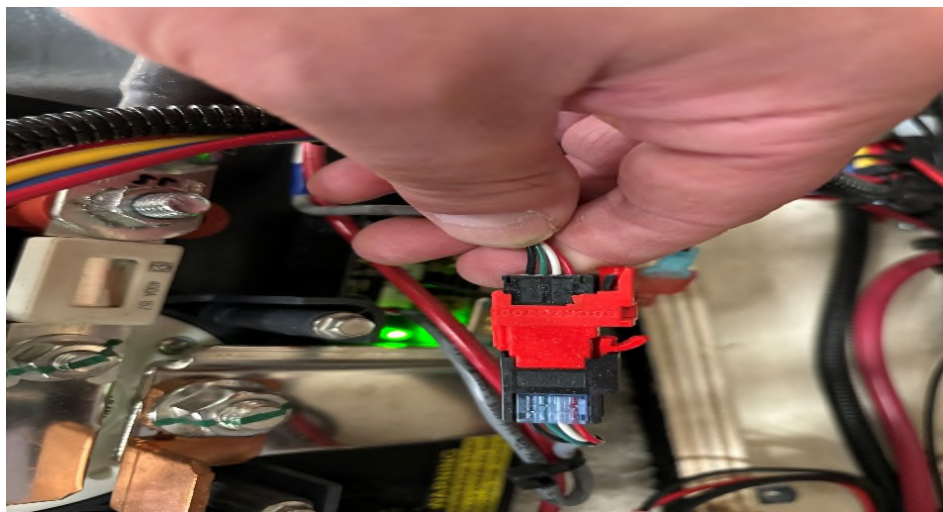
Disconnect the communication cable:

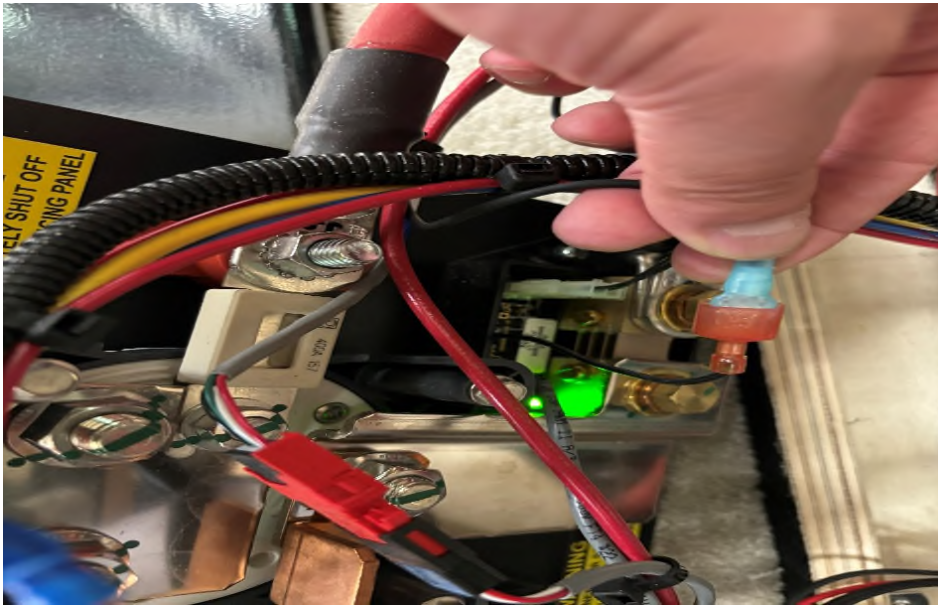
Disconnect the ground:

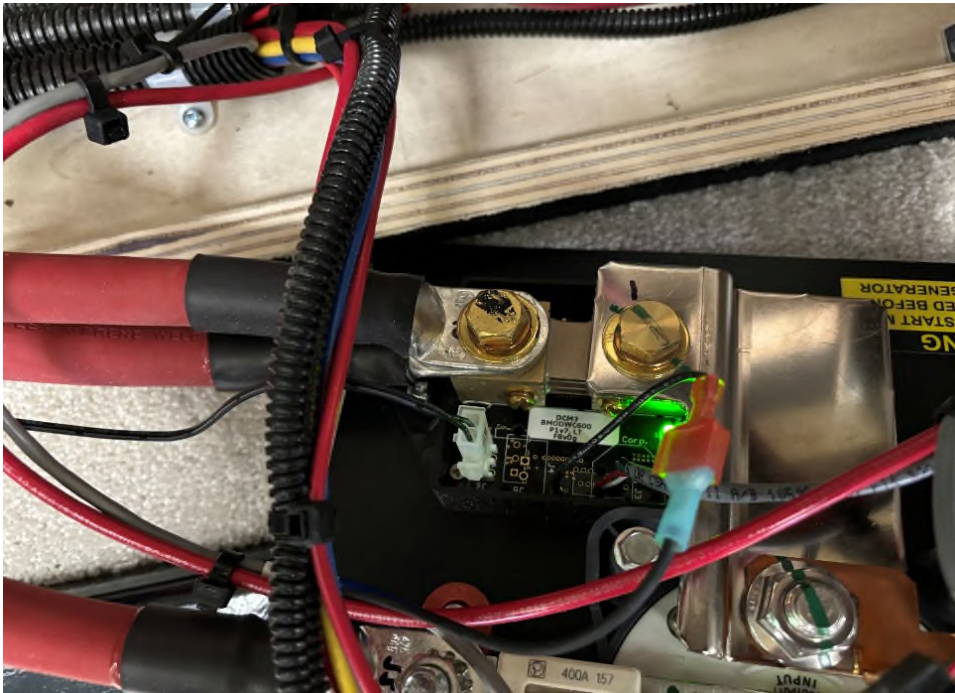
Remove the 2 brass colored bolts using a 9/16 socket. Keep note of the longer bolt as it is required for the connection with the 2 red cables.

\*Tape these 2 red cables as carefully set aside making sure they do not touch anything grounded. These lines are live with 12v + from the batteries. The metal bar that secures the seatbelts at the back of the coach for example is grounded.

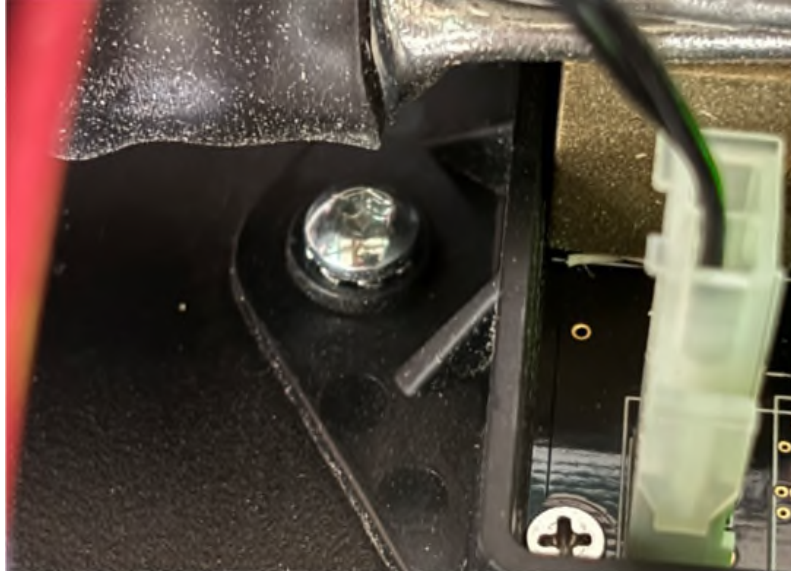
There is a Torx screw, size T20, securing the module to the DCD panel. Remove this Torx screw and slide the module out of position.

Slide the new module into position and secure the Torx screw first. Then work your way in reverse order to re-install the replacement module. The brass colored bolts are torqued to 100" lbs.

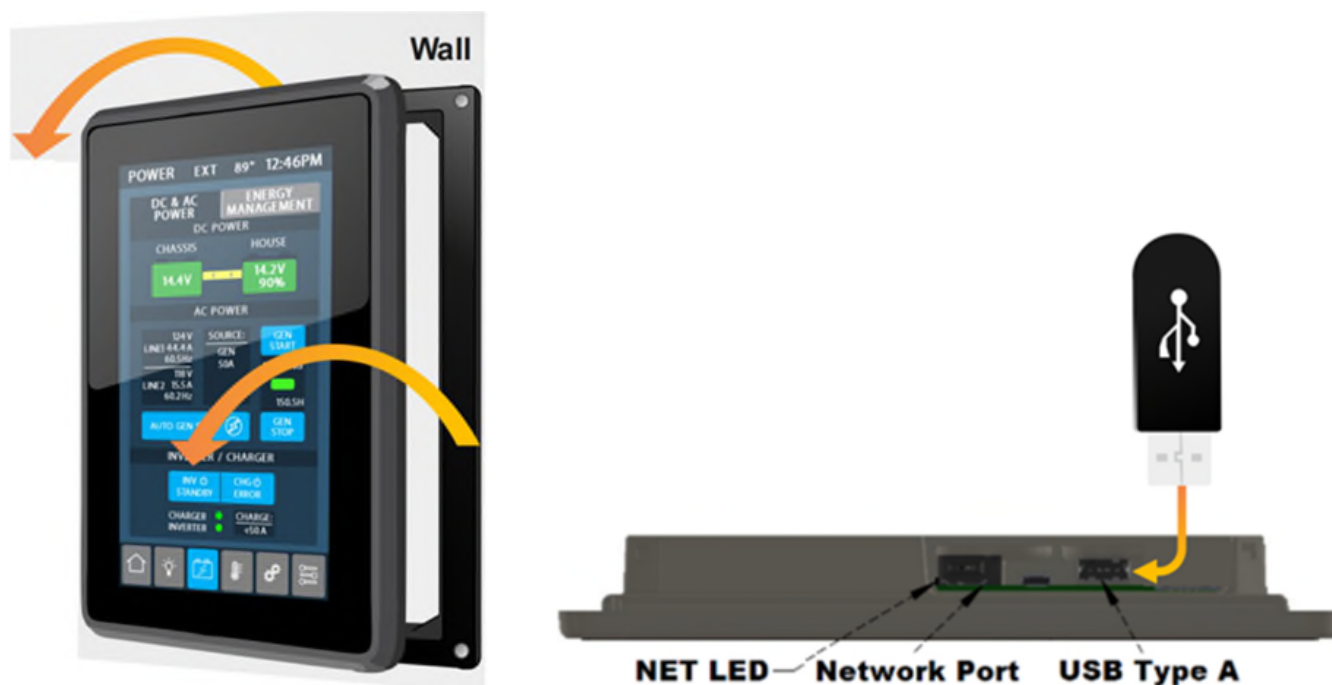
Pry the touchscreen from the wall by gently pulling on the top or bottom corner and insert the provided USB drive into the USB-A port.

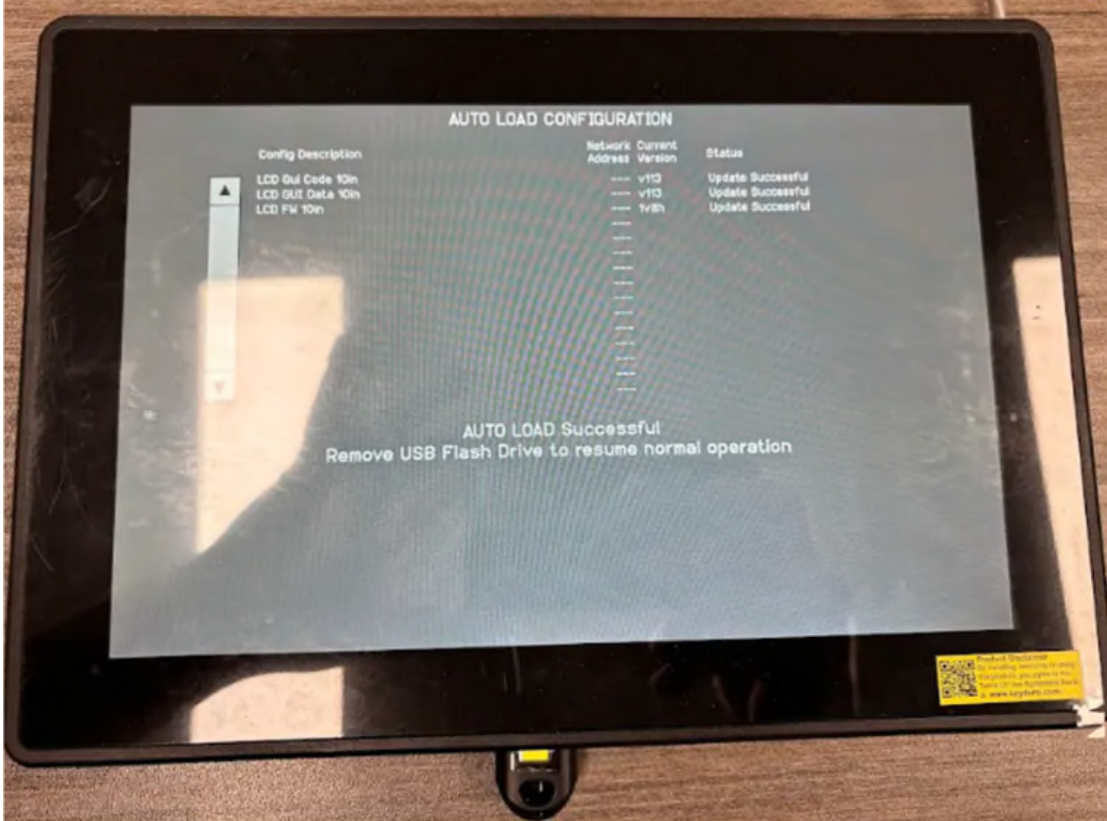
Unplug the communication cable on the back of the touchscreen and plug it back in. The screen will boot up with the upload page. Select Auto Load and Start Autoload to begin. Remove the USB once the screen displays Auto Load Successful. Do this for all LCD screens in the coach.

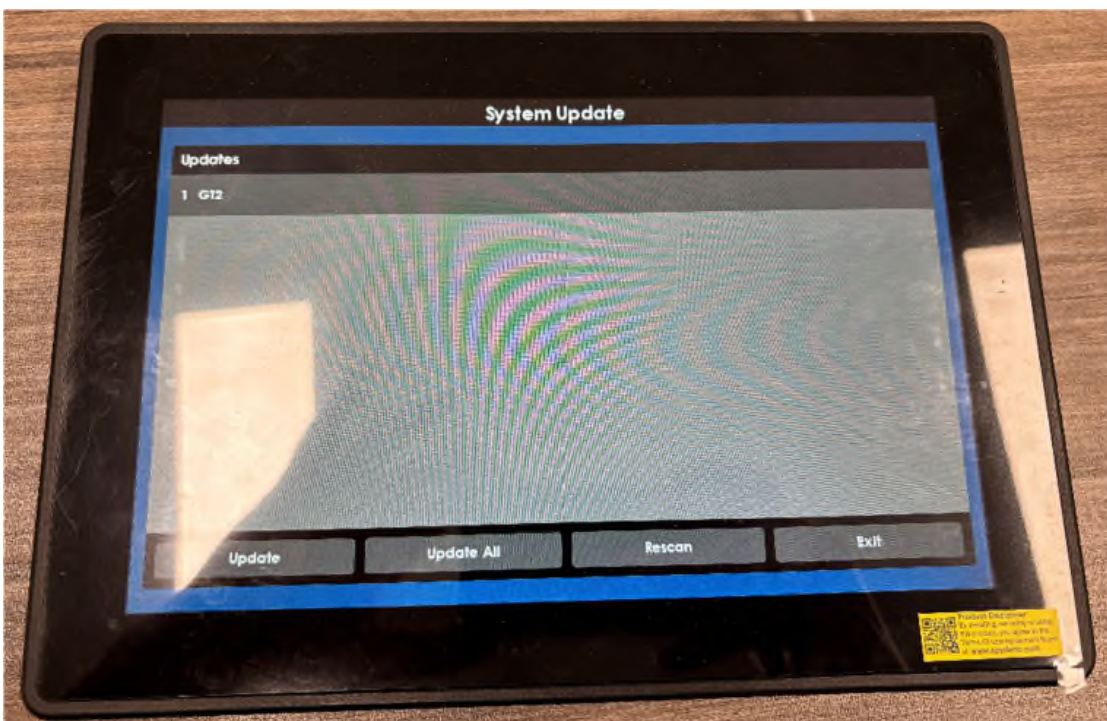
On the Main LCD screen at the rear of the vehicle, go to the settings page and select System Update. Select Update All and Update Now on the following page. Press Exit once the screen displays the system is up to date.

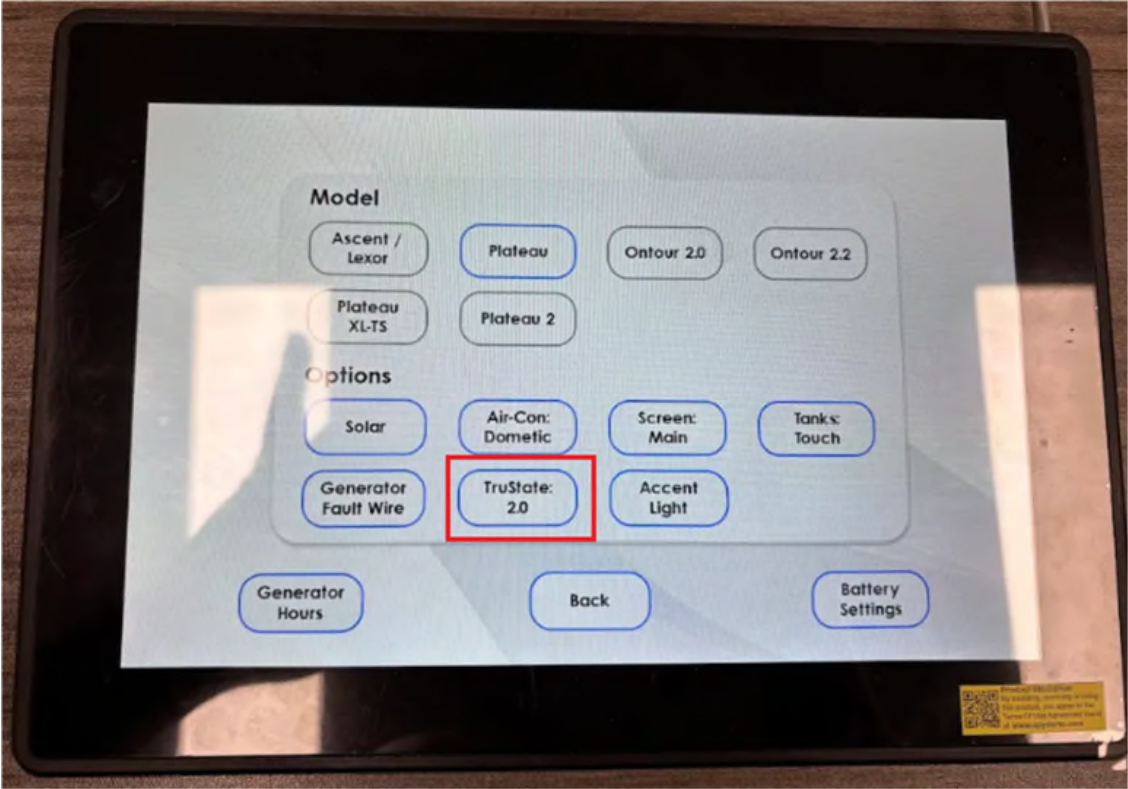
Once the System Update is complete, hold your finger on coach model of the Settings page until prompted for a pin number. Type in 8365 to gain access to the program settings. You

can now change TruState 1.0 to TruState 2.0 and press back to exit the program setting and complete the repair.
