**TECHNICAL INSTRUCTIONS**

**EMISSION NONCOMPLIANCE RECALL 26TC03**

**Certain 2022 – 2025 Model Year RAV4**  
**Incorrect Mass Air Flow Sensor Reading**

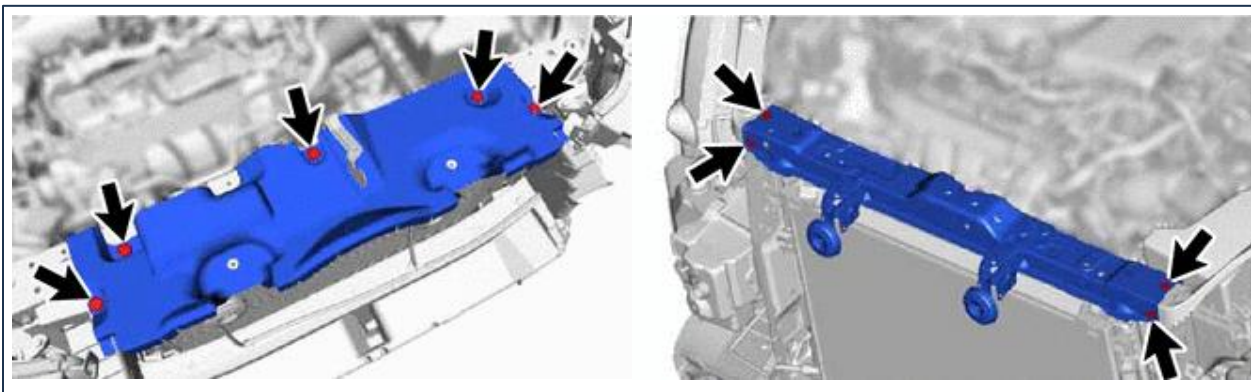
### VI. COMPONENTS

| 1 | UPPER RADIATOR AIR GUIDE PLATE |
| 2 | RADIATOR SUPPORT SUB-ASSEMBLY |

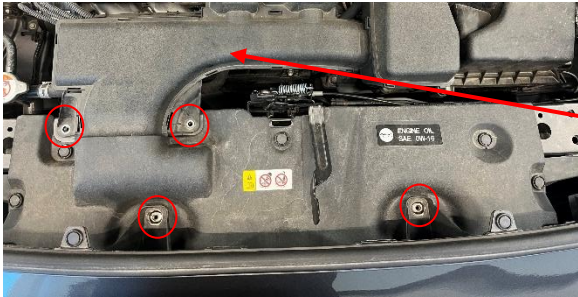
**1. Remove four 10mm bolts from Upper Radiator Air Guide Plate.**

**2. Remove Inlet Duct Assembly.**

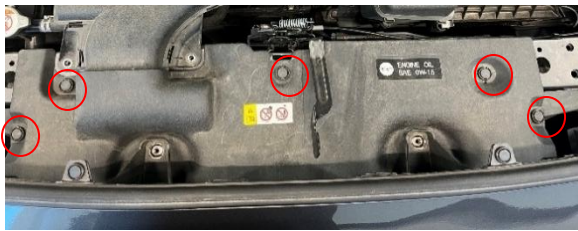
**3. Using pry tool, remove 5 push clips from Upper Radiator Air Guide Plate.**

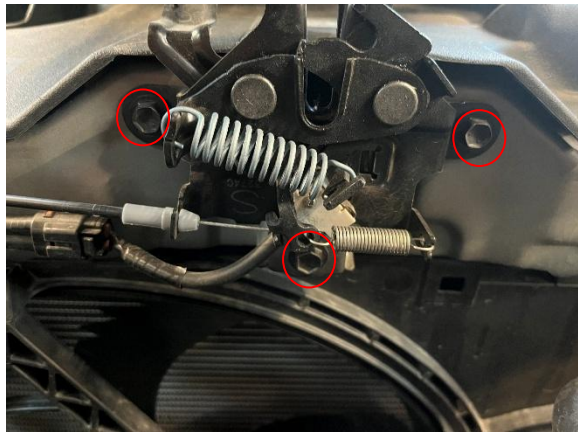
**4. Remove three 10mm bolts from Hood Latch Assembly.**

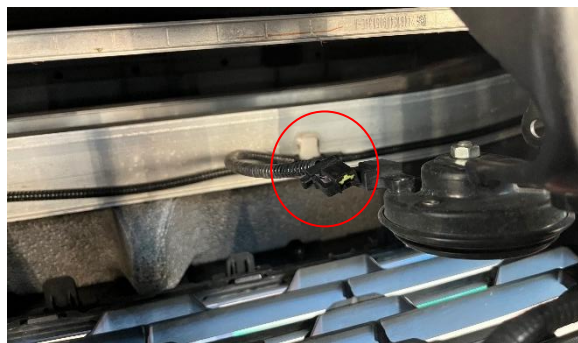
**5. Remove connectors from both horns.**

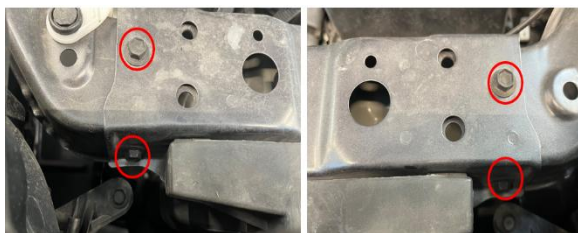
**6. Remove two 10mm bolts from each side of Radiator Upper Support.**

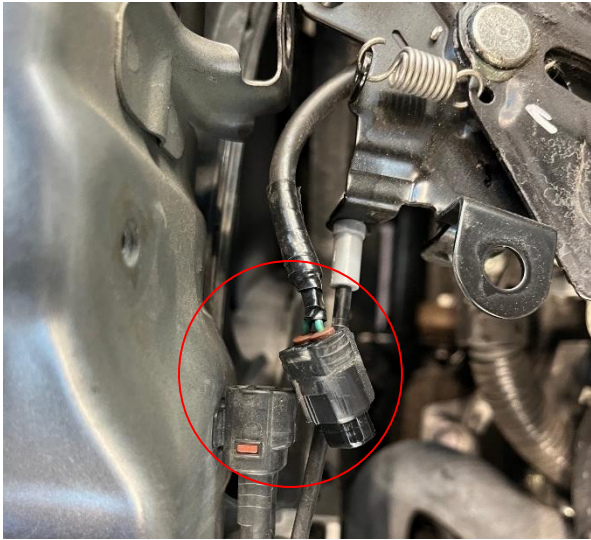
**7. Remove Hood Latch Connector and two clips securing Hood Release Cable.**

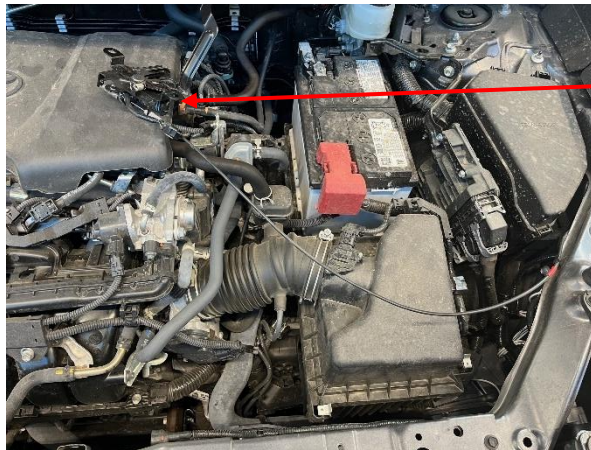
**8. Set Hood Release Cable aside.**

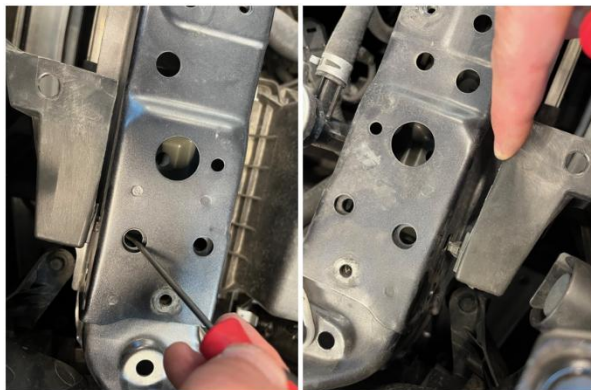
**9. Disconnect clip from Side Radiator Guides**

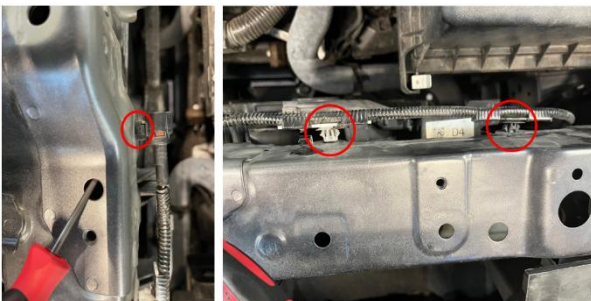
**10. Remove Hood Latch Connector clip and harness clips using pick**

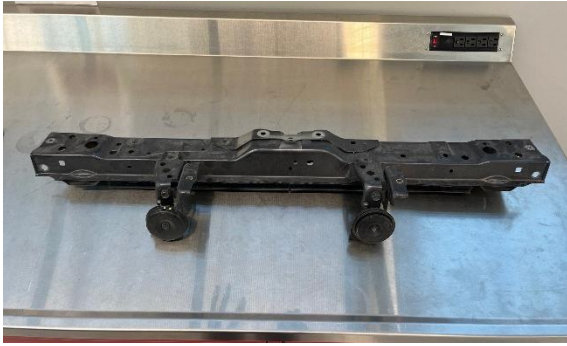
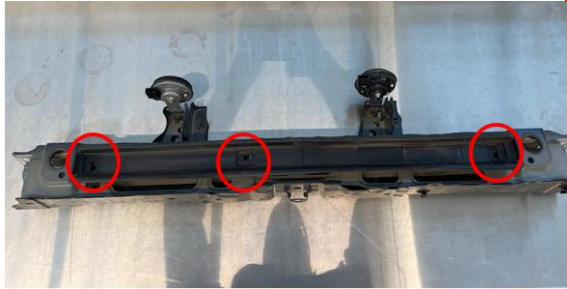
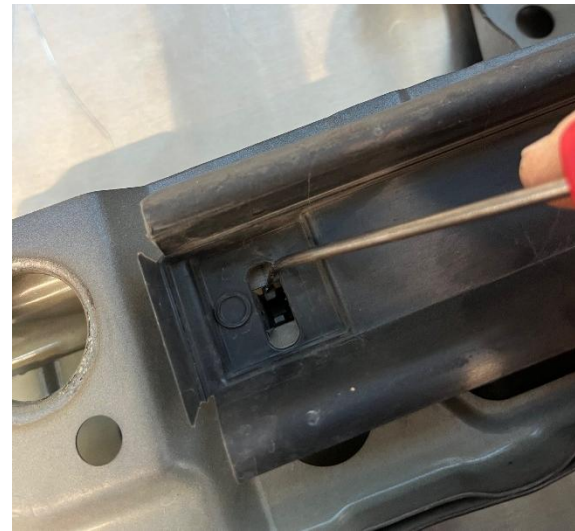
**11. Remove Upper Radiator Support.**

**12. Turn Upper Radiator Support over to access Upper Air Guide clips**

**13. Using a pick, release Upper Air Guide clips.**

**14. Remove Upper Air Guide and mark it.**

**15. Install new Upper Air Guide.**
