**Technical Service Bulletin (TSB)**  
**Headliner Delamination**

| REFERENCE: | TSB: 23-033-26<br>GROUP: 23 - Body | Date: | August 7, 2026 | REVISION: | 23-066-23 |
| VEHICLES AFFECTED: | 2023 (B1) Jeep Renegade<br>This bulletin applies to vehicles built on or after October 10, 2022 (MDH 1010XX) and on or before May 10, 2023 (MDH 0510XX). | | | MARKET APPLICABILITY:<br><div><input checked="" type="checkbox"/> NA<input type="checkbox"/> CH</div> <div><input type="checkbox"/> EE<input type="checkbox"/> IAP</div> <div><input checked="" type="checkbox"/> SA<input type="checkbox"/> MEA</div><br><b>NOTE:</b> This bulletin applies to the South America and North America markets. | |

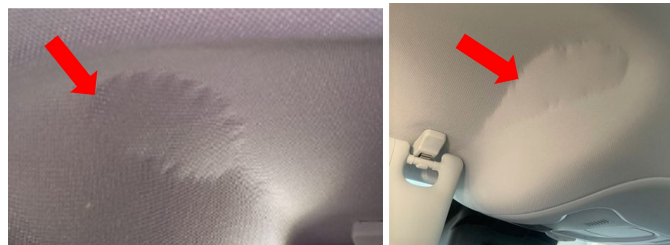
| CUSTOMER SYMPTOM: | Customers may experience the following: <ul style="list-style-type: none"><li>The headliner is delaminating (bubbling) <a href="#">Fig. 1</a>.</li></ul> | | | | |
| CAUSE: | Poor adhesion | | | | |

**Fig. 1**  
Headliner Delamination (Bubbling) Examples

This bulletin involves replacing the headliner.

1. Replace the headliner. Refer to the detailed service procedures available in DealerCONNECT/Service Library under: Service Info>23 - Body / Interior / Headliner / Removal and Installation.
