## INSTRUCTION TO SERVICE

| ITS61263 | | February 05, 2025 |
| SUBJECT: | Fuel Neck Fill Replacement (on coaches with Temco valve) | |
| ISSUE: | Customers are complaining of fuel splashback at high flow rates. | |

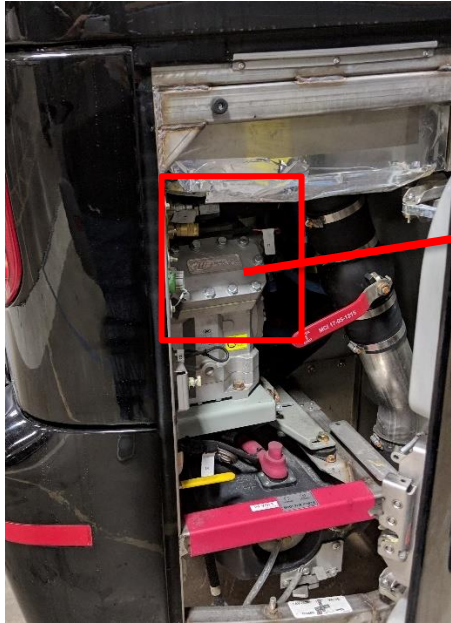
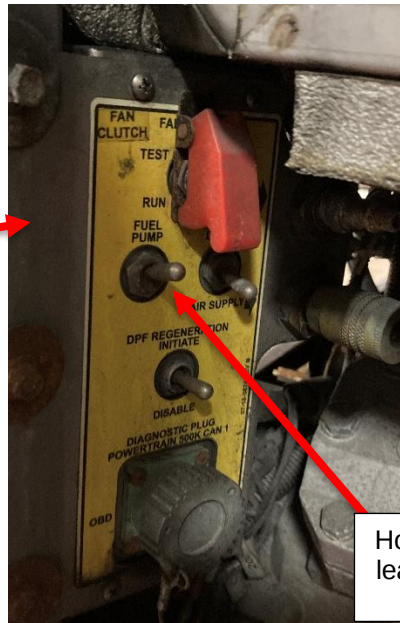
Hold the switch for at least one minute

24. Turn on coach ignition.
25. Push and hold the fuel pump switch in the RH service compartment for at least one minute to ensure no air bubbles in the fuel filter
