# MOUNTING THE ADAPTER CABLE START RELAY

2026 990 RC R

2026 990 RC R TRACK

### BASIC INFORMATION:

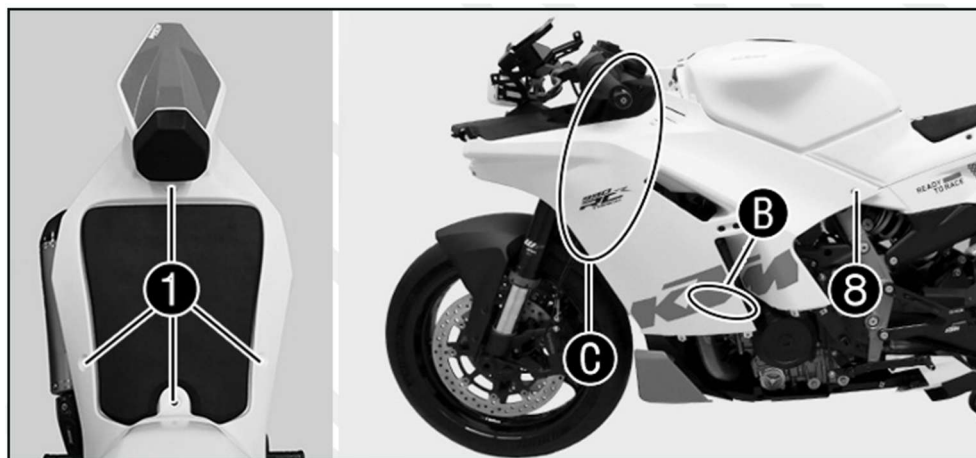
**Fig. 1 – Remove the 990 RC R Track seat fairing**

- 990 RC R: Remove the seat and remove the battery.
- 990 RC R Track:
  - Remove screws (1) of the seat fairing (see Fig.1).
  - Remove screws (8) of the side spoiler (left/right) (see Fig.1).
  - Carefully push the side spoiler to the side, lift and remove the seat fairing at the rear (see Fig. 2). Remove the battery.
- Pre-assemble the adapter cable, retaining plate and relay 07 (see Figs.3 and 4).
- Unplug the start relay, mount the retaining plate and adapter cable (see Figs. 5 and 6).
- Fix the adapter cable next to the battery box with the cable tie (see Fig.7)
- Connect adapter cable plug, start relay plug and start relay (see Fig.8).
- Assemble and connect the battery (see Fig.8).
- Check plug connections for tightness.
- Complete the vehicle, set the time and date and conduct a test drive.

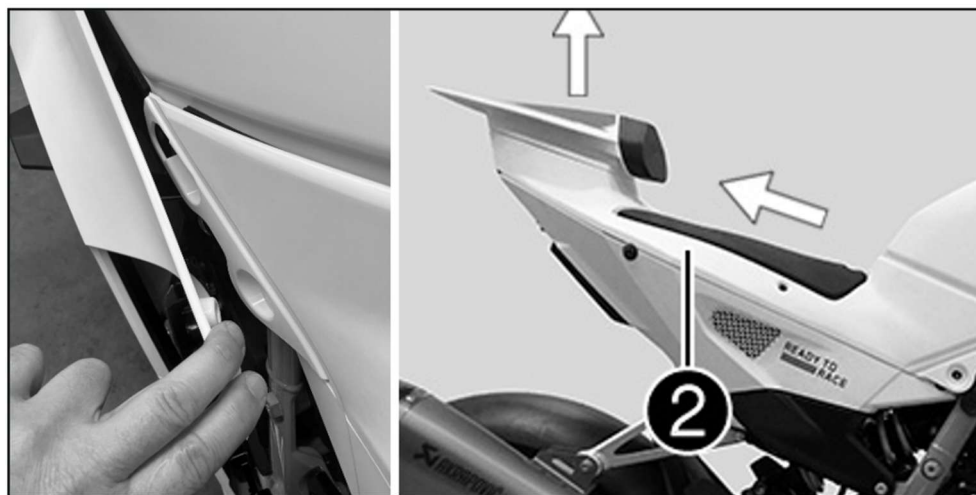
**Fig. 2 – Remove the 990 RC R Track seat fairing**

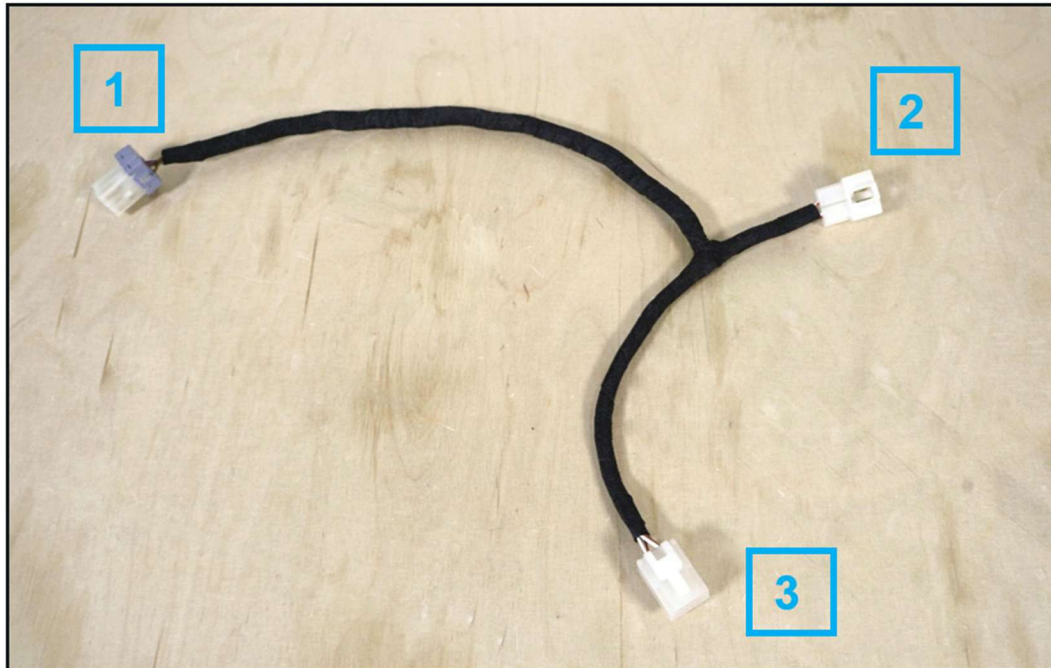
**Fig. 3 - Adapter cable start relay**

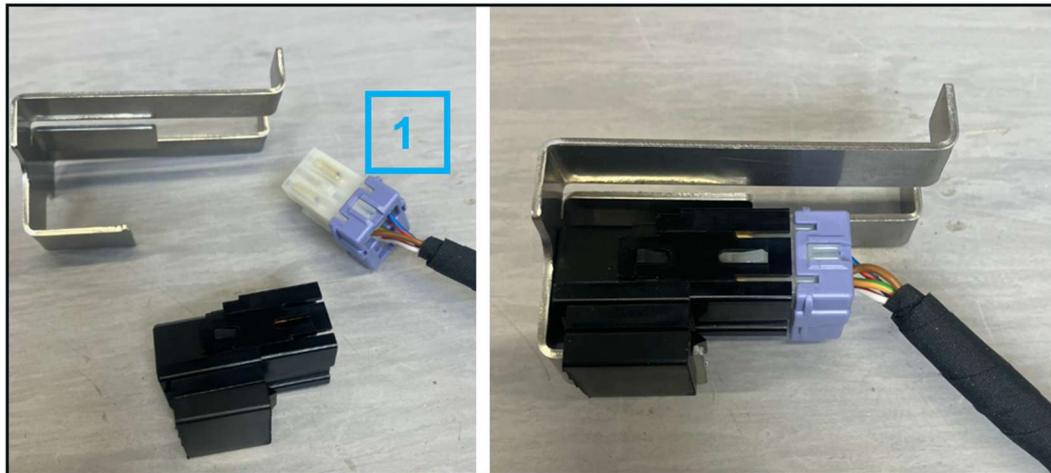
**Fig. 4 – Pre-assemble the adapter cable**

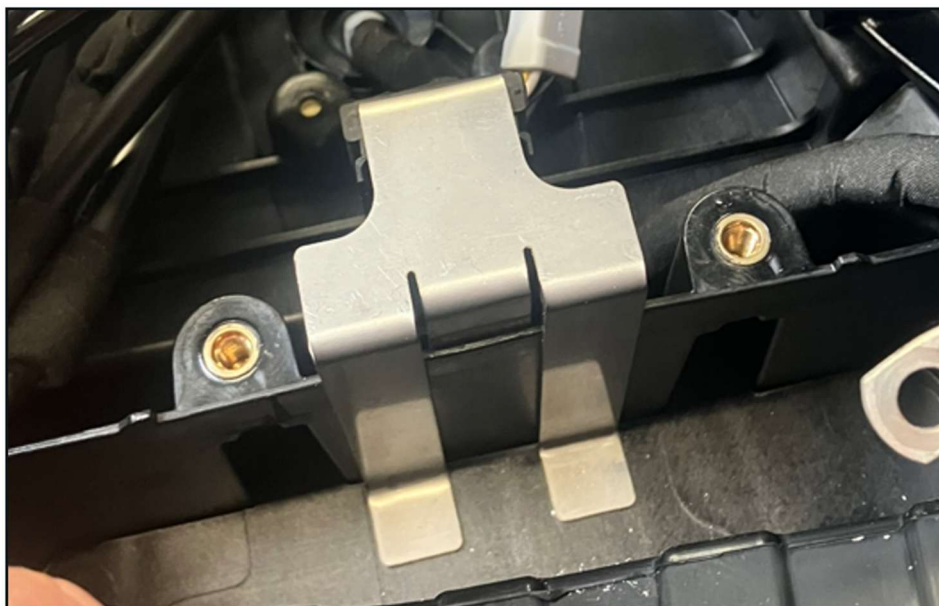
**Fig. 5 – Retaining plate position on the battery box (middle flap outside)**

Carefully remove the cover cap of the start relay, reserve fuses fall out easily. The mounting position of the battery fixes the relay retaining plate.

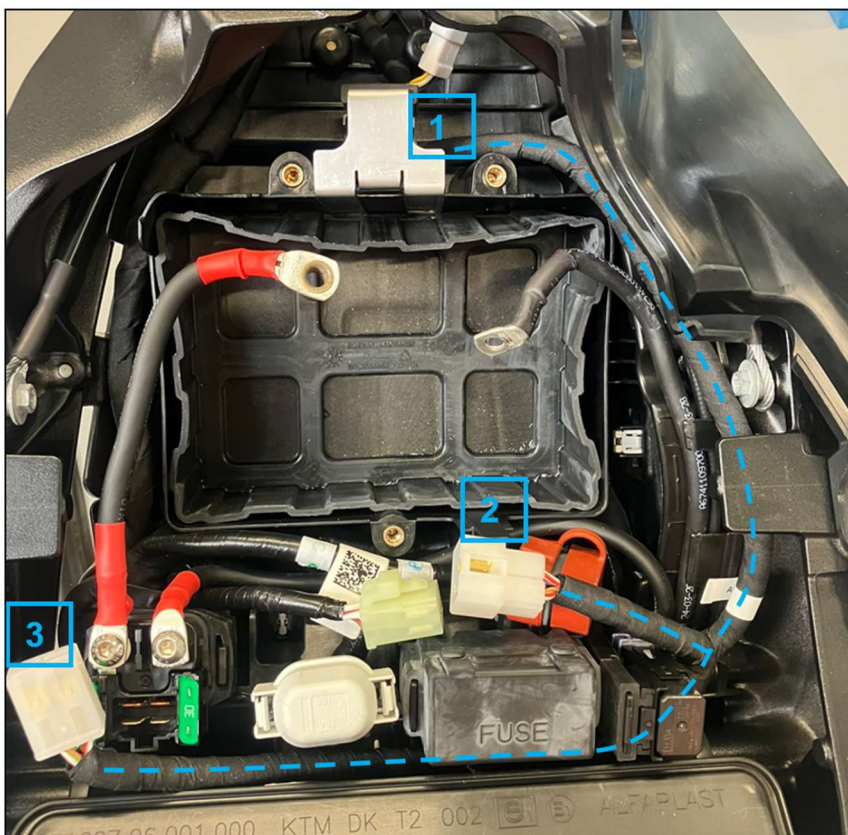
**Fig. 6 – Adapter cable routing**

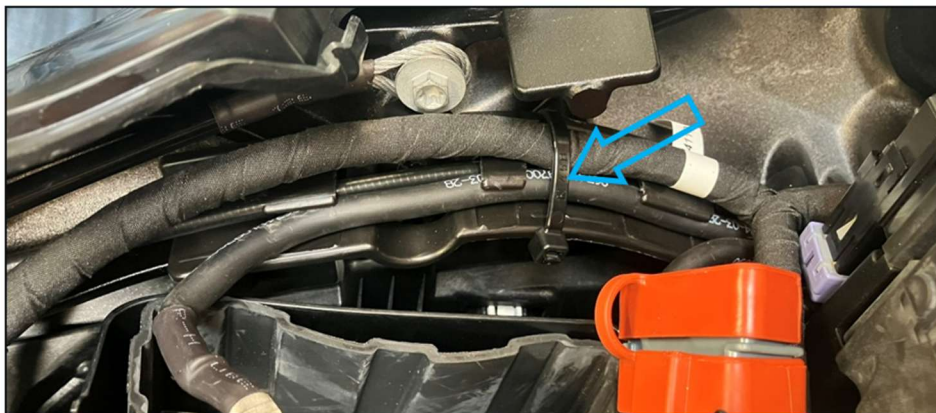
Fig. 7 – Fixation with cable ties

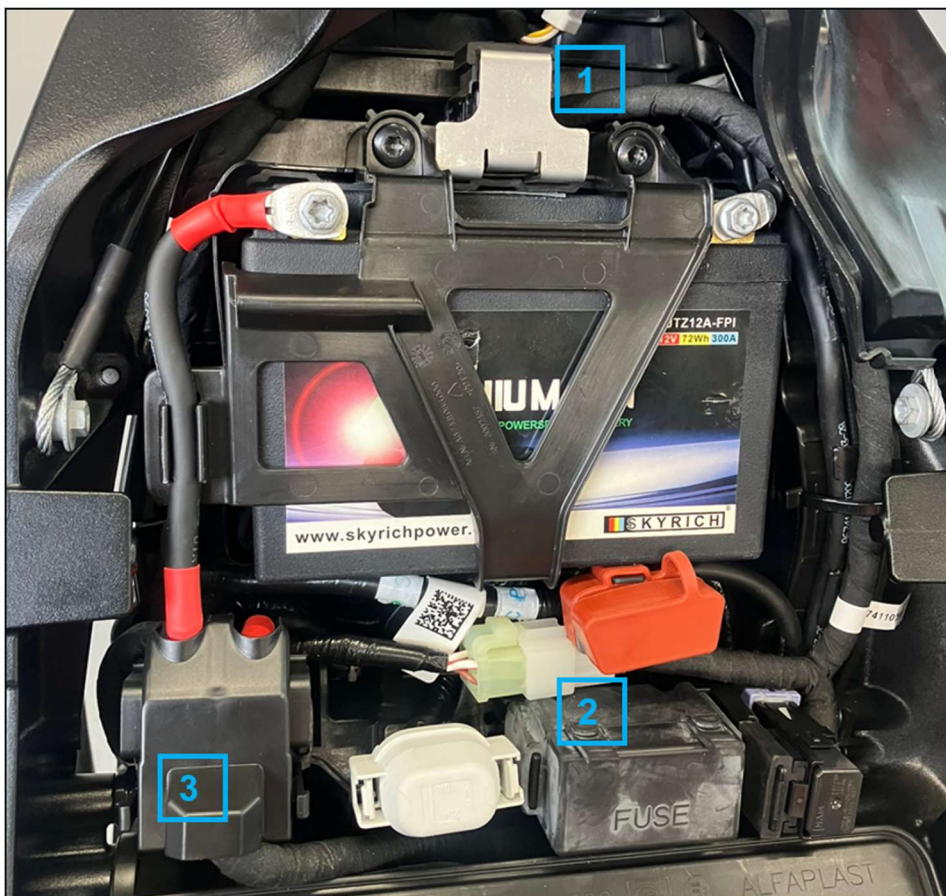
Fig. 8 – Mounted adapter cable start relay
