**Pleasure-Way**

## Trustate 2.0 Retrofit Instructions.

### Start with the Trustate Monitor Replacement

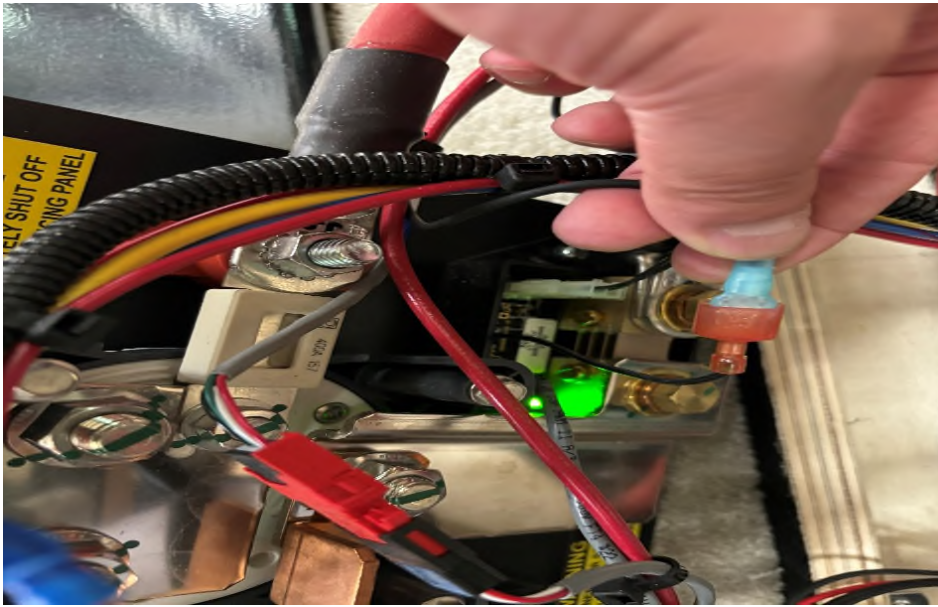
Disconnect the ground:

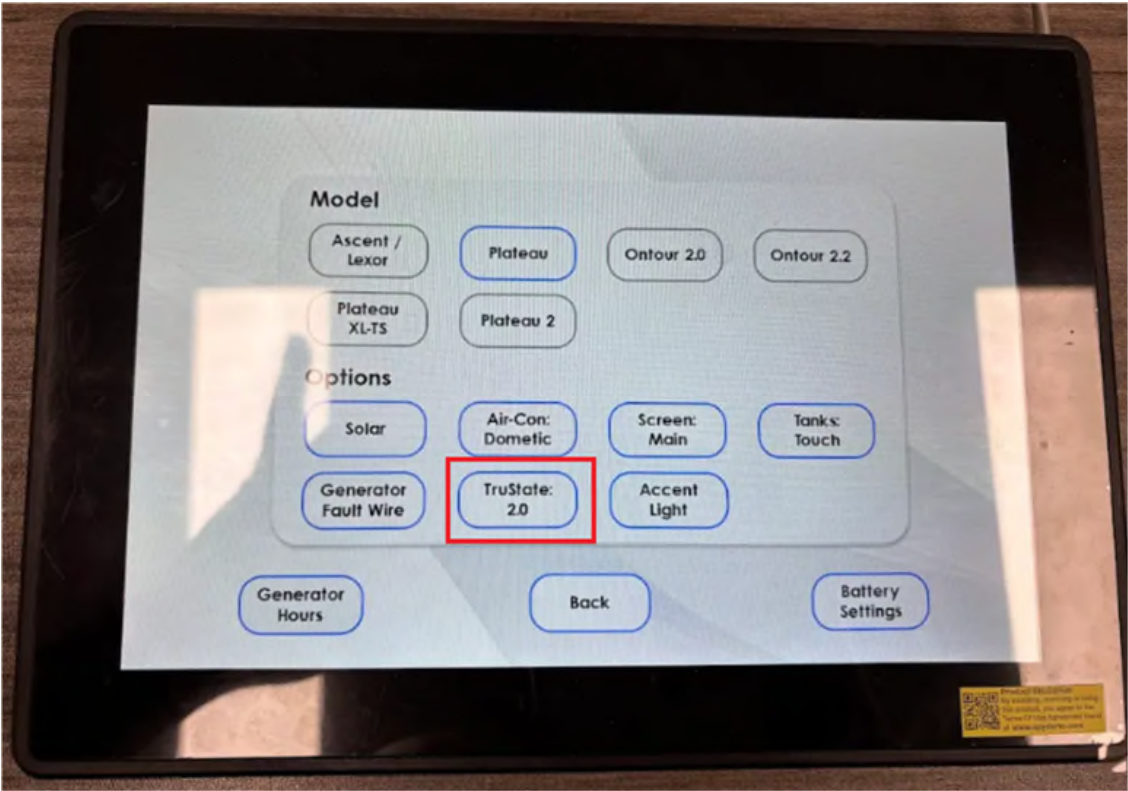
Once the System Update is complete, hold your finger on coach model of the Settings page until prompted for a pin number. Type in 8365 to gain access to the program settings. You

can now change TruState 1.0 to TruState 2.0 and press back to exit the program setting and complete the repair.
