# Service Bulletin

Bulletin No.: PIT6550

**Subject:** Diagnostic Tip - Inside Rearview Mirror Camera Image is Angled Down or Skewed

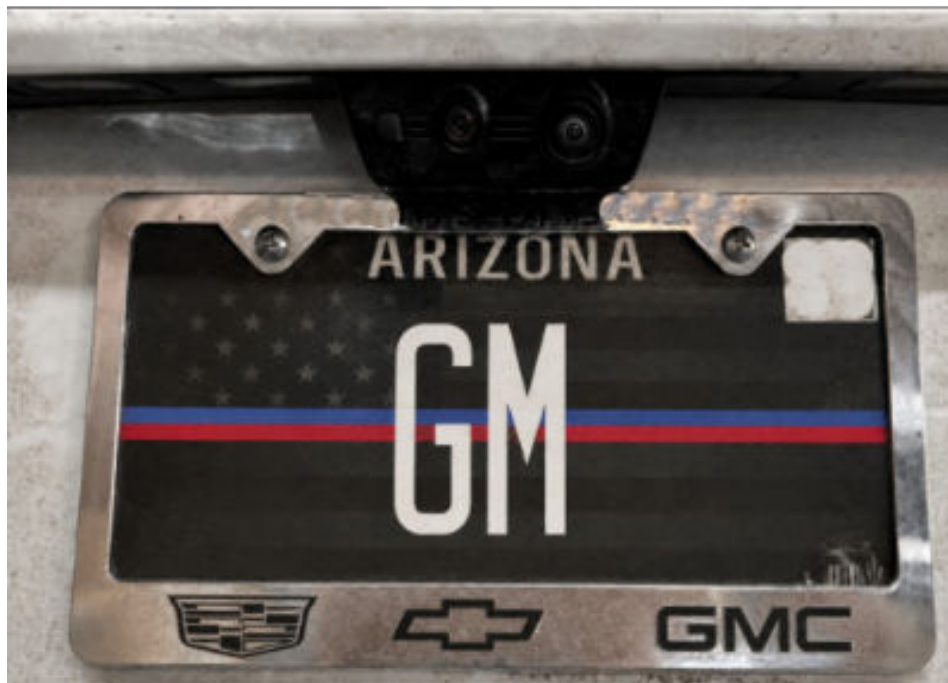
7216829

The cause of this condition maybe the installation of an aftermarket or dealer-installed rear license plate applique that is interfering with the rear camera mounting, as shown below. This can push the rear camera mounting upward, which skews the Inside Rearview Mirror Camera Image.

Inspect the rear license plate area for an aftermarket or dealer-installed license plate frame that contacts or applies pressure to the rear camera mounting. Remove, reposition, or replace the interfering frame as necessary so that it does not interfere with the rear camera mounting.
