PRODUCT SAFETY RECALL

SUBJECT: Hood Striker Corrosion

MODELS: 2013-2015 Chevrolet Spark

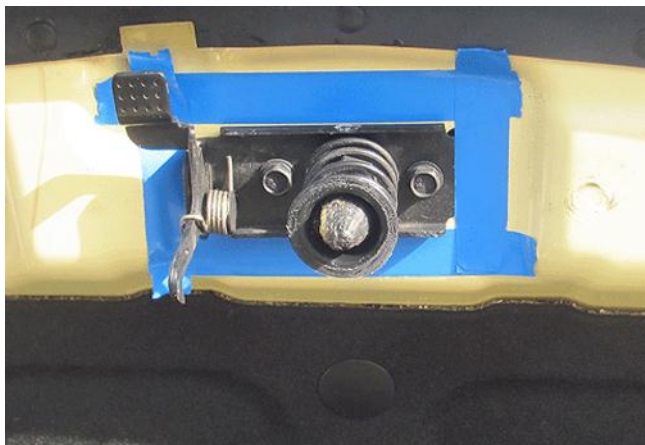
3997083

1. Raise the hood.
2. Locate the hood latch striker assembly, mounted on the hood.

3. Using masking tape, mark the location of the striker assembly.
4. Remove the striker assembly. Save the fasteners, they will be reused.
5. Install the new striker assembly. Align the striker using the masking tape.

6. **Tighten** 8.5 N.m (75 lb in).
7. Inspect the hood for proper alignment.
8. Remove the masking tape from the hood.
