**SUBJECT: Customer Satisfaction Program 16N01**  
Certain 2013-2015 Model Year Police Interceptor Utility and Sedan Vehicles  
Paint Peeling and/or Rust around Lock Cylinder on Liftgate or Luggage  
Compartment Lid

**Customer Satisfaction Program 16N01**

## CERTAIN 2013-2015 MODEL YEAR POLICE INTERCEPTOR UTILITY AND SEDAN VEHICLES - PAINT PEELING AND/OR RUST AROUND LOCK CYLINDER ON LIFTGATE OR LUGGAGE COMPARTMENT LID

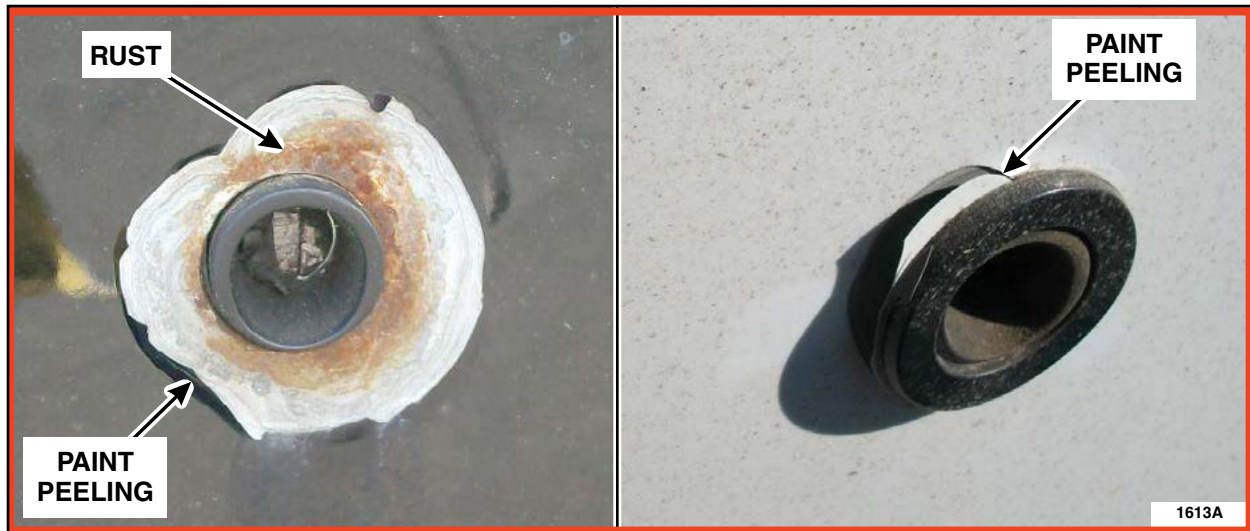
**FIGURE 1**

1. Is paint peeling and/or rust present around the lock cylinder? See Figure 1.

2. Wash the repair area with detail wash or pH-neutral soap and water.
3. Remove any trim, emblems and/or graphics from the area, as needed.
4. Remove the lock cylinder. Please follow the Workshop Manual (WSM) procedures in Section 501-14A.
5. Sand or media blast the surface to remove the corrosion near the lock cylinder surface, keeping the repair area as minimal as possible.
6. Treat any bare metal surface to prevent flash corrosion, and prime and block sand as necessary prior to refinishing.

7. Mask the adjacent panels to protect from overspray.
8. Spot repair the base coat as necessary, following the paint manufacturer's prescribed procedures.
9. Apply clear coat to the entire panel, following the paint manufacturer's prescribed procedures.
