#### **DEMONSTRATION / DELIVERY HOLD - Safety Recall 16S06**

Certain 2015-2016 Model Year Transit Wagon Vehicles Seat Belt Buckle Repair/Replacement

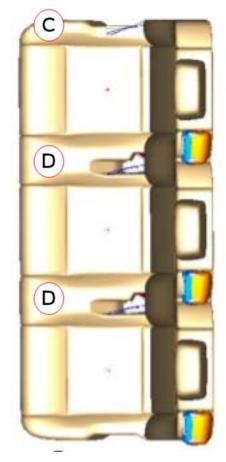
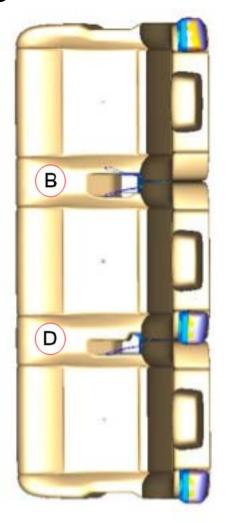
### VC 1 - 8 Passenger, Low Roof

NOTE: Do not install a new webbing buckle if a webbing buckle is already present in location C.

- B Replace Double Buckle CK4Z-1460044-A Qty. 1
- C Install Webbing Buckle BK3Z-6160044-A Qty. 1
- D Refer to Attachment III: Technical Information
  Inspect All LH Seat Belt Buckle/Retractor Assemblies
  Install 3 Reinforcement Blockers CK4Z-14613D10-B
  (1 package includes 5 pieces)

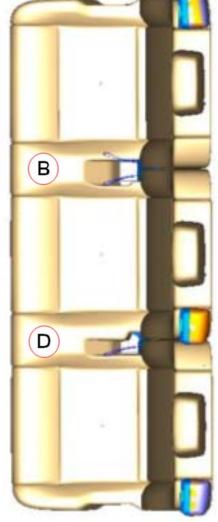
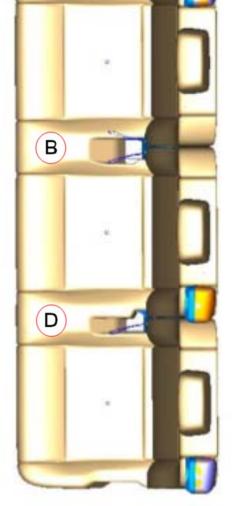
## VC 2 - 8 Passenger, Mid Roof

Front Seats
Not Affected

Refer to Attachment III: Technical Information
Inspect All LH Seat Belt Buckle/Retractor Assemblies
Install 2 Reinforcement Blockers CK4Z-14613D10-B
(1 package includes 5 pieces)

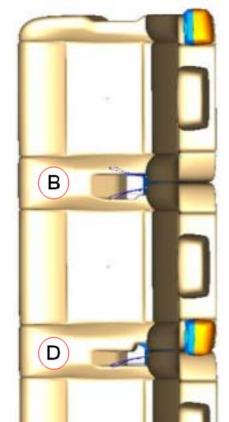
# VC 3 - 10 Passenger

Front Seats
Not Affected

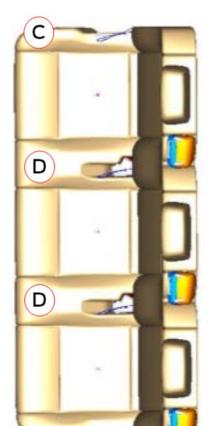
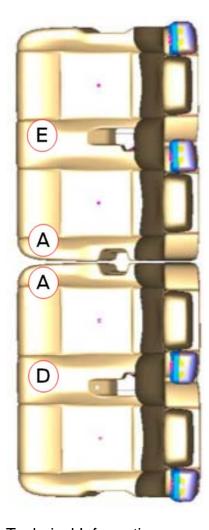
## VC 4 - 12 Passenger

NOTE: Do not install a new webbing buckle if a webbing buckle is already present in location C.

Front Seats
Not Affected

- A Replace Single Buckle CK4Z-1460044-B Qty. 4
- C Install Webbing Buckle BK3Z-6160044-A Qty. 1
- Refer to Attachment III: Technical Information
- D Inspect All LH Seat Belt Buckle/Retractor Assemblies
- Inspect All RH Seat Belt Buckle/Retractor Assemblies
  Install 5 Reinforcement Blockers CK4Z-14613D10-B
  (1 package includes 5 pieces)

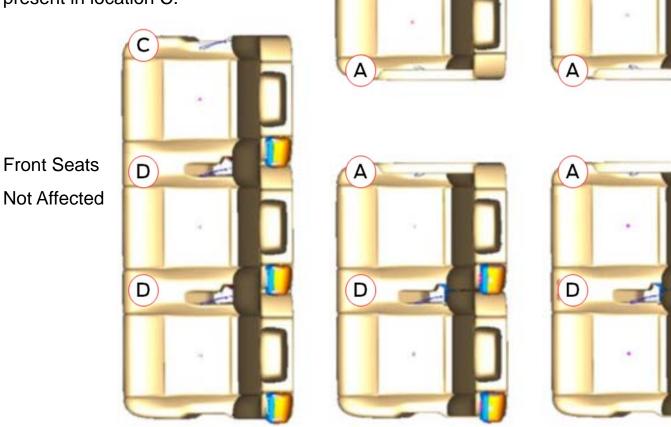
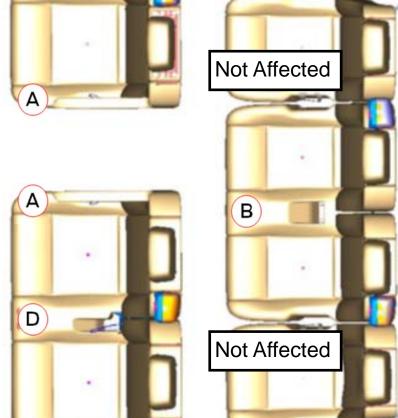
### VC 5 - 15 Passenger

NOTE: Do not install a new webbing buckle if a webbing buckle is already present in location C.

- A Replace Single Buckle CK4Z-1460044-B Qty. 4
- B Replace Double Buckle CK4Z-1460044-A Qty. 1
- C Install Webbing Buckle BK3Z-6160044-A Qty. 1
- Refer to Attachment III: Technical Information
  Inspect All LH Seat Belt Buckle/Retractor Assemblies
  Install 4 Reinforcement Blockers CK4Z-14613D10-B
  (1 package includes 5 pieces)

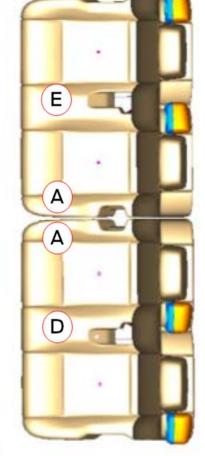
# VC 6 - 15 Passenger, Extended-Length

NOTE: Do not install a new webbing buckle if a webbing buckle is already present in location C.

Front Seats Not Affected

Refer to Attachment III: Technical Information
