CERTAIN 2005-2009 MUSTANG VEHICLES — PASSENGER AIRBAG INFLATOR REPLACEMENT

AIRBAG INFLATOR REPLACEMENT

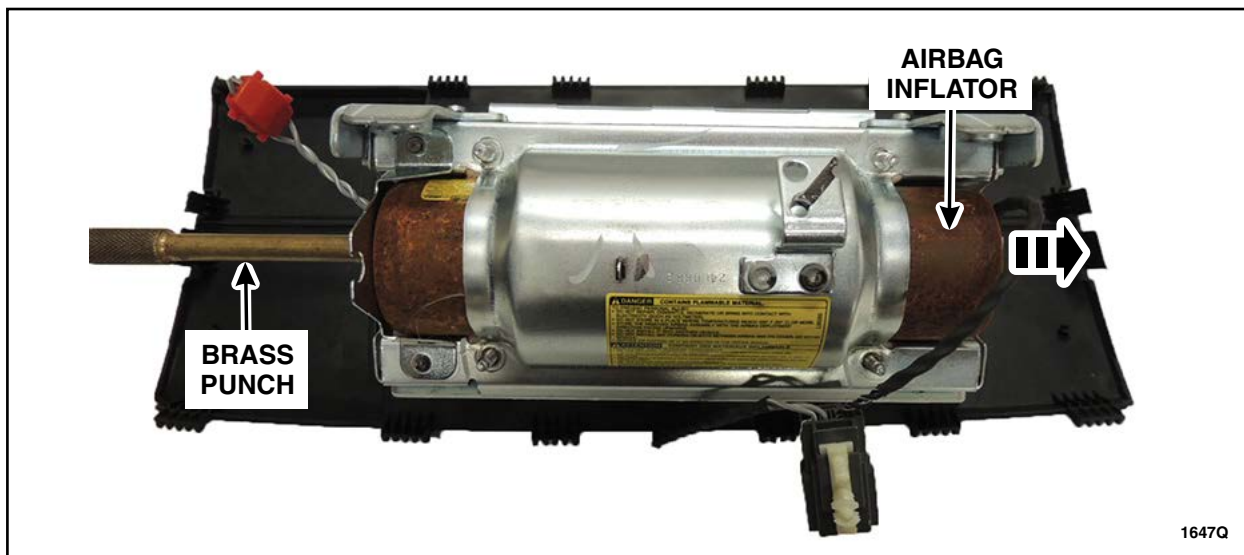
FIGURE 6

8. With an assistant holding the passenger airbag assembly, remove the inflator from the assembly by pushing outward on the inflator. Set the airbag inflator aside for return shipping. See Figure 6.
- If required, use of a brass punch is permitted (only at the location shown) to free the inflator from its mounted position.
