SUBJECT: **Safety Recall 17S01 – Supplement #4**
 Certain 2005-2006 Ford GT, 2005-2009 and 2012 Mustang, 2006-2009 Milan,
 2006-2009 and 2012 Fusion and MKZ/Zephyr, 2007-2009 Edge and MKX, and
 2007-2009 Ranger Vehicles
 Passenger Airbag Inflator Replacement

CERTAIN 2005-2006 FORD GT AND 2012 MUSTANG VEHICLES — PASSENGER AIRBAG INFLATOR REPLACEMENT

CERTAIN 2005-2009 MUSTANG VEHICLES — PASSENGER AIRBAG INFLATOR REPLACEMENT

CERTAIN 2007-2009 RANGER VEHICLES — PASSENGER AIRBAG INFLATOR REPLACEMENT

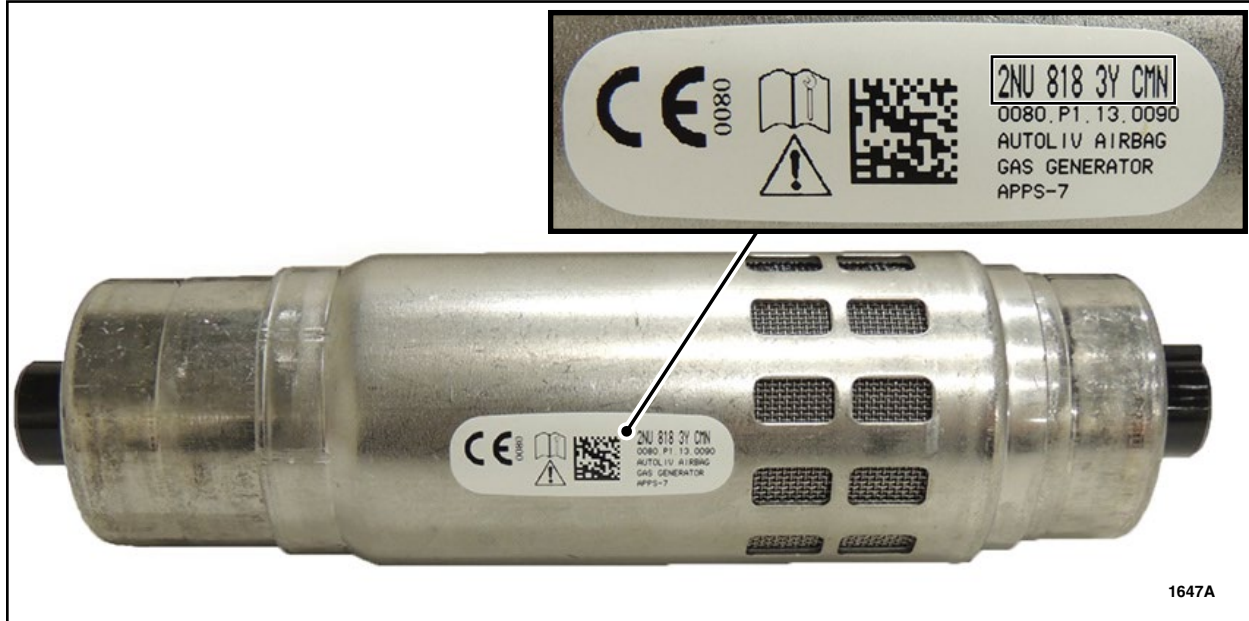
FIGURE 7

9. Record the 11 character serial number of the *new* airbag inflator on the repair order. See Figure 7.

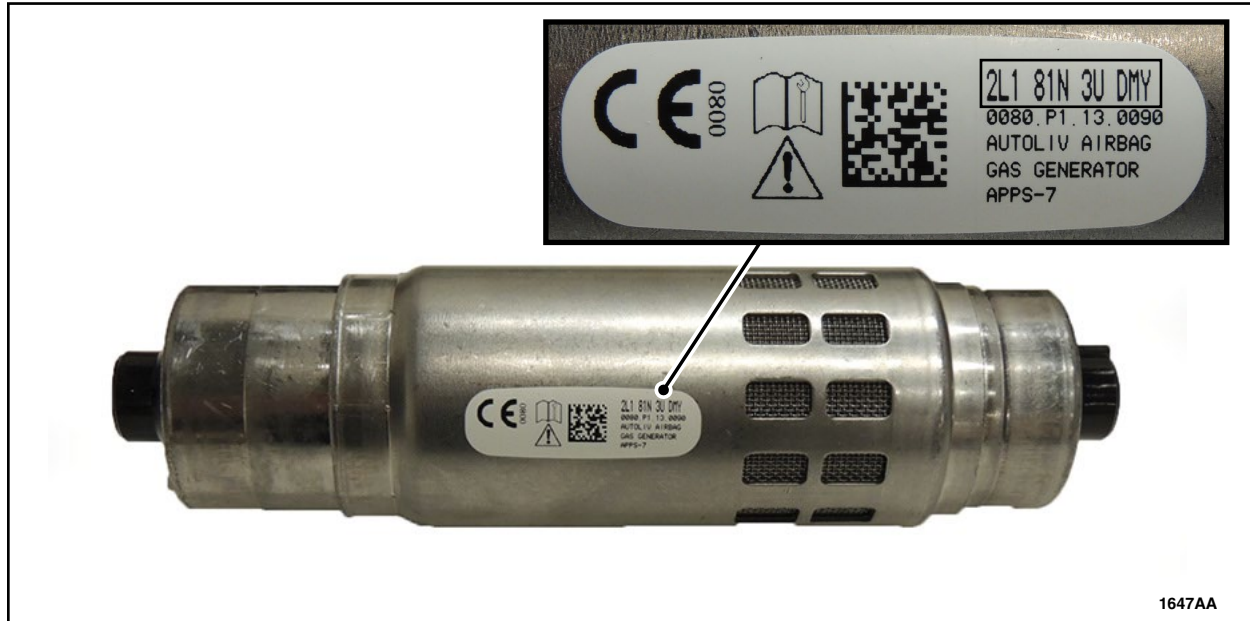
FIGURE 7

9. Record the 11 character serial number of the *new* airbag inflator on the repair order. See Figure 7.

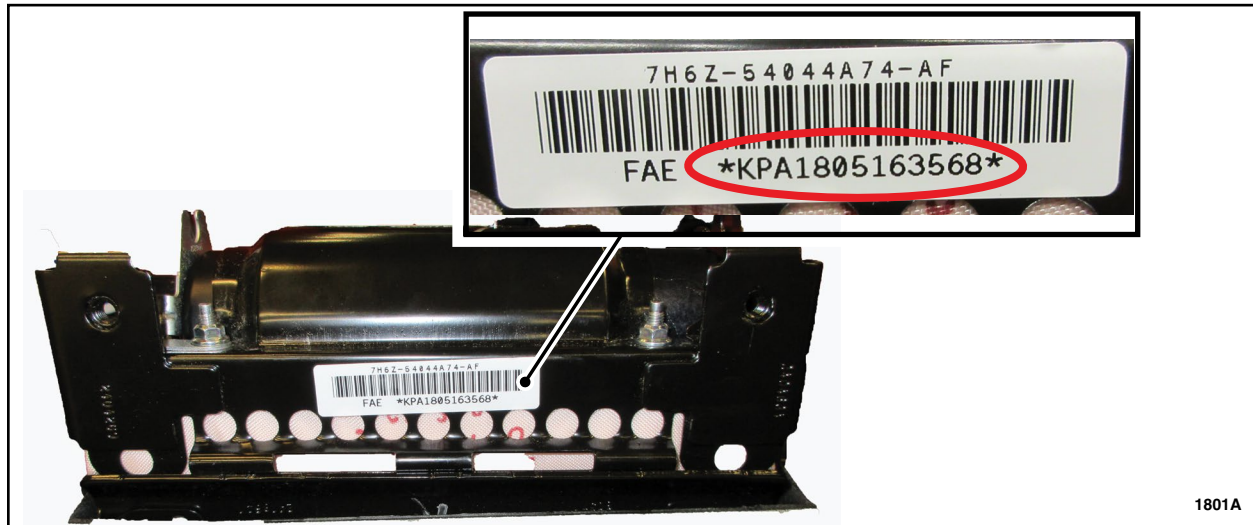
FIGURE 1

1. Record the 13 character serial number of the new airbag module on the repair order. See Figure 1.
2. Replace the passenger airbag module. Refer to section 501-20B of the Workshop Manual.
3. Package the replaced airbag module in the new part box and provide to the appropriate dealership personnel for part returns.
