F/CMVSS Noncompliance Recall

18315 Rear Seatbelt Automatic Locking Retractor (ALR) Function

Reference Number: N182180720

Release Date: September 2018
Revision: 00

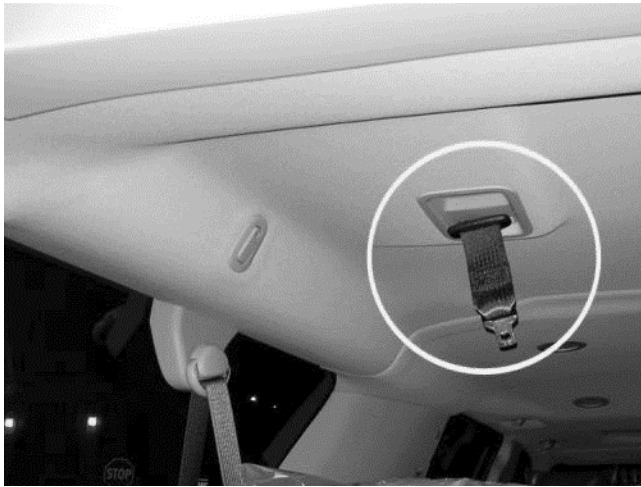
5149693

1. Remove the middle third row seatbelt buckle from the headliner seatbelt bezel.

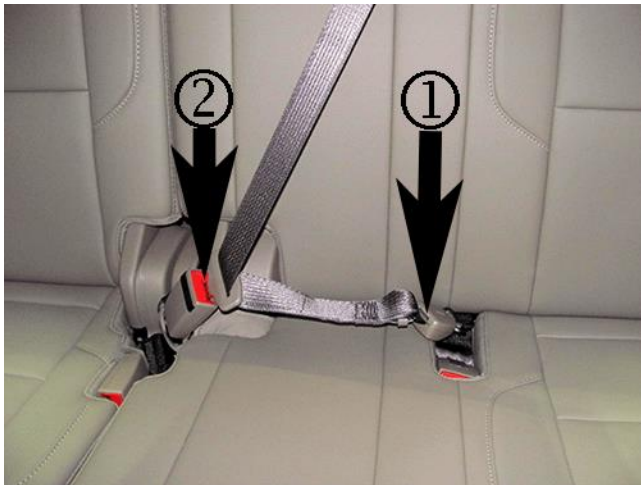
5149695

2. Pull the seatbelt out of the retractor and install the small latch plate into the detachable anchor (1). Install the large latch plate into the buckle as if buckled over an occupant (2).

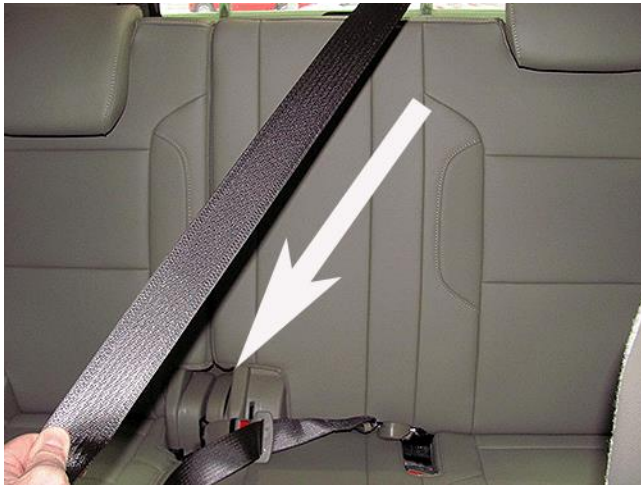
5149696

3. Pull the complete length of the seatbelt out until it reaches a hard stop.

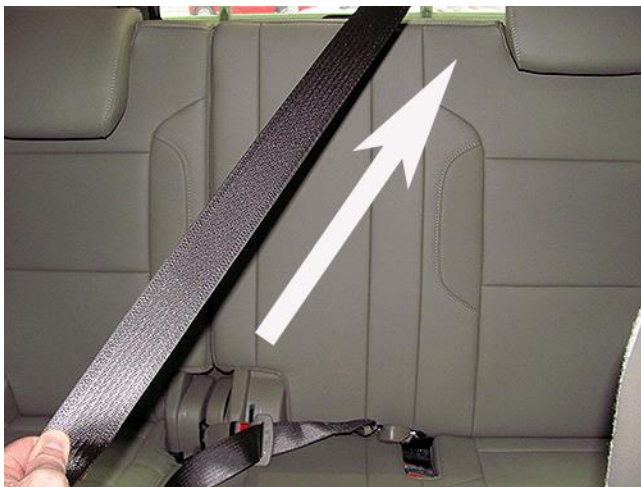
5149697

4. Allow approximately 12 inches (30 cm) of the belt to slowly retract back into the retractor (you will hear a ratcheting sound).
5. Firmly tug on the belt and verify that it locks and cannot be pulled out of the retractor.

6. Allow another 12 inches (30 cm) to retract into the retractor, firmly tug on the belt and verify that it locks and cannot be pulled out of the retractor.

7. Allow another 12 inches (30 cm) to retract into the retractor, firmly tug on the belt and verify that it locks and cannot be pulled out of the retractor.

8. Disconnect the large latch plate from the buckle and allow the seatbelt to retract.
9. Reconnect the latch plate into the buckle.
10. Repeat steps 3-9 six times.

- **If the seatbelt retractor locks without releasing six times in succession, no further action is required,** the belt system is performing as designed.

- **If the seatbelt fails to lock at any time during the six cycles, the seatbelt retractor assembly requires replacement.** Revised service parts are currently NOT available. This bulletin will be updated once revised service parts are available. Other vehicle seating positions and/or the vehicle's LATCH anchorage system may be appropriate for use with a customer's child seat until the final recall remedy is performed. If a customer has questions regarding whether another seating position or the vehicle's LATCH anchorage system is appropriate

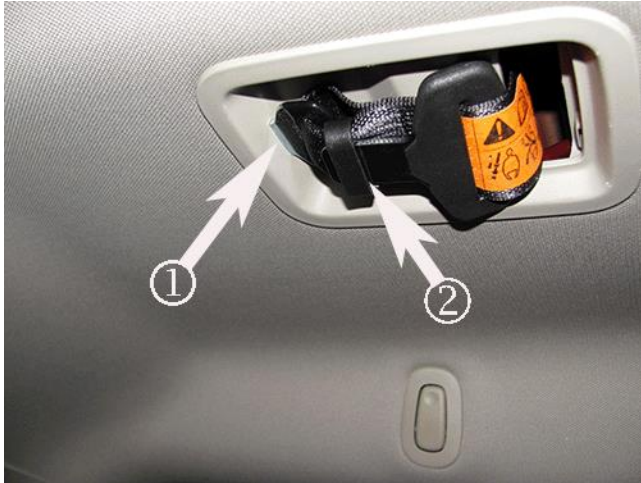
5149700

11. Disconnect both latch plates and reinstall the seatbelt buckle into the bezel (1) and ensure it is secured in the anti-rattle receiver (2).

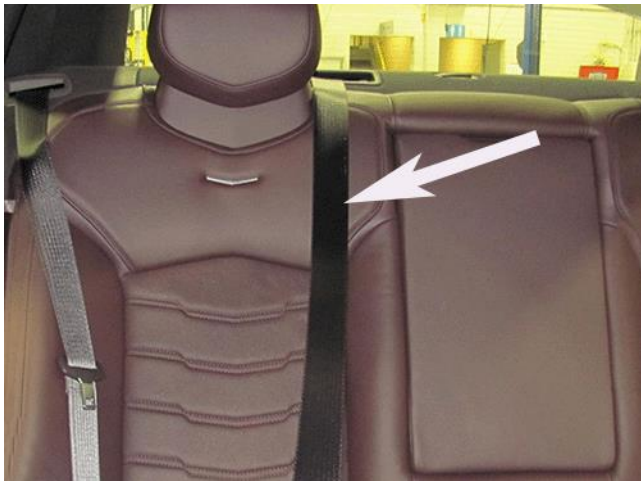
5149702

1. Locate the middle rear seatbelt.
2. Pull the seatbelt out of the retractor and insert the latch plate into the buckle.

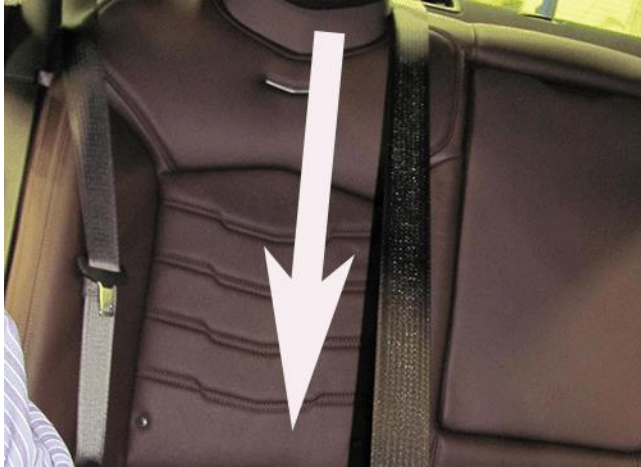
5149703

3. Pull the complete length of the seatbelt out until it reaches a hard stop.

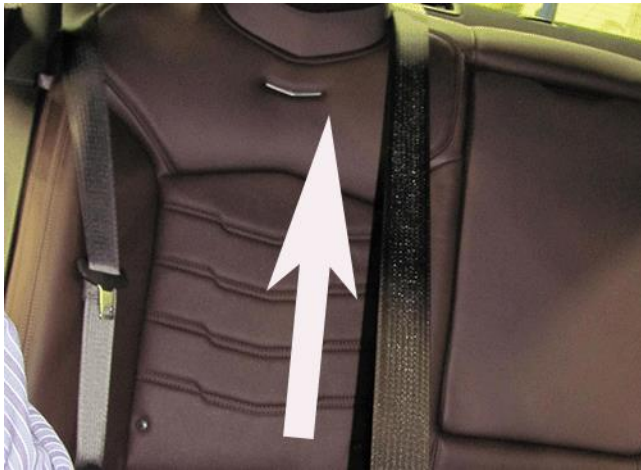
5149704

Important: When performing the following steps, do not allow more than the specified length to retract, this will ensure the manufacturer-built threshold to lock isn't passed.

4. Allow approximately 12 inches (30 cm) of the belt to slowly retract back into the retractor (you will hear a ratcheting sound).
5. Firmly tug on the belt and verify that it locks and cannot be pulled out of the retractor.

6. Allow another 12 inches (30 cm) to retract into the retractor, firmly tug on the belt and verify that it locks and cannot be pulled out of the retractor.

7. Allow another 12 inches (30 cm) to retract into the retractor, firmly tug on the belt and verify that it locks and cannot be pulled out of the retractor.

8. Disconnect the latch plate and allow the seatbelt to fully retract.
9. Repeat steps 2-8 six times.
 - **If the seatbelt retractor locks without releasing six times in succession, no further action is required,** the belt system is performing as designed.

- **If the seatbelt fails to lock at any time during the six cycles, the seatbelt retractor assembly requires replacement.** Revised service parts are currently NOT available. This bulletin will be updated once revised service parts are available. Other vehicle seating positions and/or the vehicle's LATCH anchorage system may be appropriate for use with a customer's child seat until the final recall remedy is performed. If a customer has questions regarding whether another seating position or the vehicle's LATCH anchorage system is appropriate for use with the customer's child seat, please refer the customer to the instructions provided in vehicle's owner's manual and the child-seat owner's manual.

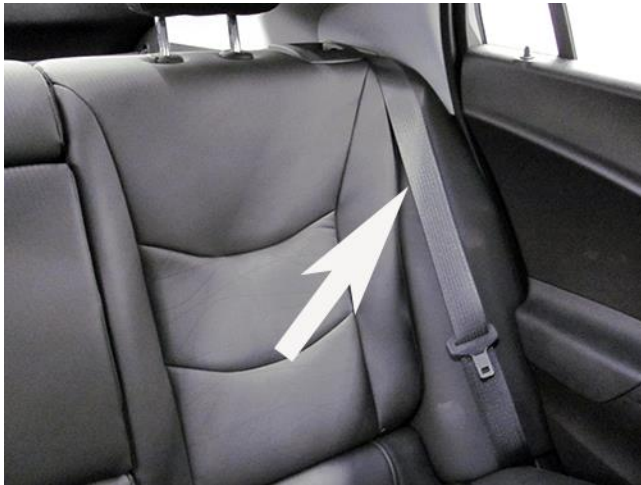
5149706

1. Locate the driver side rear seatbelt.

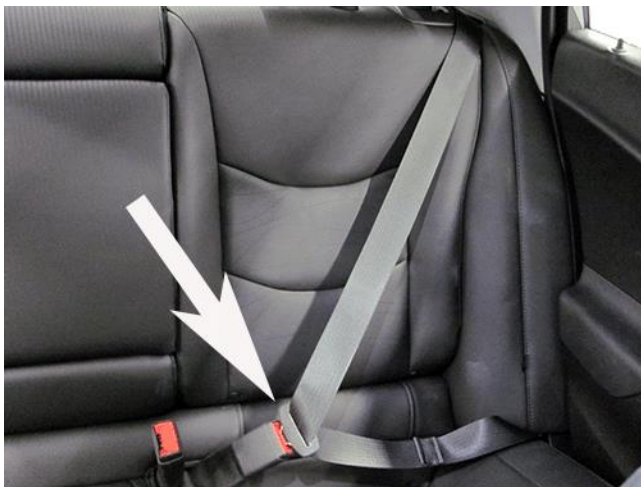
5149707

2. Pull the seatbelt out of the retractor and insert the latch plate into the buckle.

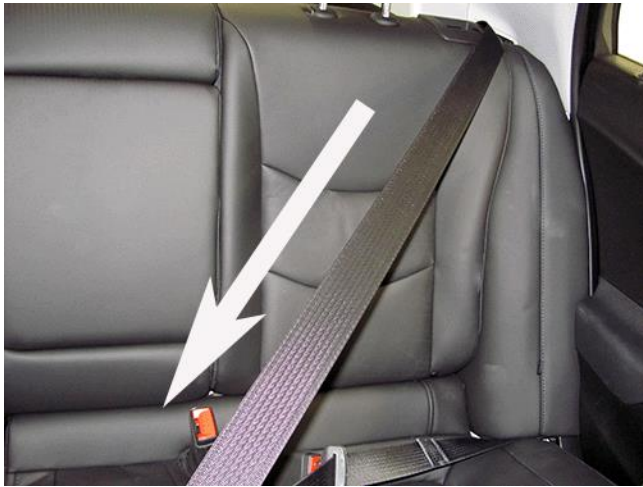
5149708

3. Pull the complete length of the seatbelt out until it reaches a hard stop.

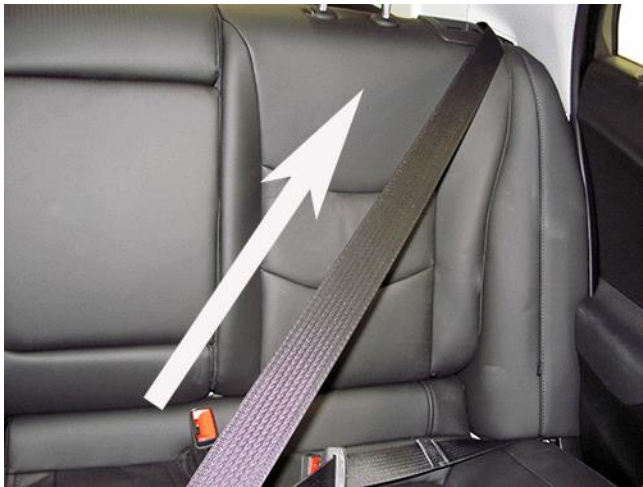
5149709

4. Allow approximately 12 inches (30 cm) of the belt to slowly retract back into the retractor (you will hear a ratcheting sound).
5. Firmly tug on the belt and verify that it locks and cannot be pulled out of the retractor.

6. Allow another 12 inches (30 cm) to retract into the retractor, firmly tug on the belt and verify that it locks and cannot be pulled out of the retractor.

7. Allow another 12 inches (30 cm) to retract into the retractor, firmly tug on the belt and verify that it locks and cannot be pulled out of the retractor.

8. Disconnect the latch plate from the buckle and allow the seatbelt to fully retract.
9. Repeat steps 2-8 six times.
10. Repeat steps two through nine on the passenger side rear seatbelt.

- **If the seatbelt retractor locks without releasing six times in succession, no further action is required,** the belt system is performing as designed.

- **If the seatbelt fails to lock at any time during the six cycles, the seatbelt retractor assembly requires replacement.** Revised service parts are currently NOT available. This bulletin will be updated once revised service parts are available. Other vehicle seating positions and/or the vehicle's LATCH anchorage system may be appropriate for use with a customer's child seat until the final recall remedy is performed. If a customer has questions regarding whether another seating position or the vehicle's LATCH anchorage system is appropriate
