SOLERA® SMART ARM AWNING CONTROLLER REPLACEMENT RECALL #18E-050

Solera Awning Smart Arm Controller Recall: #18E-050

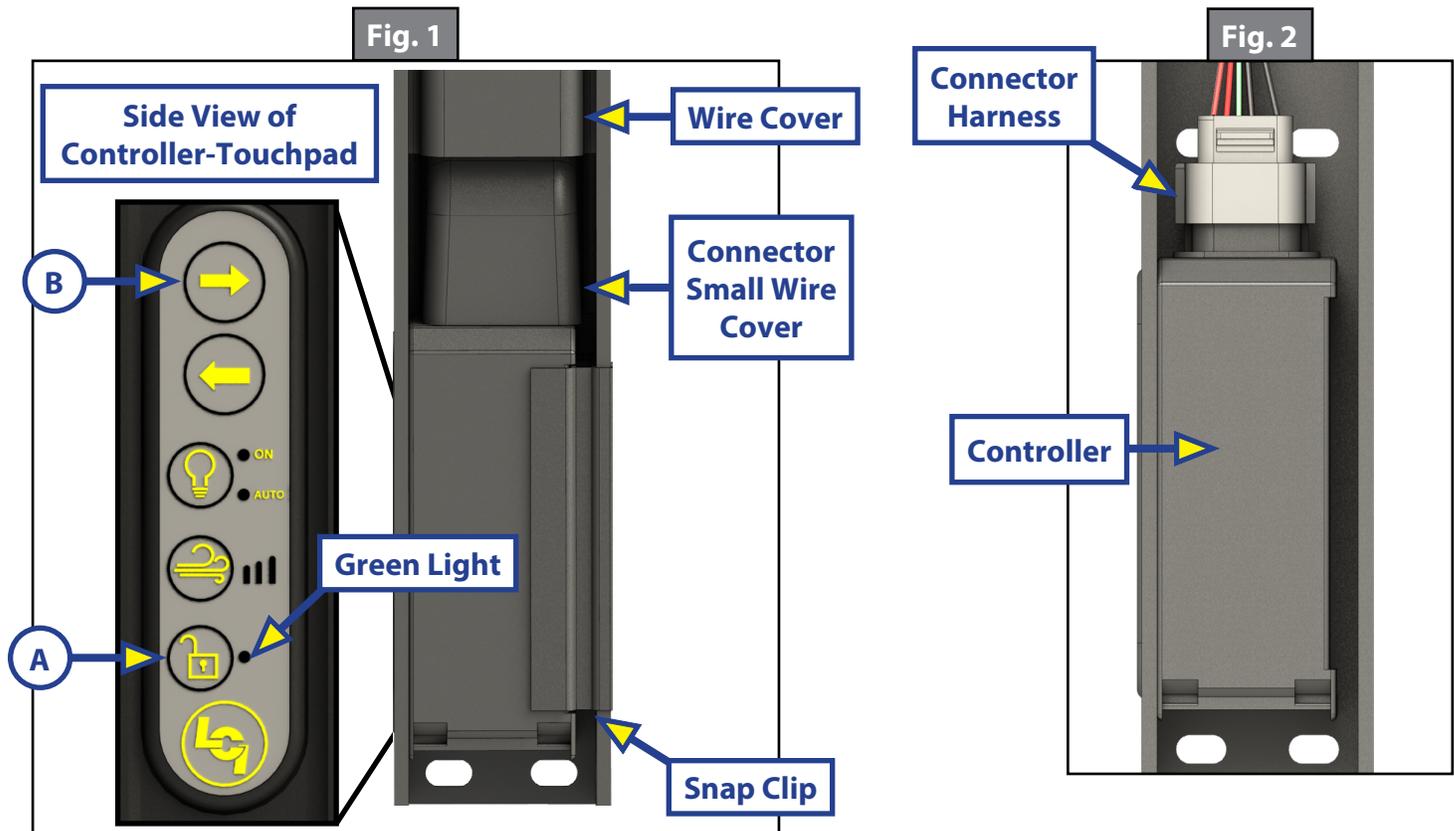
1. Press and hold the unlock button (Fig. 1A) until the green light illuminates.
2. Press and hold the extend arrow button (Fig. 1B) until the awning is fully extended.
3. Remove the snap clip, wire cover and connector small wire cover (Fig. 1) from the drive side awning arm assembly.
4. If equipped with an infrared (IR) sensor (Fig. 4), disconnect by unplugging it from the bottom of the smart arm controller (Fig. 3) and retain for reinstallation.
5. Remove the smart arm controller from the drive side mount arm.
6. Detach the connector harness (Fig. 2) from the smart arm controller.

NOTE: If corrosion is present within the connector harness, the harness **MUST** be replaced.

4. Fit the smart arm controller back into place so the touchpad face of the controller fits into the hole in the drive side mount arm, then push the snap clip into place (Fig. 1).
5. Reinstall the connector small wire cover and wire cover (Fig. 1), in that order.

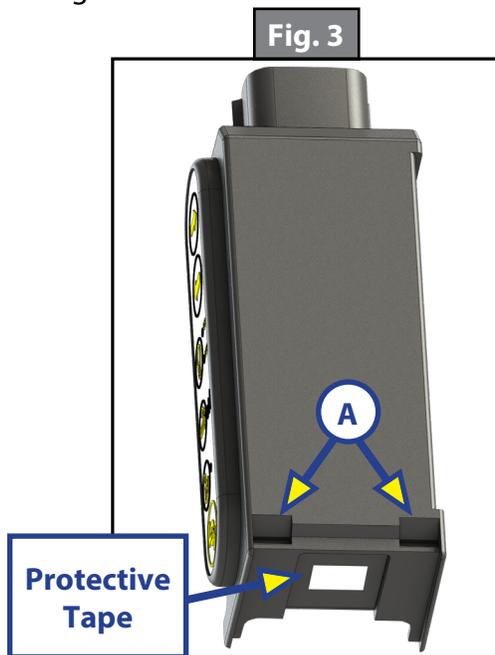
1. Remove the protective tape (Fig. 3) covering the connection pins at the bottom of the smart arm controller.
2. Align the IR sensor (Fig. 4) to the bottom of the smart arm controller with the white sensor dome facing outward. Line up notches on the front of the controller (Fig. 3A) with the tabs of the IR sensor (Fig. 4A), then push the IR sensor up and back to lock the sensor into place.

NOTE: The tab on the back of the IR sensor (Fig. 4B) will snap onto a tab at the bottom of the smart arm controller.

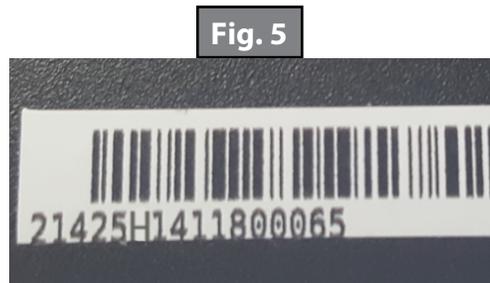
Please submit your completed work order with full unit information (including 17-digit VIN, Brand/Model and Date of Mfr) directly to LCI via email. Your submission must include a clear photo of the destroyed controller with the controller serial number (Fig. 5). Please send with repair documents via email to customerservice@lci1.com.

NOTE: Serial number is found on the side of the controller opposite the touchpad.
