**TECHNICAL INSTRUCTIONS**  
**FOR**  
**SAFETY RECALL H0A**  
**FRONT PASSENGER AIRBAG INFLATOR MODULE**  
**CERTAIN 2009 MODEL YEAR MATRIX**

The subject vehicles are equipped with front passenger airbag inflators produced by Takata. The propellant in these inflators may degrade after prolonged exposure to high absolute humidity and fluctuating high temperatures. Degraded propellant can cause inflator rupture during airbag deployment. In the event of an inflator rupture, metal fragments could pass through the airbag cushion material, striking the vehicle occupants, and result in serious injury or death.

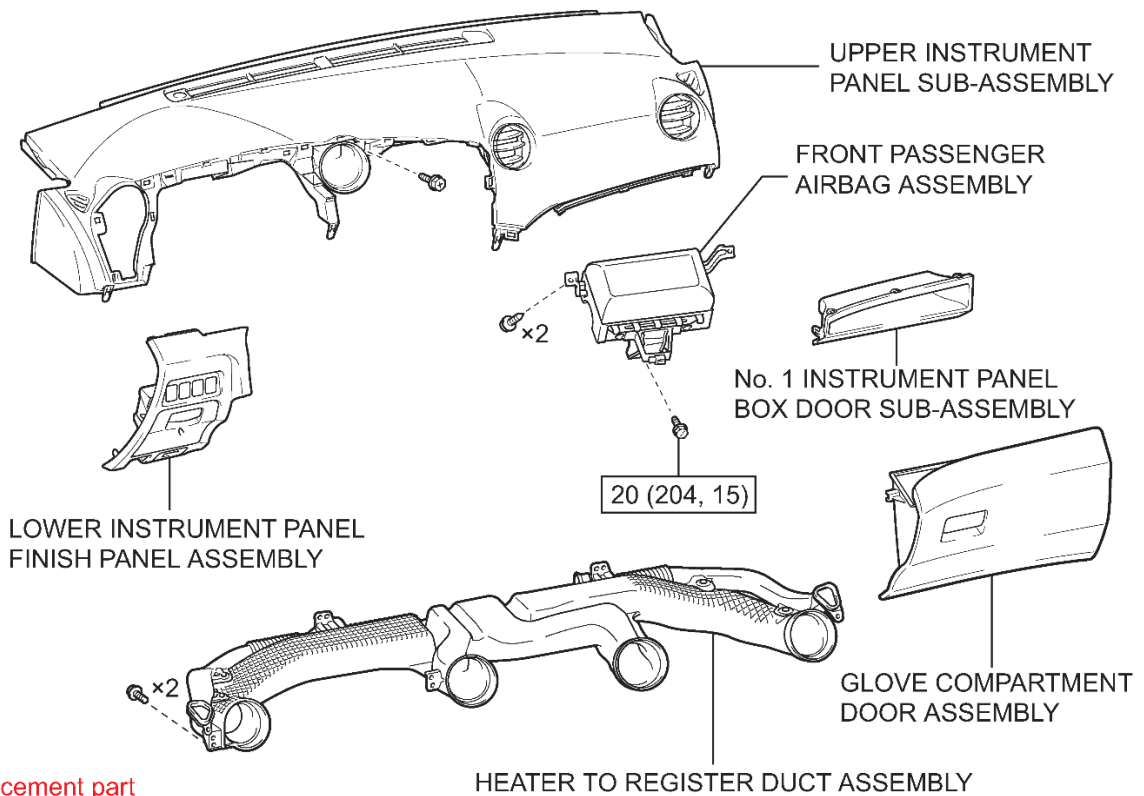
R1703010003

**3.9 N·m (40, 35 in.\*lbf)**  
**Be careful not to**  
**overtighten.**

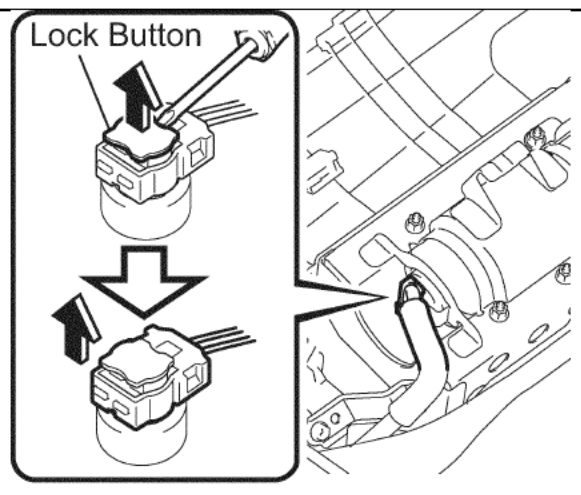
Lock Button

- Use a screwdriver to release the lock button.
- Disconnect the connector.
- Disconnect the wire harness clamps.

**NOTE:** Disconnect the connector where the fixed stop plate is located.

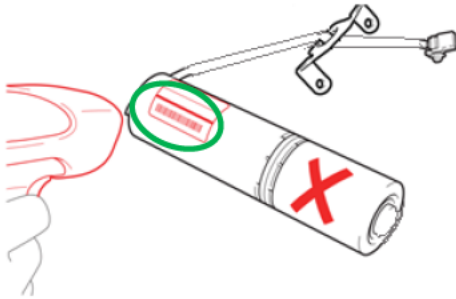
**Step a) Old Inflator (bar code)**

- Scan the **OLD** inflator bar code.
- Scan the **NEW** inflator QR code.

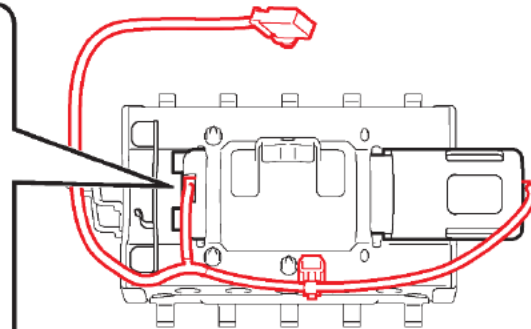
R1702270041

- b) Connect the connector to the inflator and ensure that the connector lock is fully engaged as shown.  
c) Route and secure the wire harness as shown.

**ALIGN CONNECTORS**

Wire Harness Side:

Inflator Side:

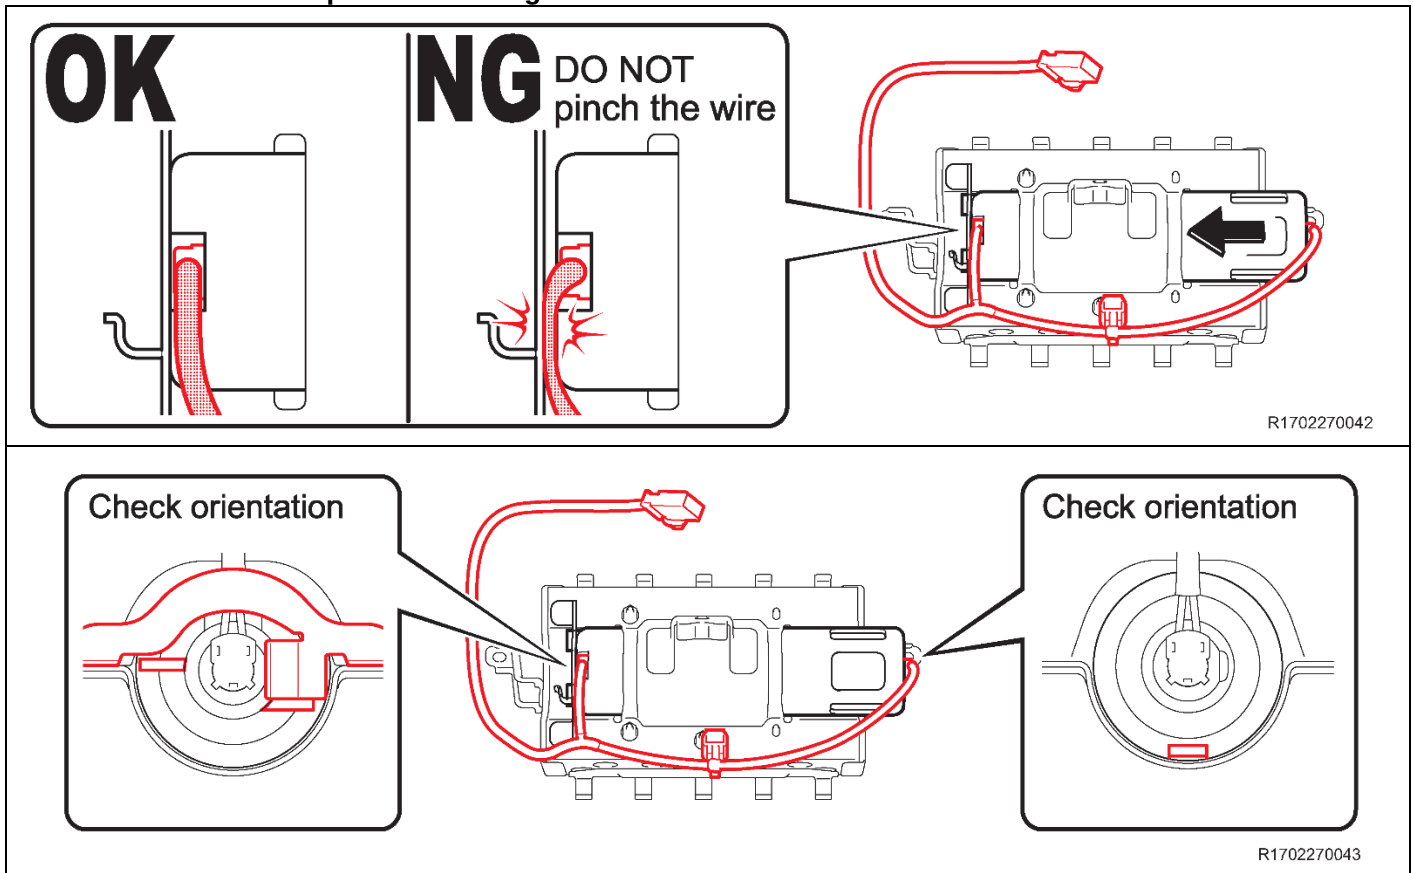
R1703080015

d) Fully insert the inflator and ensure that the inflator is correctly oriented as shown.

**NOTE: DO NOT pinch the wiring between the bracket and the inflator.**

**OK**

Install the plate so that  
there is no float

**NG**

DO NOT mistake the  
orientation of the plate

e) Install the **NEW** stopper plate.

**NOTE: Ensure that the stopper plate is the one from the bracket kit and installed in the correct orientation.**

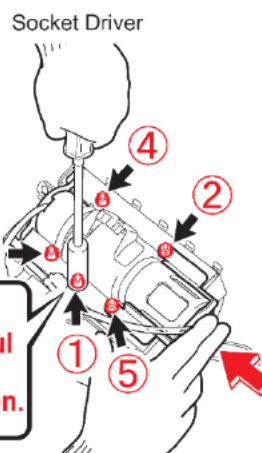
R1702270046

- a) Tighten the 5 nuts evenly in several increments in the sequence shown. Use a socket driver or torque wrench to tighten the nuts.

Torque: 35in. lbf (3.9N·m)

- There will be some resistance when tightening the nuts because they are self-locking, confirm the nuts are tightened correctly.
- **DO NOT** use a power tool, T-handle, or ratchet when tightening the nuts to avoid over torqueing and deforming the studs.
- You may need to turn the airbag to the left or right with in the mounting bracket to access the center nut.

3.9 N·m  
Be careful  
not to  
overtighten.

**Too Tight!**

**These tools cause overtightening !**
