TECHNICAL INSTRUCTIONS FOR SAFETY RECALL GLH FRONT PASSENGER AIRBAG INFLATOR REPLACEMENT CERTAIN 2007 – 2010 MY ES 350

UPDATED 4-18-2018

The subject vehicles are equipped with front passenger airbag inflators produced by Takata. The propellant in these inflators may degrade after prolonged exposure to high absolute humidity and fluctuating high temperatures. Degraded propellant can cause inflator rupture during airbag deployment. In the event of an inflator rupture, metal fragments could pass through the airbag cushion material, striking the vehicle occupants, and result in serious injury or death.

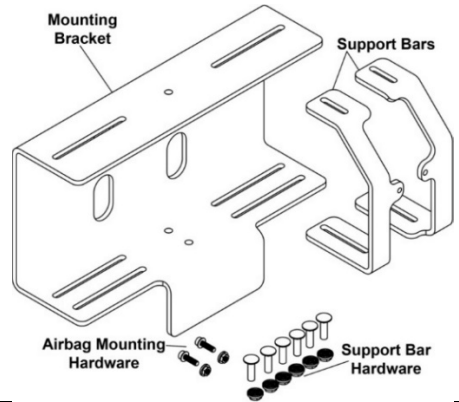
Airbag Mounting Bracket & hardware (Provided to the dealership at the launch of SSC DLC)	1

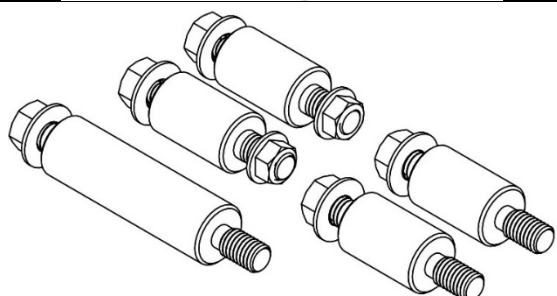
579943 Adaptor set*	1

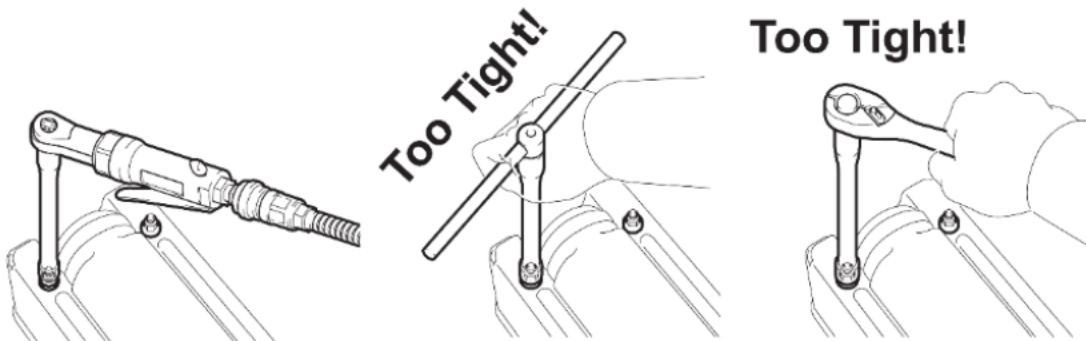
R1701260011Z01

k) Tighten the 5 nuts evenly in several increments in the sequence shown. Use a socket driver or torque wrench to tighten the nuts.

Torque: 35 in. lbf (3.9N·m)

- There will be some resistance when tightening the nuts because they are self-locking, confirm the nuts are tightened correctly.
- **DO NOT** use a power tool, T-handle, or ratchet when tightening the nuts to avoid over torqueing and deforming the studs.
- You may need to slide the airbag to the left or right with in the mounting bracket to access the center nut.

These tools cause overtightening !
