# IMPORTANT UPDATE

## TECHNICAL INSTRUCTIONS FOR SAFETY RECALL G0P FRONT PASSENGER AIRBAG INFLATOR MODULE CERTAIN 2009 –2013 MODEL YEAR MATRIX

**Updated 7-17-18**

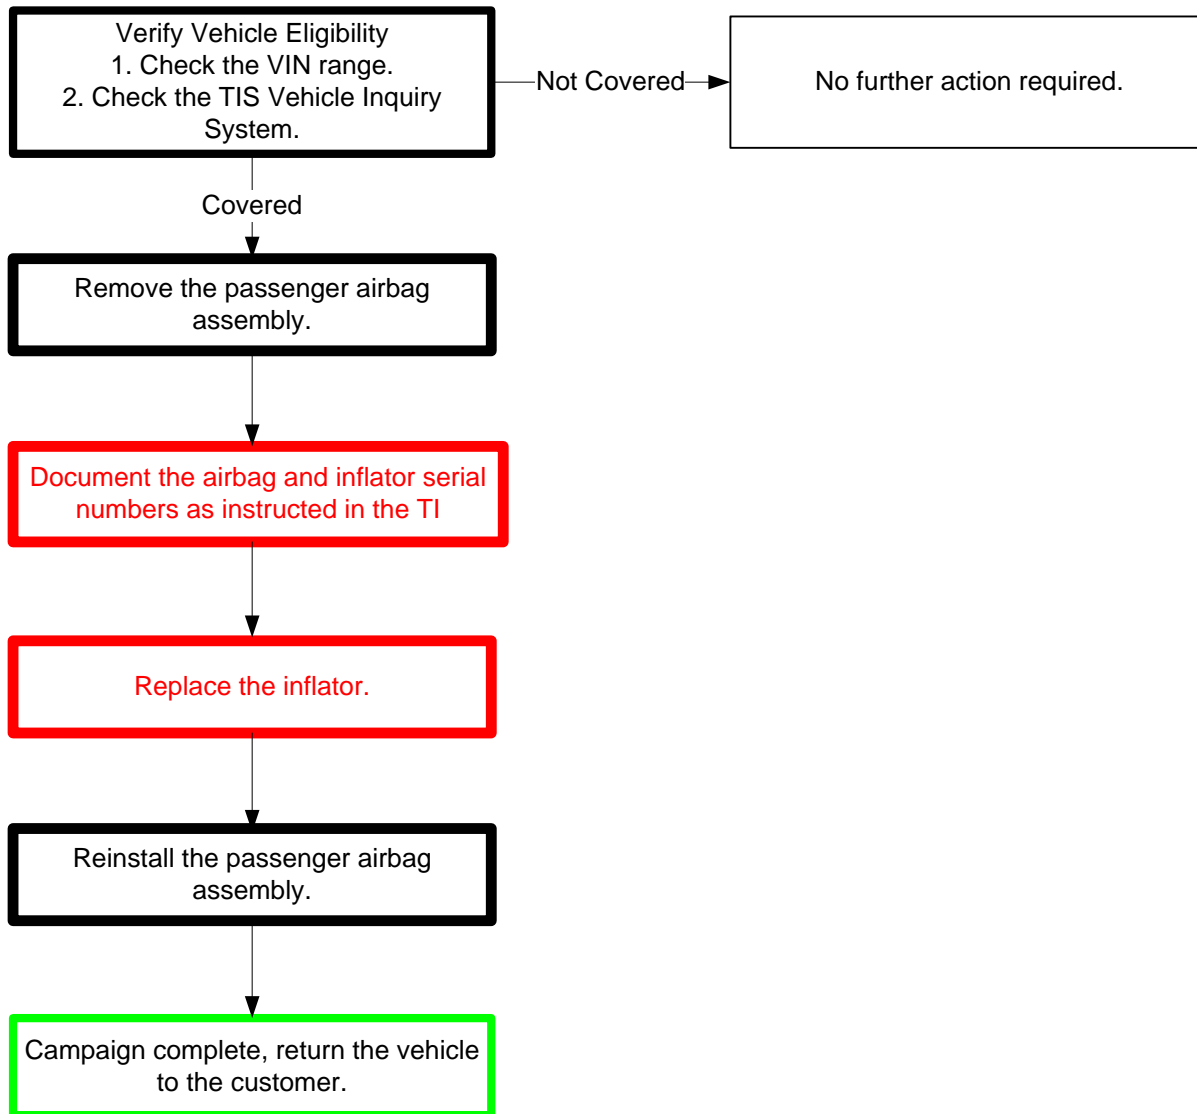
## I. OPERATION FLOW CHART

The flow chart is for reference only. **DO NOT** use it in place of the full technical instructions. Follow **ALL** steps as outlined in the full technical instructions to confirm the campaign is completed correctly.

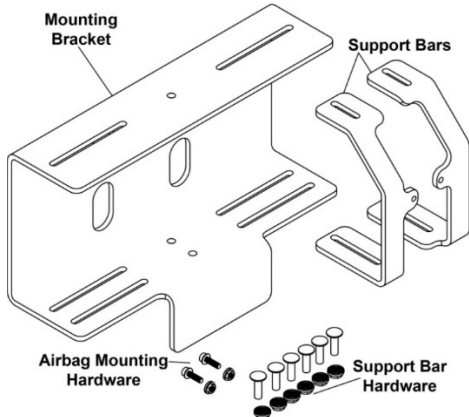
Airbag Mounting Bracket & hardware	1

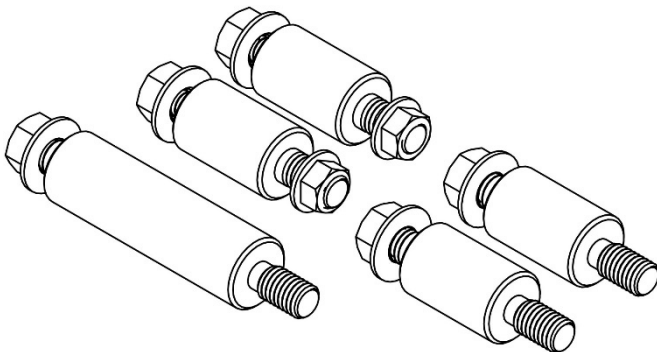
Adaptor set*	1

\*The adaptor set was sent to dealers at the start of this campaign.

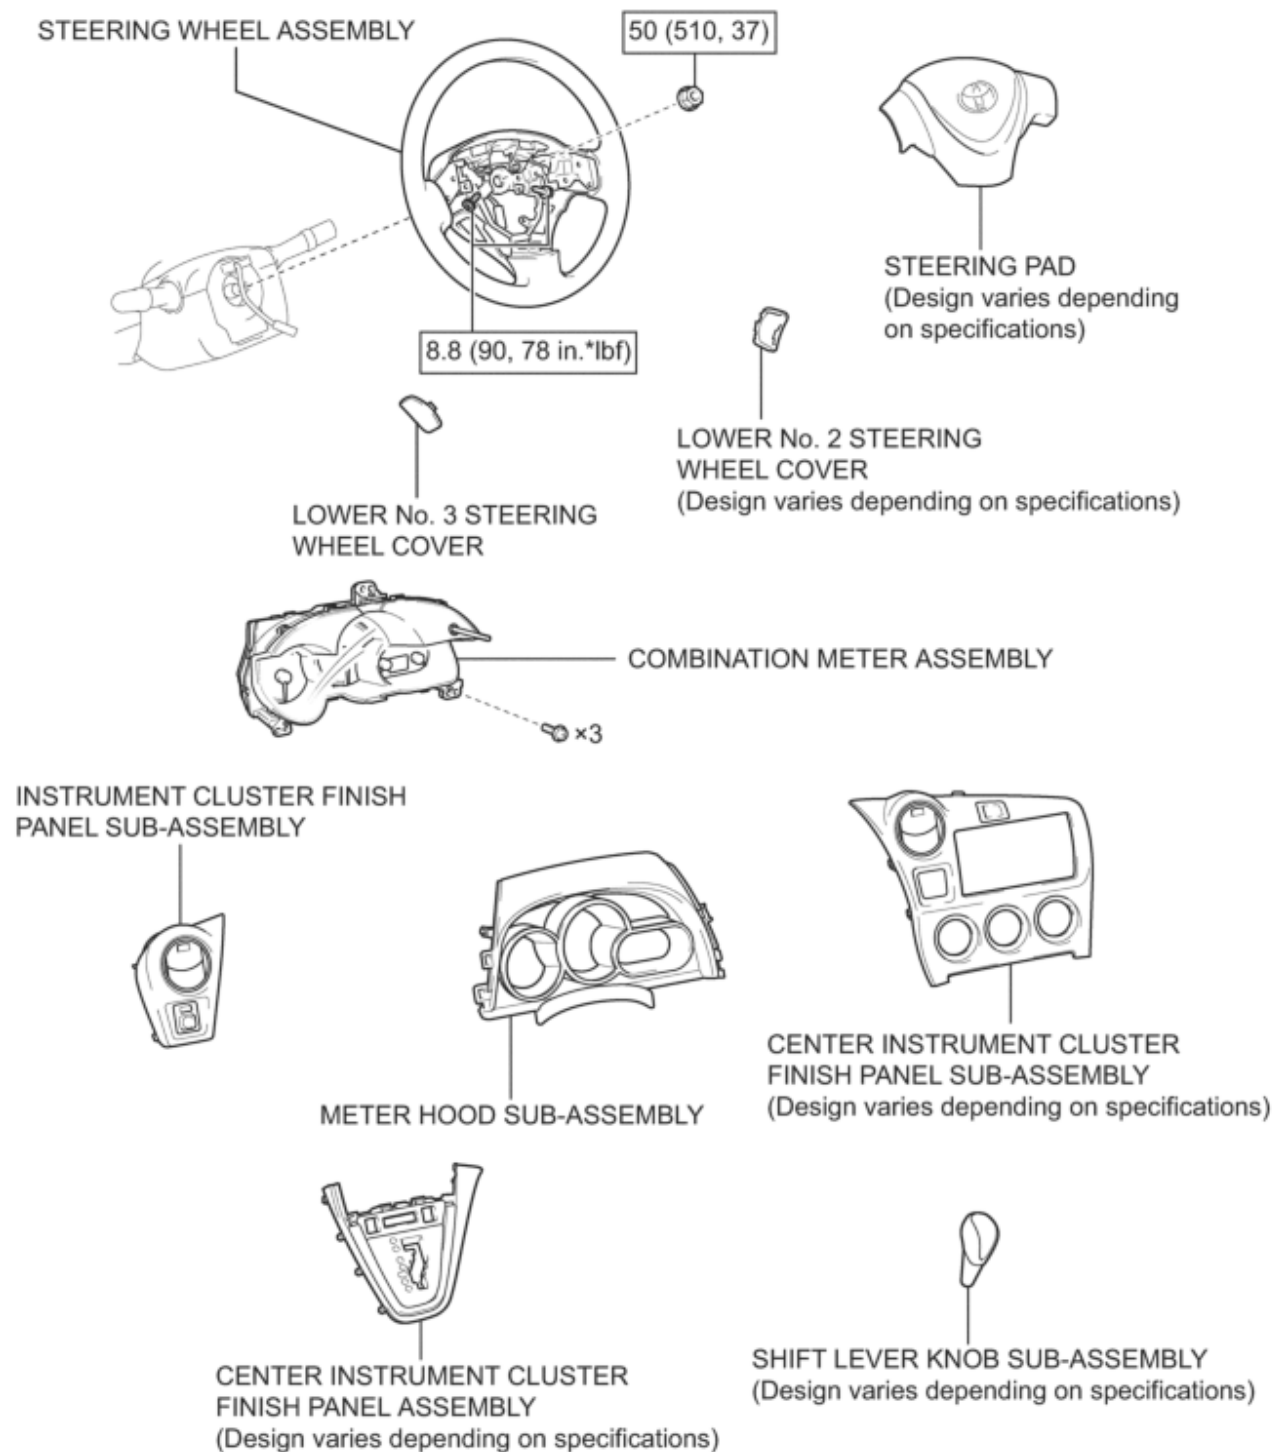
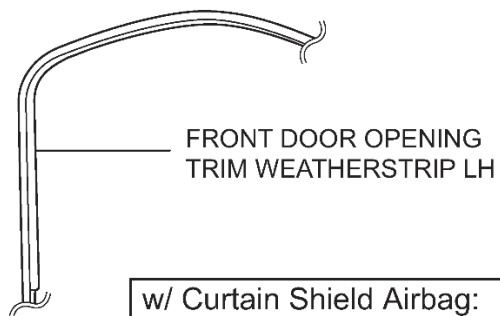
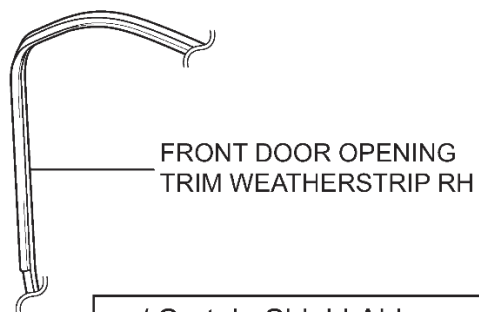
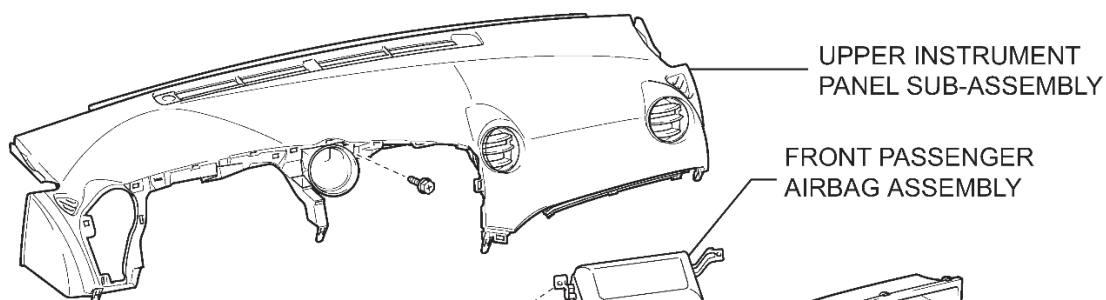
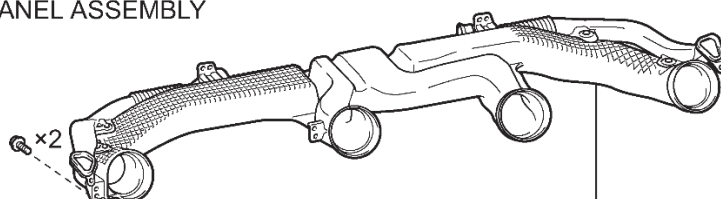
R1703010002

FRONT PILLAR GARNISH LH

FRONT PILLAR GARNISH RH

LOWER INSTRUMENT PANEL  
FINISH PANEL ASSEMBLY

No. 1 INSTRUMENT PANEL  
BOX DOOR SUB-ASSEMBLY

GLOVE COMPARTMENT  
DOOR ASSEMBLY

HEATER TO REGISTER DUCT ASSEMBLY

● : Replacement part

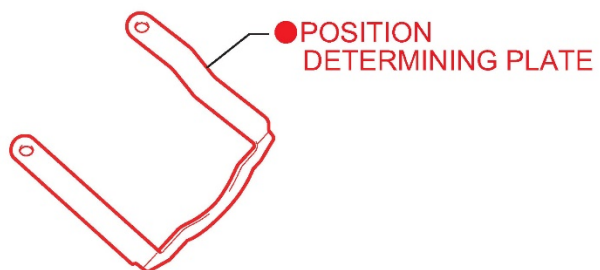
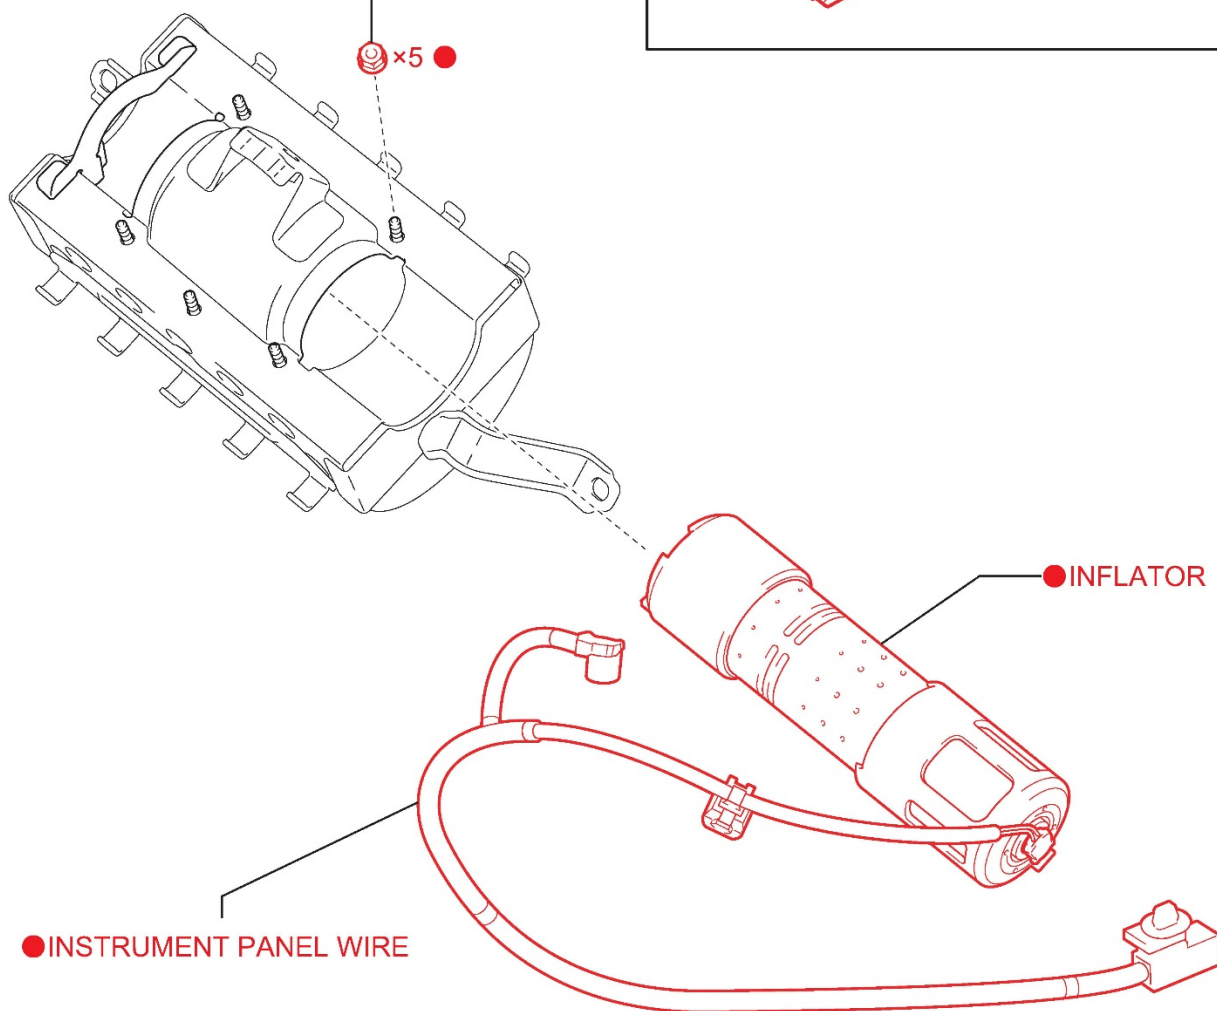
R1702270035

**3.9 N·m (40, 35 in.\*lbf)**  
**Be careful not to**  
**overtighten.**

for MATRIX:

● : Replacement part

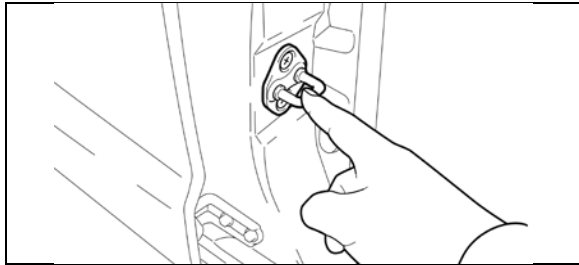
#### 1. ELIMINATE STATIC ELECTRICITY

- Before starting work and periodically while working on the vehicle, touch a metallic part of the vehicle to discharge static electricity in the body.

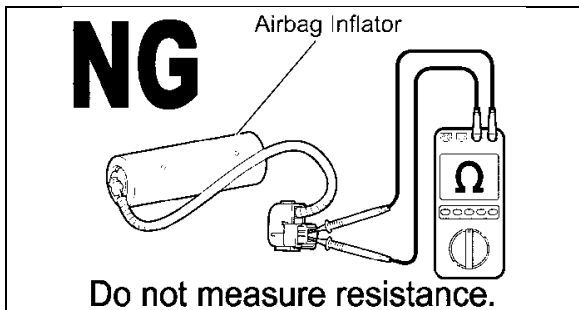
#### 2. DO NOT MEASURE RESISTANCE

- DO NOT** measure resistance of airbag components, this may cause accidental activation.

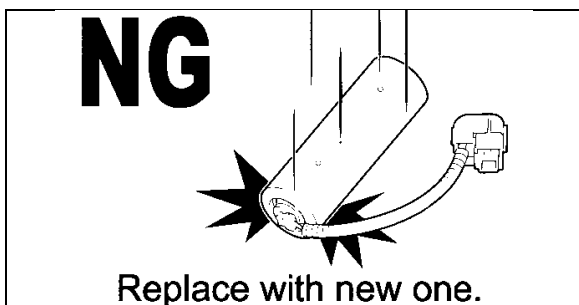
#### 3. HANDLE THE AIRBAG CAREFULLY

- If an inflator is dropped, replace it with a **NEW** inflator.

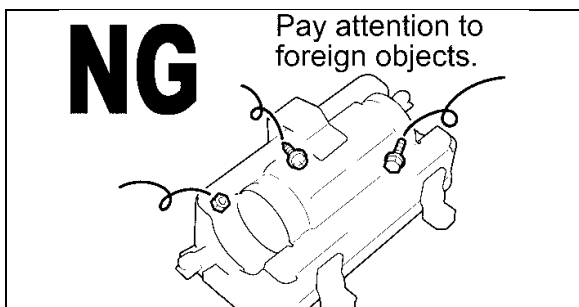
#### 4. DO NOT ALLOW FOREIGN OBJECTS NEAR AIRBAG

- Be sure to collect and account for all removed nuts/bolts to prevent them from landing in the airbag assembly.
- Any foreign objects in the airbag assembly may cause damage or injury if the airbag is activated.

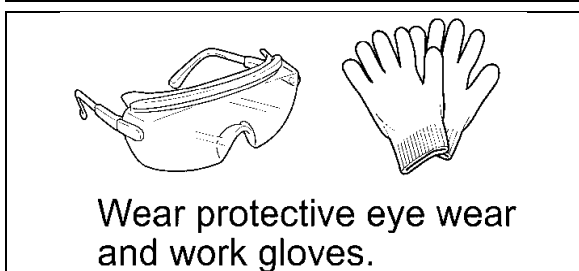
#### 5. WEAR PROTECTIVE EQUIPMENT

- Always wear appropriate protective equipment when working on the SRS.

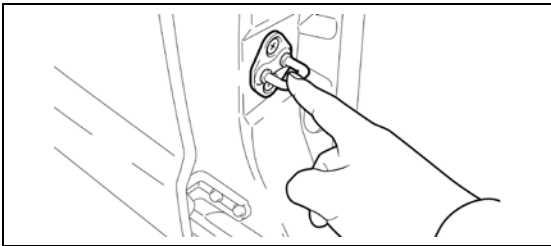
The anti-static mat set that is an essential SST may be available at your dealership and is optional to use during inflator replacement. If the anti-static kit is not available, before starting work and periodically while working on the vehicle, touch a metallic part of the vehicle to discharge static electricity in the body.

If the anti-static kit is not available, before starting work and periodically while working on the vehicle, touch a metallic part of the vehicle to discharge static electricity in the body.

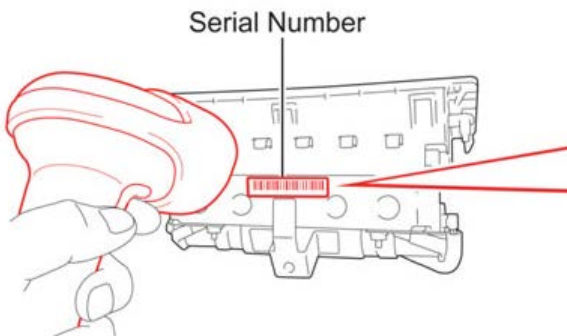
**Airbag Serial Number Label Example**

- The airbag serial number is **ALWAYS** the 12 **DIGITS** located between the asterisks.
- The 3 digits before the asterisk **ARE NOT** part of the serial number, and **SHOULD NOT** be entered or an inaccurate response may be returned.

The **AIRBAG ASSEMBLY** serial number and the **INFLATOR** serial number are **DIFFERENT**. The **AIRBAG ASSEMBLY** serial number **MUST** be recorded prior to replacement.

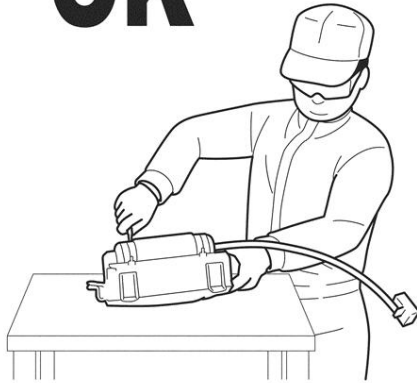
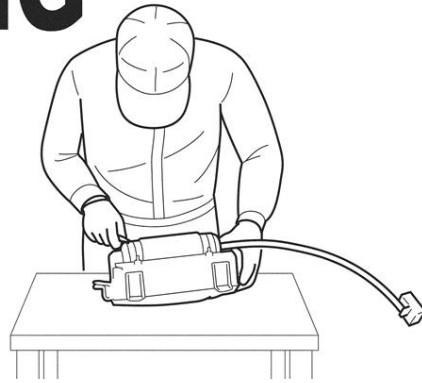
R1301230008E

- Carefully place the airbag on the bench inflator side up.

**NOTE: Place clean sheet(s) of paper on the bench to protect the airbag.**

- Avoid standing directly over the inflator.

# OK

# NG

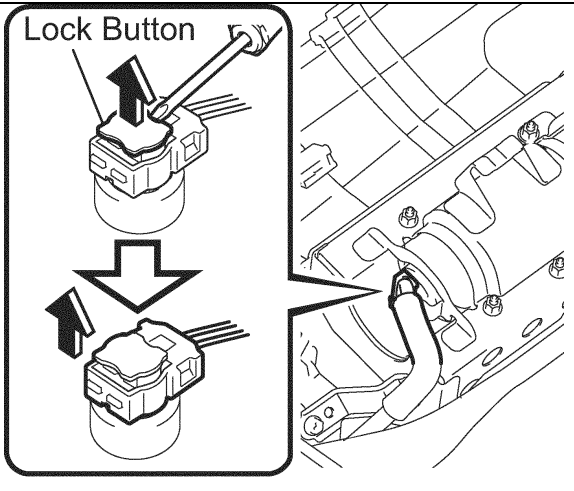
Lock Button

- Use a screwdriver to release the lock button.
- Disconnect the connector.
- Disconnect the wire harness clamps.

**NOTE: Disconnect the connector where the fixed stop plate is located.**

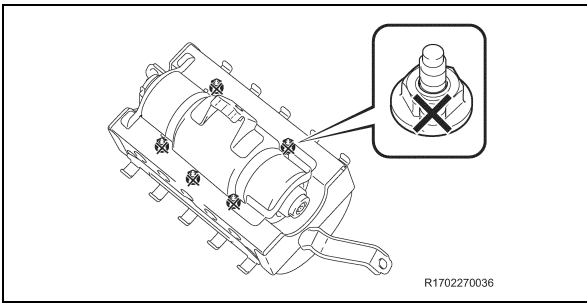
d) Mark all 5 nuts so they will not be reused.

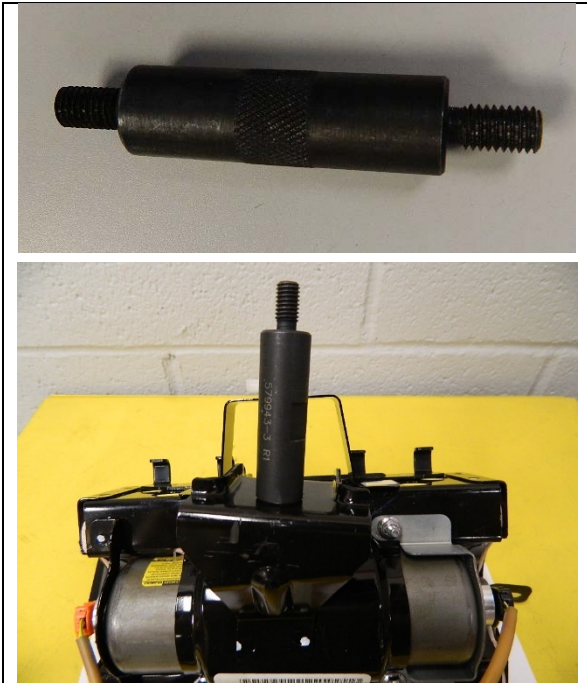
e) Use the long adaptor shown.

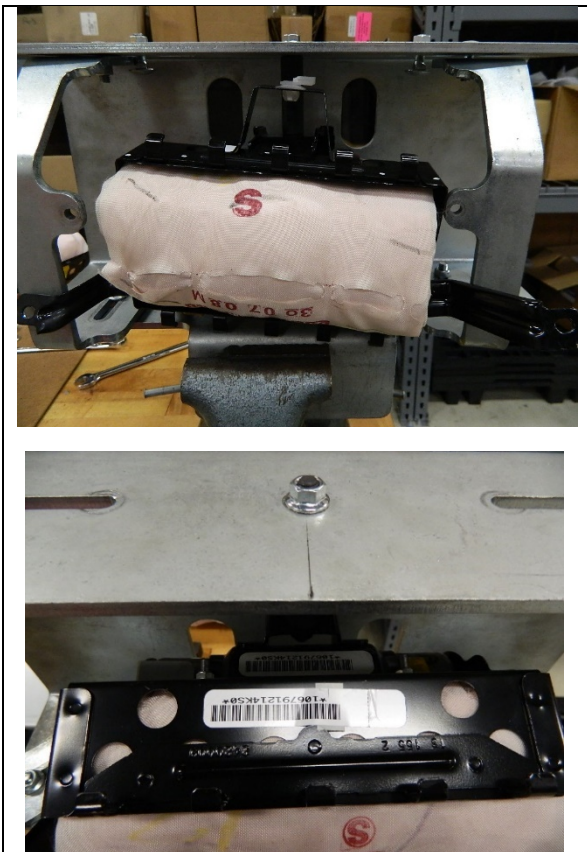
f) Thread the adaptor into the airbag as shown.  
**Note: Use the same mounting nut on the airbag that attaches the airbag to the vehicles cross tube.**

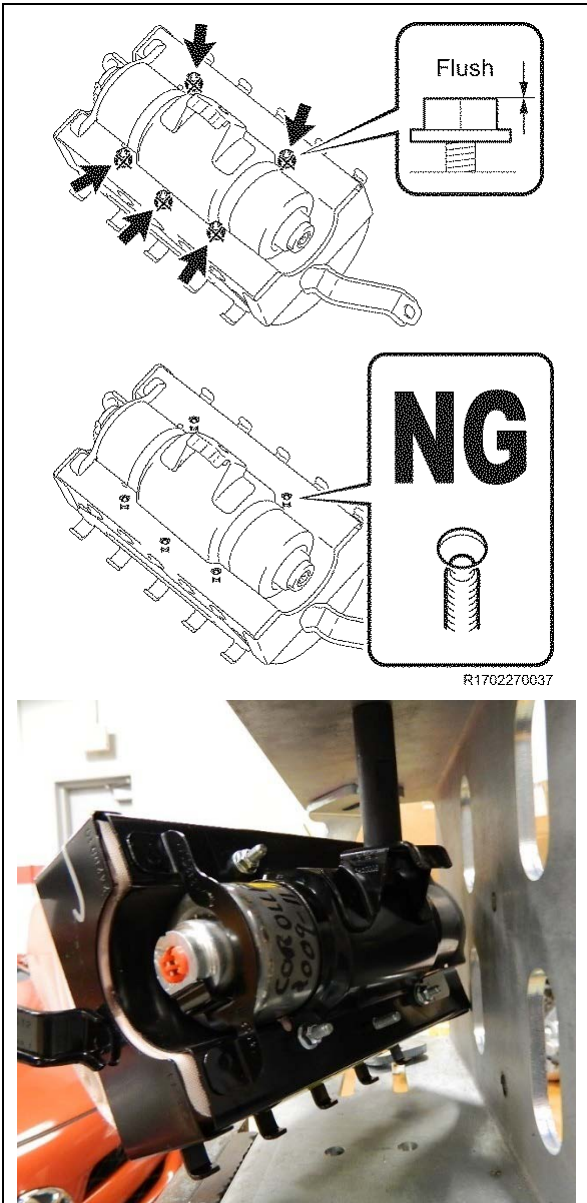
g) Mount the airbag into the mounting bracket as shown. Pass the stud on the adaptor through the hole in the middle of the bracket with the nut.

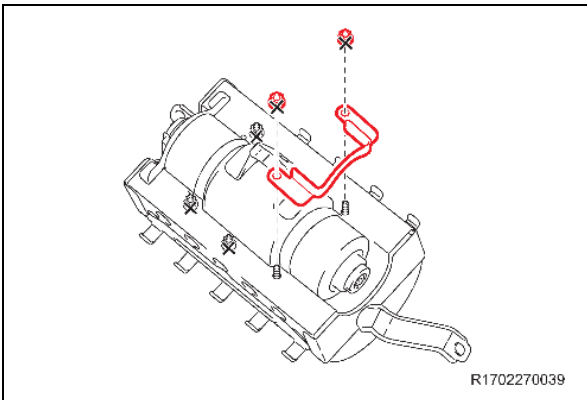
- a) Loosen the 5 nuts until the nuts are at the top of the studs as shown, through the openings in the mounting bracket.

**Note:** The airbag may need to be turned to the left or right to access the center nut.

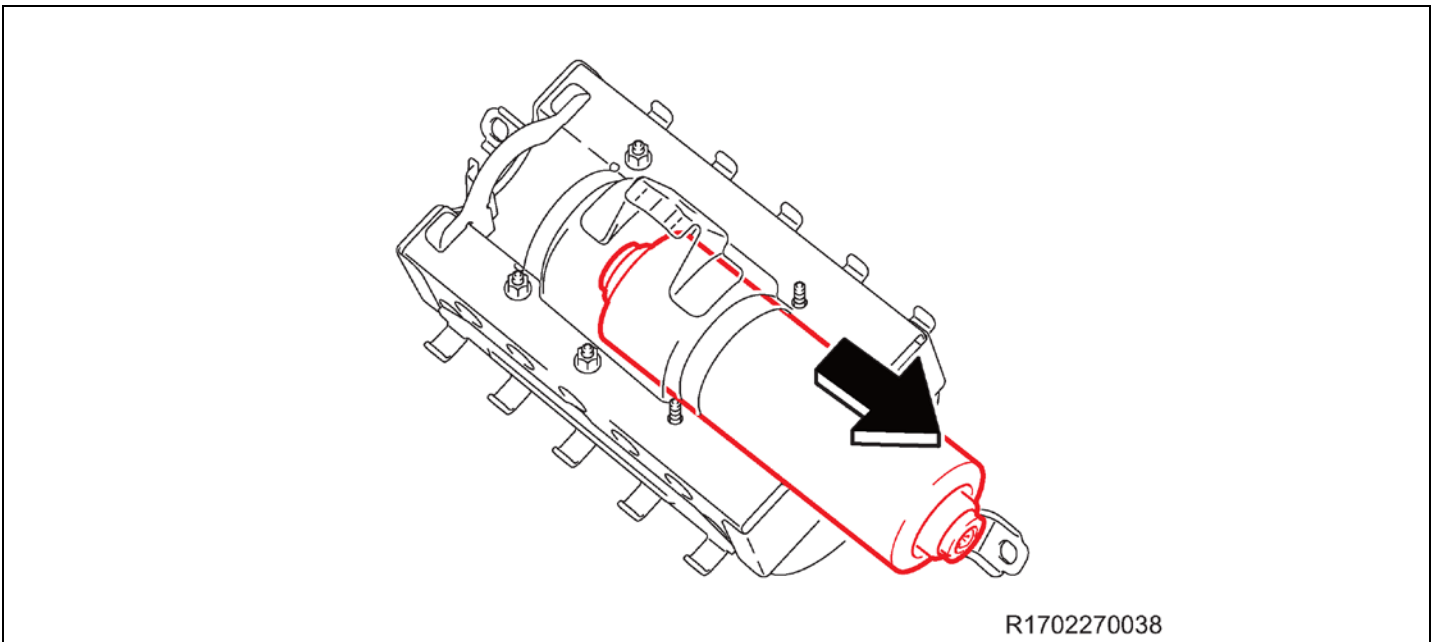
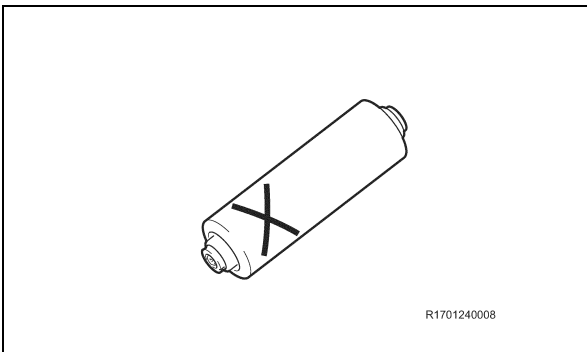
- a) Gently push in the studs until the nuts make contact with the housing to loosen the inflator for removal.

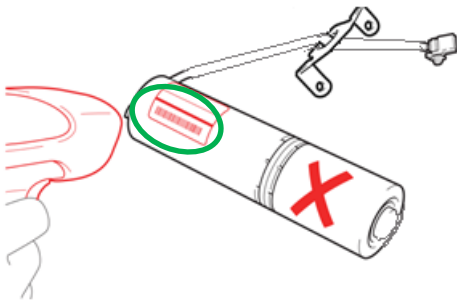
### Step a) Old Inflator (bar code)

- Scan the **OLD** inflator bar code.
- Scan the **NEW** inflator QR code.

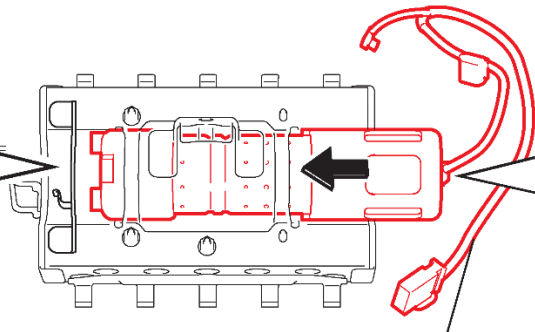
R1702270040

a) Carefully slide the new inflator into the airbag assembly and align as shown.

- **DO NOT** connect the inflator harness at this time. It is **CRITICAL** to first confirm that the inflator is installed in the correct position before connecting the harness.

**DO NOT insert fully.**

Check orientation

Upper side

Bottom

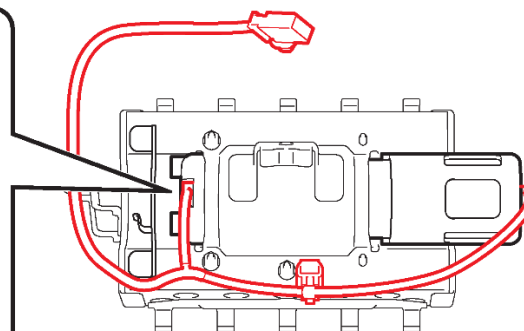
R1702270041

b) Connect the connector to the inflator and ensure that the connector lock is fully engaged as shown.

c) Route and secure the wire harness as shown.

**ALIGN CONNECTORS**

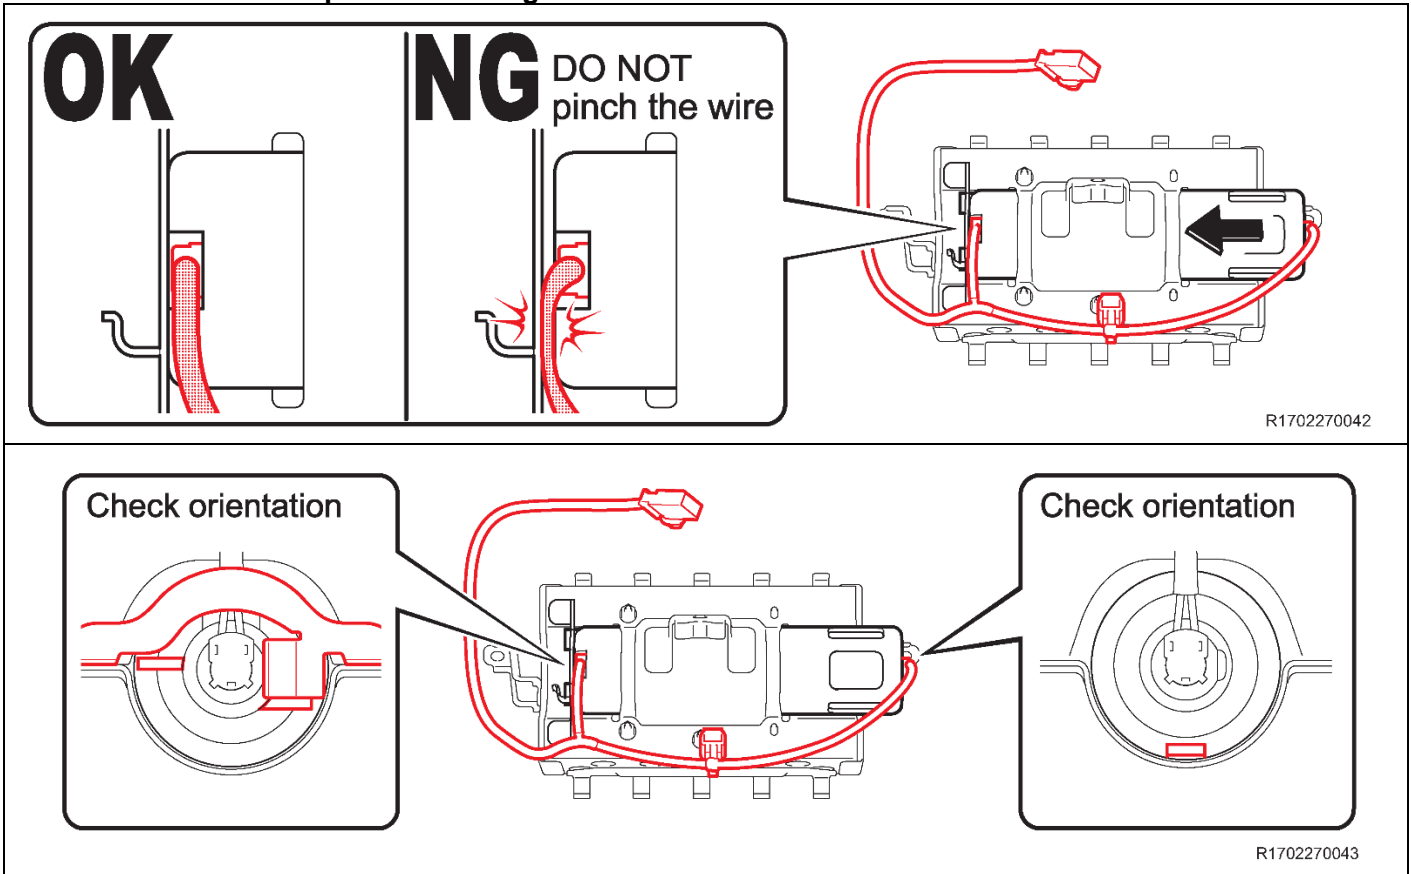
R1703080015

- d) Fully insert the inflator and ensure that the inflator is correctly oriented as shown.

**NOTE: DO NOT pinch the wiring between the bracket and the inflator.**

Install temporarily by hand.

Install the plate so that there is no float

DO NOT mistake the orientation of the plate

- e) Install the **NEW** stopper plate.  
f) Install 2 **NEW** nuts by hand.

**NOTE: Ensure that the stopper plate is the one from the bracket kit and installed in the correct orientation.**

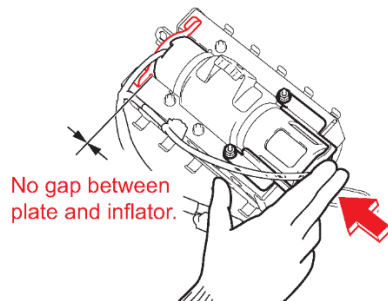
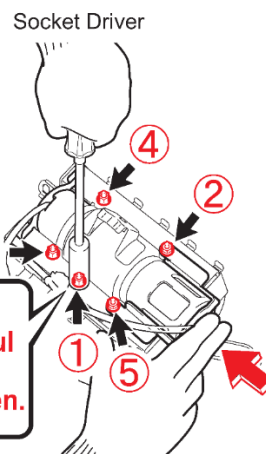
R1702270046

- a) Tighten the 5 nuts evenly in several increments in the sequence shown. Use a socket driver or torque wrench to tighten the nuts.

Torque: 35in. lbf (3.9N·m)

- There will be some resistance when tightening the nuts because they are self-locking, confirm the nuts are tightened correctly.
- **DO NOT** use a power tool, T-handle, or ratchet when tightening the nuts to avoid over torqueing and deforming the studs.
- You may need to turn the airbag to the left or right with in the mounting bracket to access the center nut.

3.9 N·m  
Be careful  
not to  
overtighten.

**These tools cause overtightening !**

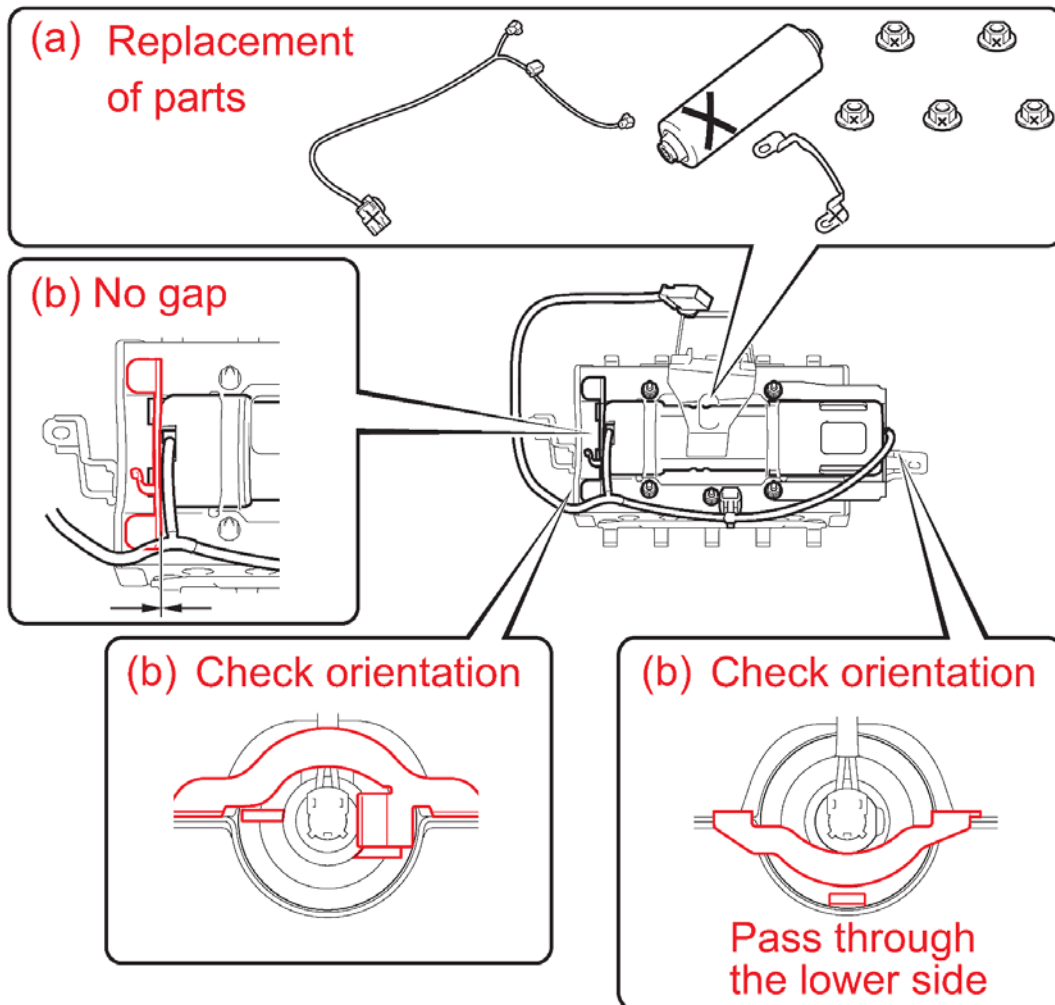
R1703080022

- a) Confirm the **NEW** inflator and 5 **NEW** nuts have been installed.
- b) Confirm the position of the inflator and position determining plates are correct.
- c) Confirm the routing of the inflator wire harness.
