### TECHNICAL INSTRUCTIONS FOR SAFETY RECALL H0A FRONT PASSENGER AIRBAG INFLATOR CERTAIN 2008 - 2009 MY SCION xB

**UPDATED 4-18-18**

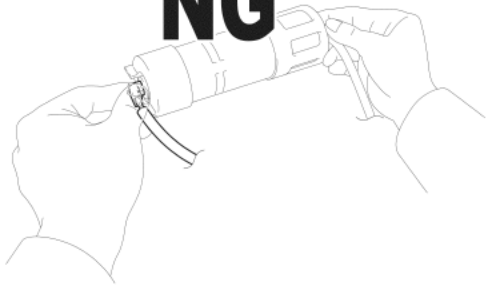
R170128000

DO NOT CONNECT PREMATURELY  
CANNOT DISCONNECTED

**NG**

1. **IMPORTANT NOTICE WHEN CONNECTING INSTRUMENT PANEL WIRE CONNECTOR TO AIRBAG INFLATOR**
  - a) Once connected, the instrument panel wire connector cannot be disconnected from the airbag inflator. If the instrument panel wire connector is incorrectly connected to the inflator, replace the instrument panel wire and inflator with new ones.

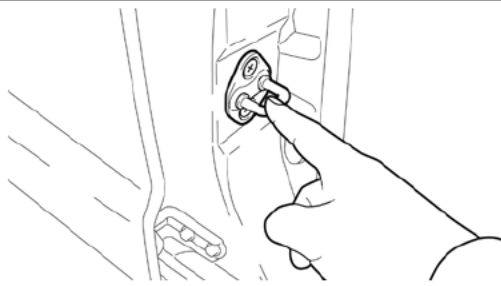
R1508210026

**NG** DO NOT  
measure resistance.

3. **DO NOT MEASURE RESISTANCE**

- a) **DO NOT** measure resistance of airbag components, this may cause accidental activation.

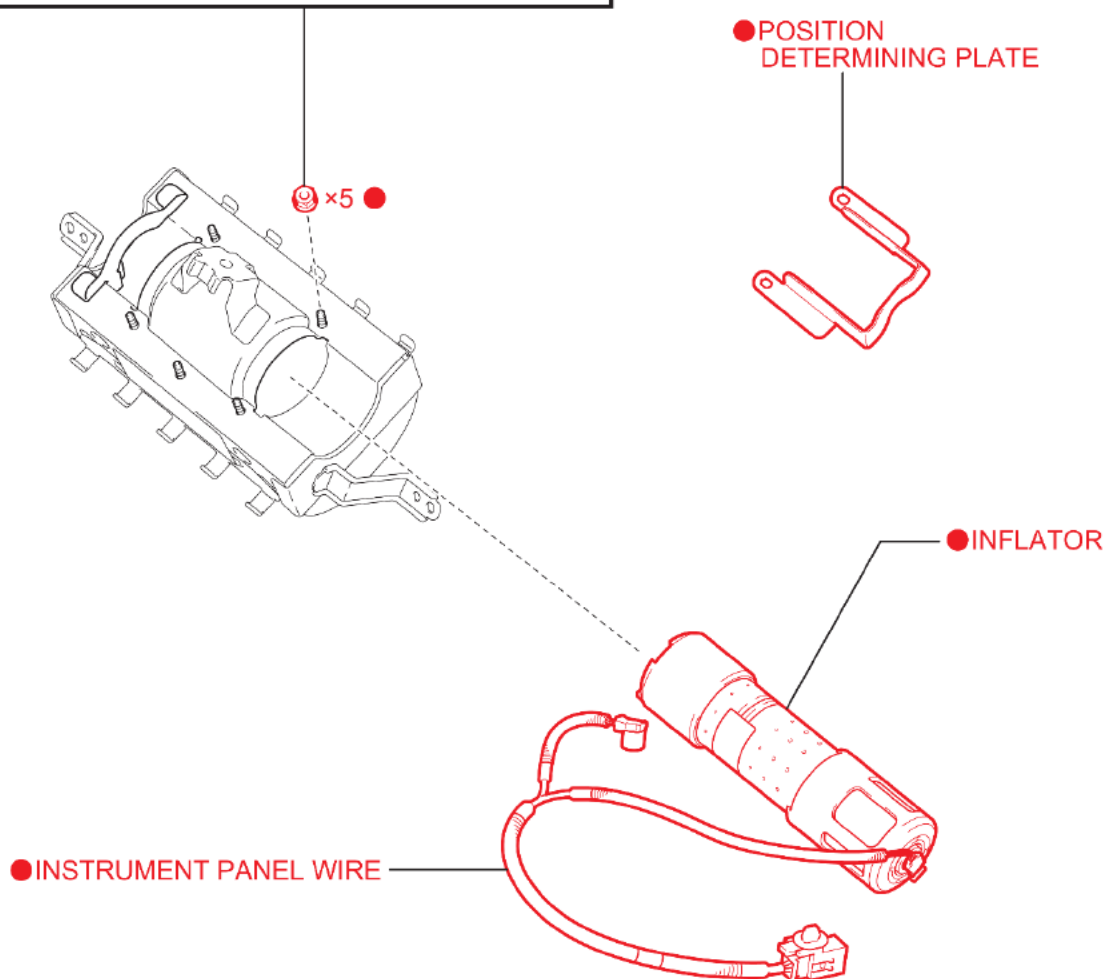
R1707250002

**3.9 N·m (40, 35 in.\*lbf)**  
**Be careful not to**  
**overtighten.**

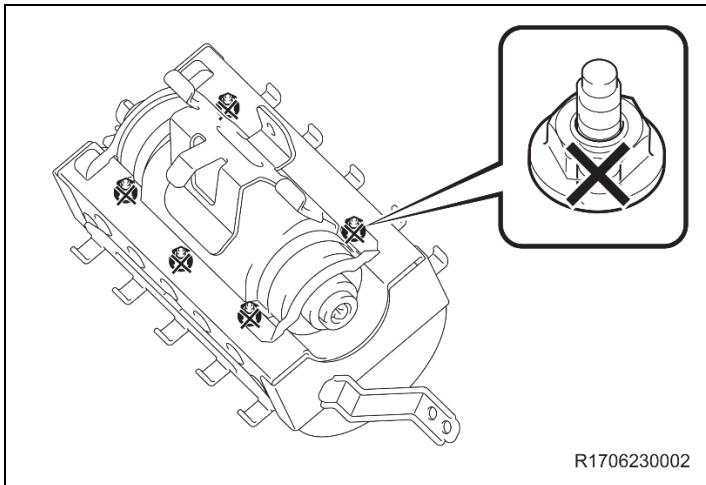
### 1. REMOVE THE INFLATOR

- a) Mark the 5 self locking nuts to prevent reuse.

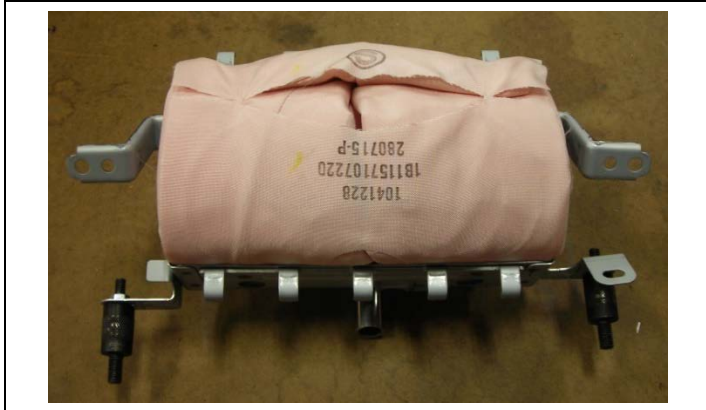
- a) Mount the adaptors (579943-3R3) to the airbag as shown.

**NOTE: The 6mm stud mounts to the airbag.**

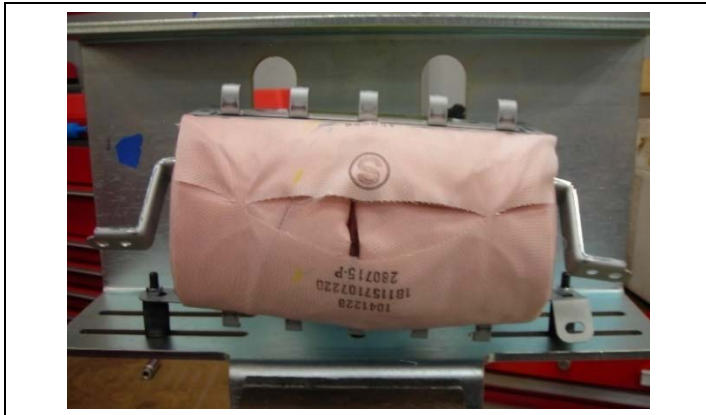
- b) Mount the airbag to the mounting bracket as shown.

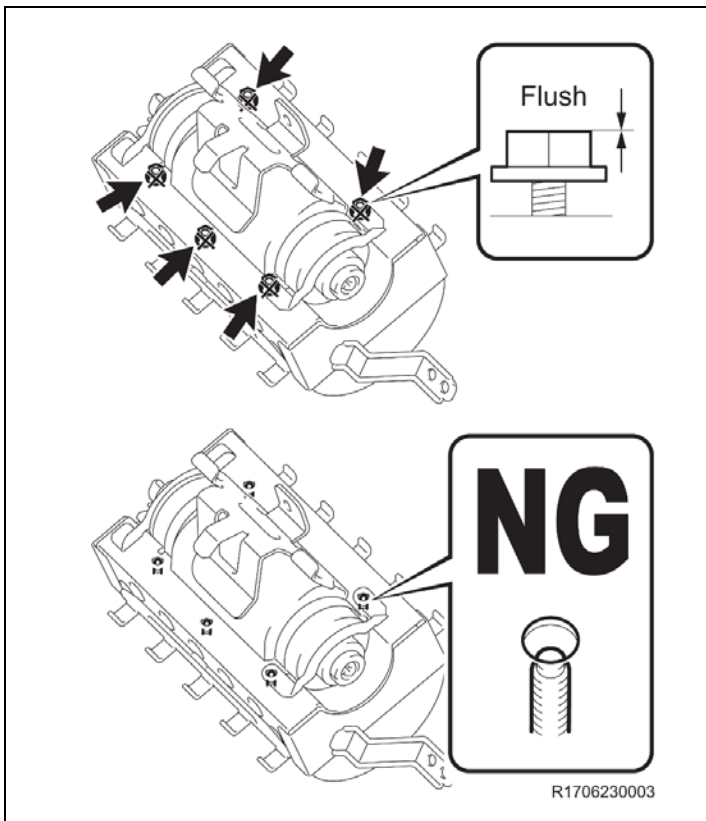
- c) Loosen the 5 nuts until each nut is flush with the top of the stud as shown.

**NOTE:** You may need to slide the airbag to the left or right to access the middle nut.  
**DO NOT** use power tools to remove the nuts.

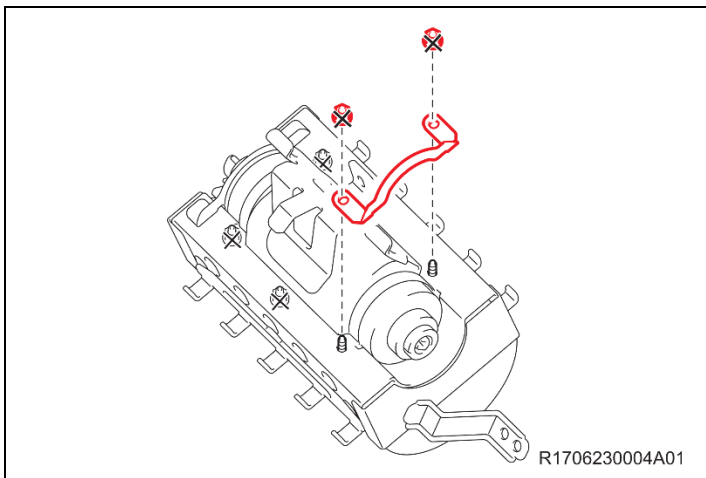
- d) Loosen and discard the 2 nuts on the end where the positioning plate is removeable.  
e) Remove and discard the plate.

**NOTE:**  
**DO NOT** use power tools.

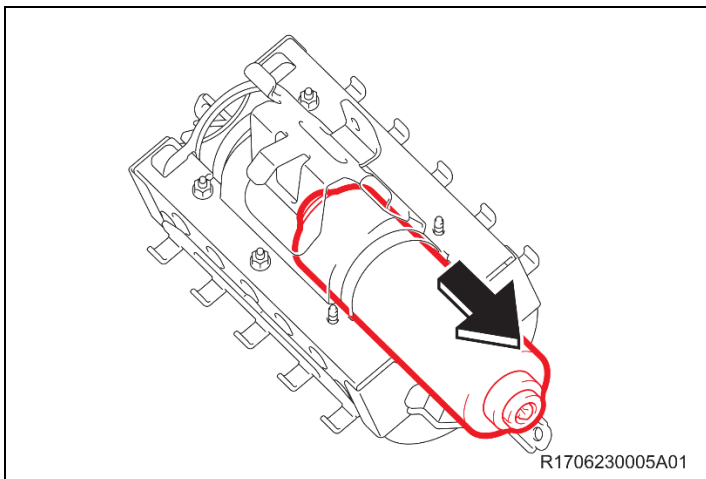
- f) Remove the inflator.

- g) Mark the old inflator so it is not reused.  
**NOTE: Return the old inflator to the parts department for recovery.**

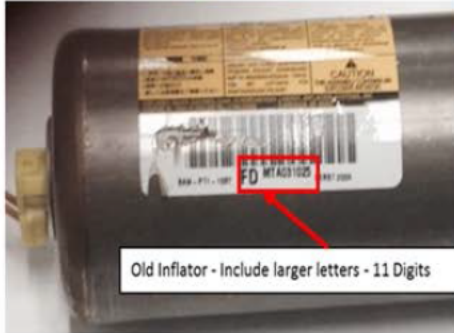
### Original Inflator

How to Identify the Inflator serial code on the Original and Replacement Inflator can?

The Inflator serial code is an **11 digit code** on the Inflator can. It can be found with a bar code on removing the Inflator can from the Airbag Assembly unit.

The first two characters of the **Original Inflator Serial code** will be from [AA, AB, AJ, FD or JD].

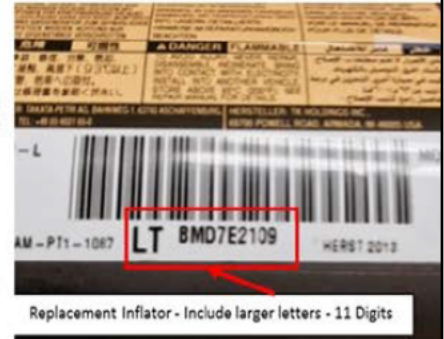
### Replacement Inflator

The first two characters of the **Replacement Inflator Serial code** will be either 'LT' or 'LR'.

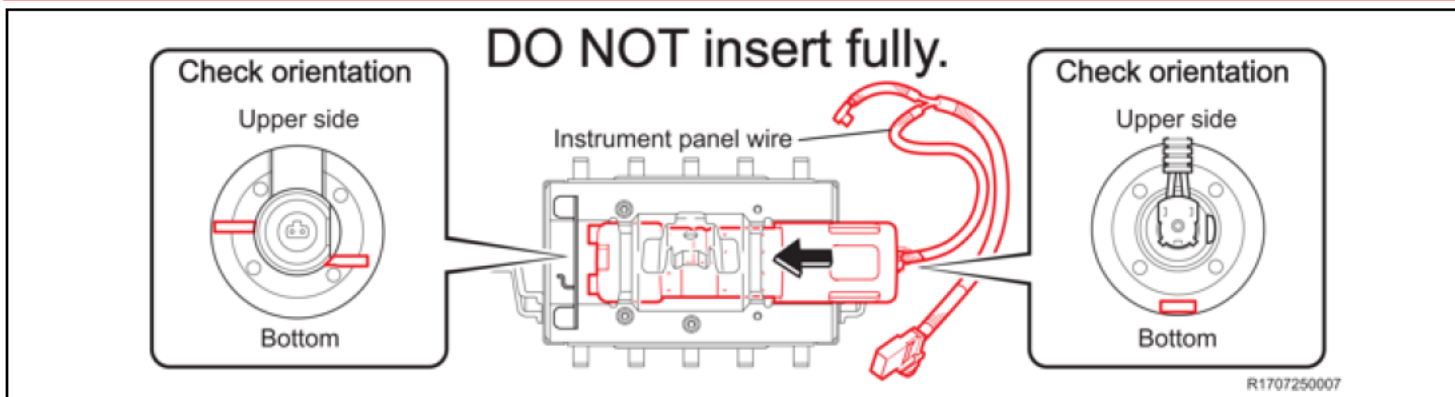
- Make sure that the passenger airbag inflator is oriented correctly as shown in the illustration, not upside down.
- If the passenger airbag inflator is upside down, it will not be able to be fully inserted.

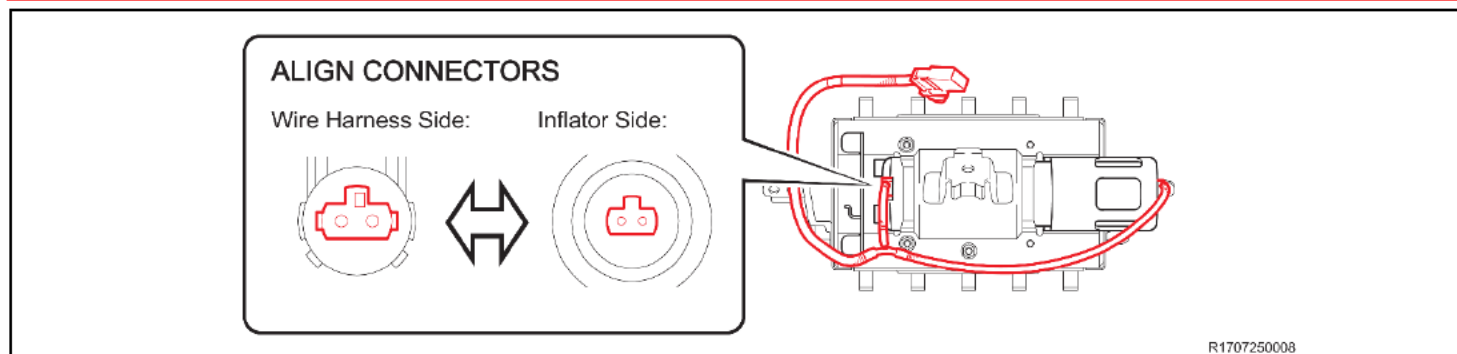
- b) Connect the airbag connector to the instrument panel passenger airbag assembly and then push in the airbag connector lock as shown in the illustration.

- Make sure to correctly align the connectors before connecting them.
- Make sure that the airbag connector is securely connected.

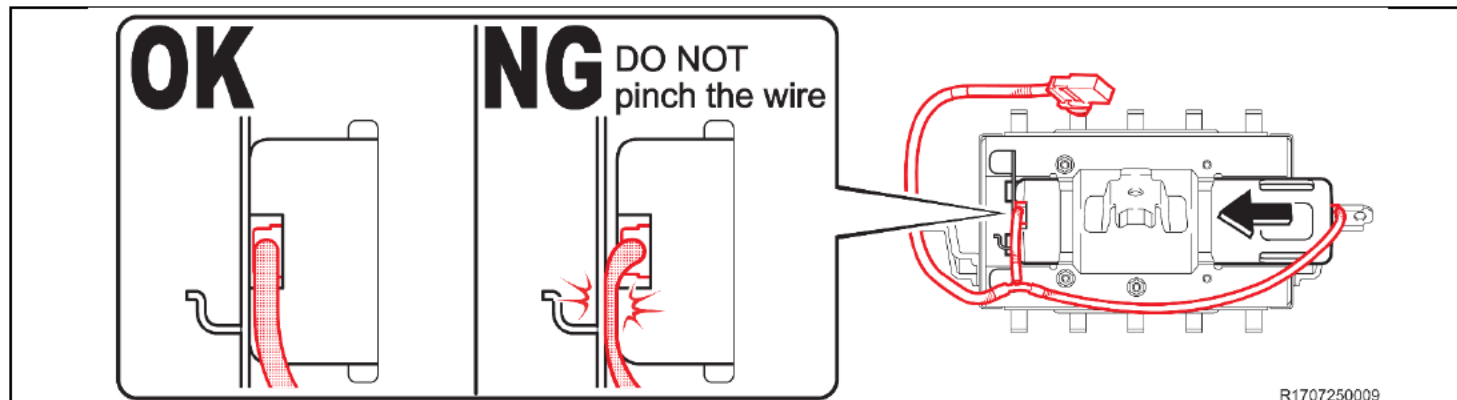
c) Insert the inflator fully as shown in the illustration.

**DO NOT pinch instrument panel wire.**

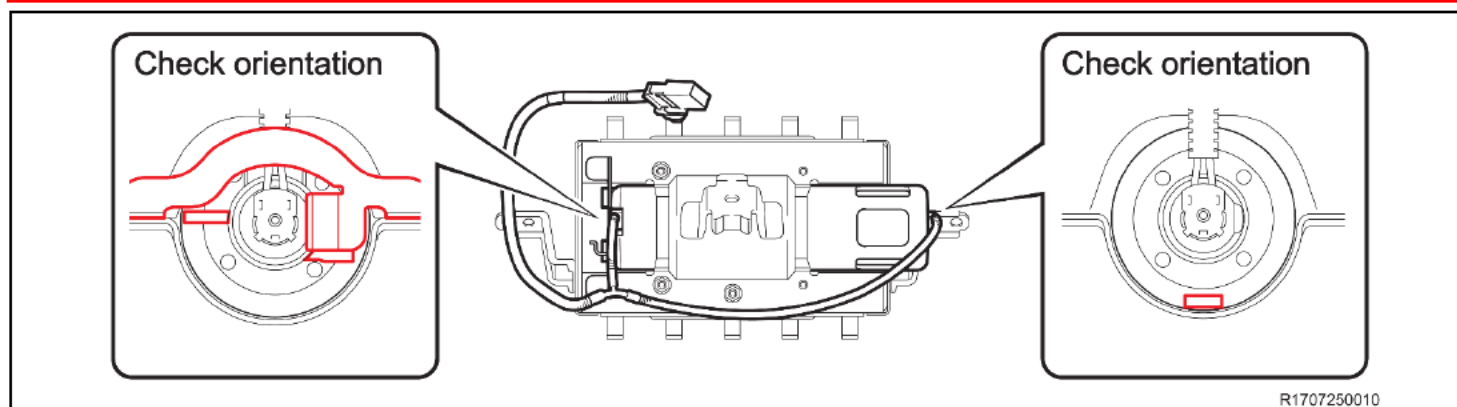
d) Insert the inflator with the correct orientation as shown in the illustration.

- Make sure that the inflator is oriented correctly as shown in the illustration, not upside down.
- If the passenger airbag inflator is upside down, it will not be able to be fully inserted.

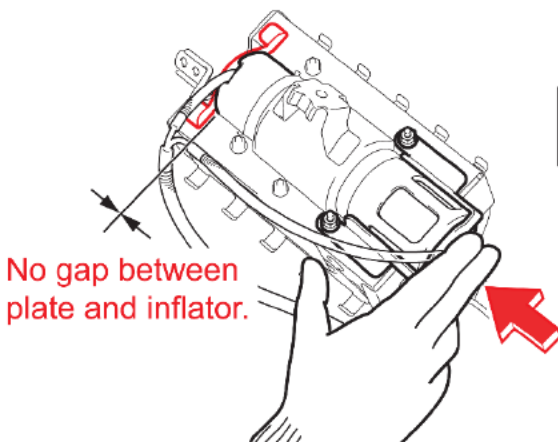
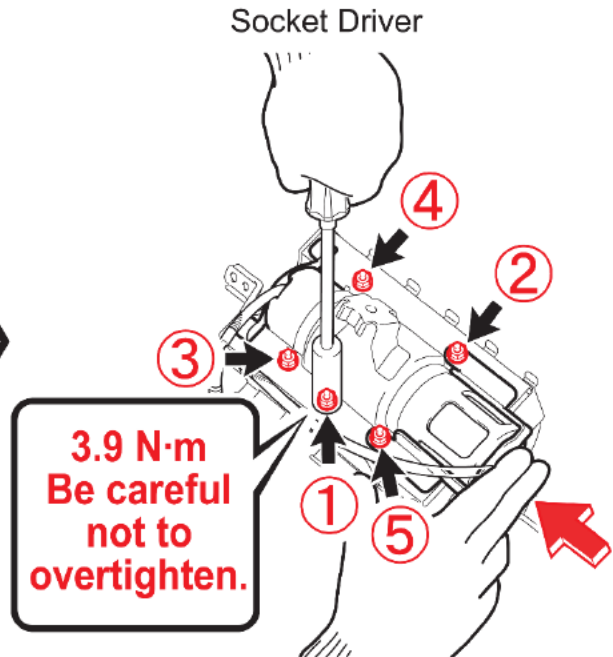
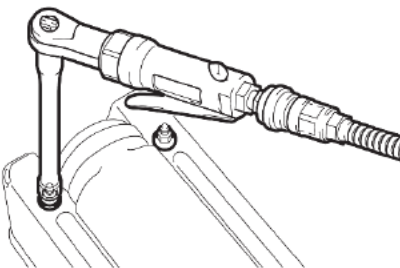
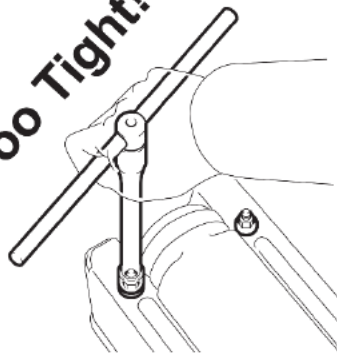
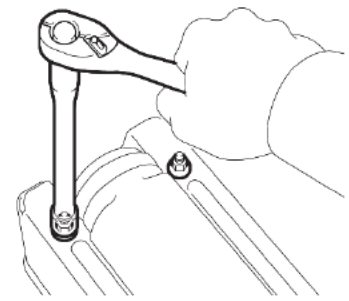
R1707250013

**The tightening torque is low (3.9 N·m). Use of an air ratchet wrench or tightening strongly with a T-handle wrench or a ratchet handle may cause deformation of the stud bolt.**

**OK**

**Too Tight!**

**These tools cause overtightening !**

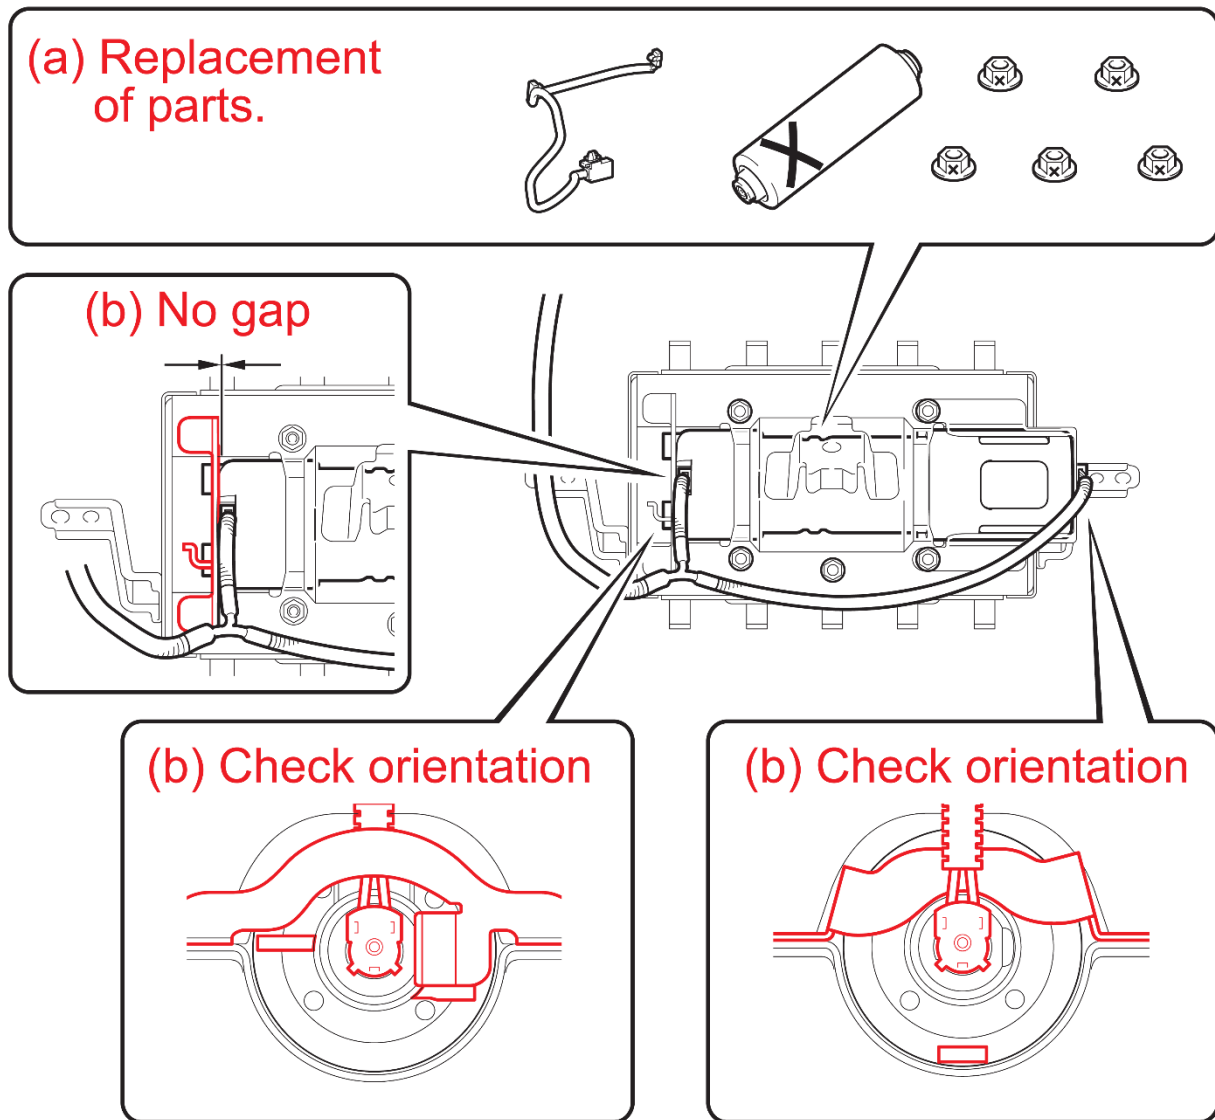
R1707250014

## 2. INTERMEDIATE INSPECTION

- a) Check that the inflator and the 5 self-locking nuts, instrument panel wire are replaced.
- b) Check that positions of the inflator and the position determining plate are correct.  
(There should be no gap.)
