January 10, 2018

Safety Recall: Front Passenger's Airbag Inflator Can Be Over-Pressurized (Phase 3)

CORRECTIVE ACTION

Replace the passenger's airbag inflator, then return the original, undeployed inflator as directed.

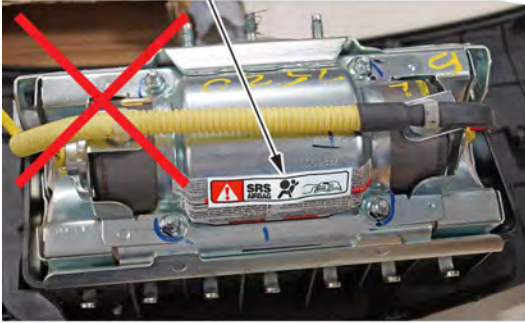
NON-STANDARD SAFETY LABEL

- If there is nothing unusual about the airbag or the inflator, continue with the inflator replacement procedure.
- If there are any unusual markings, like an incorrect label or a model year written in marker, the airbag and inflator may not be the correct airbag and/or inflator for the vehicle or it may be a counterfeit part. For more information about counterfeit airbags, you can refer to safercar.gov, enter keywords **MANAGING COUNTERFEIT**, and select **Recommended Dealer Guidance for Managing Counterfeit Air Bags** from the list. **If you suspect that the airbag or inflator is counterfeit, do not continue this procedure.** Contact your DPSM for assistance.

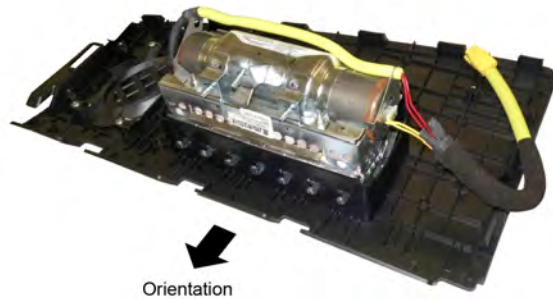
4. Place the airbag, face-down, on a clean shop towel.

- The orientation of the airbag is critical because if the inflator is installed incorrectly, the harness will be too short when you reinstall the airbag.
- The brackets between the various models are similar but may differ from the example shown.

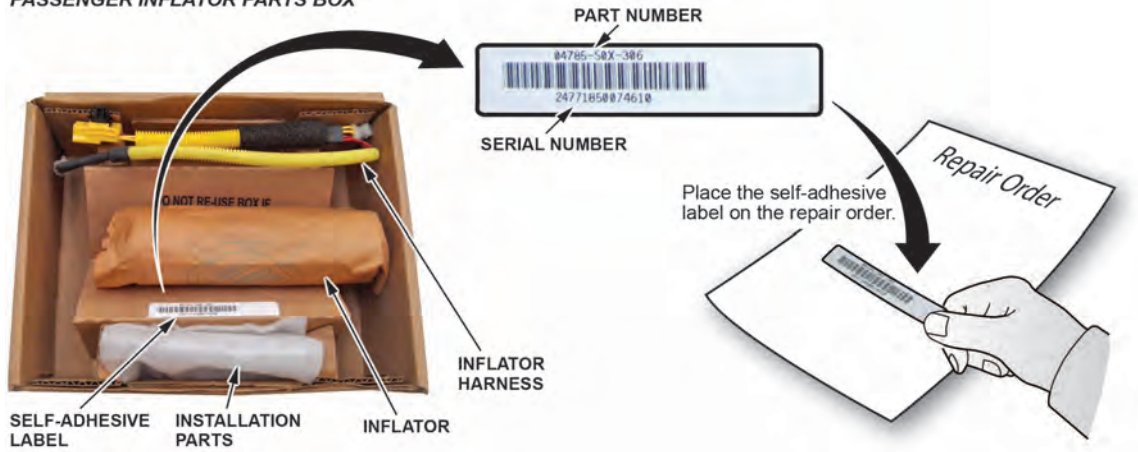
PASSENGER INFLATOR PARTS BOX

6. Peel the label located inside the inflator box from its backing and attach it to the RO. For the warranty claim to be paid, the **replacement inflator part number that you received** must be included in the warranty claim.

- The replacement part number is printed on the top part of the label and the serial number is printed on the bottom. **Make sure you attach the label to the RO and give it to the warranty clerk .**
- There may also be a colored sticker located in the kit, ignore it because it is not used.
- Not all inflator kits have a label included. In those cases, write the serial number and part number from the side of the inflator box on the RO. The part number always starts with 047.

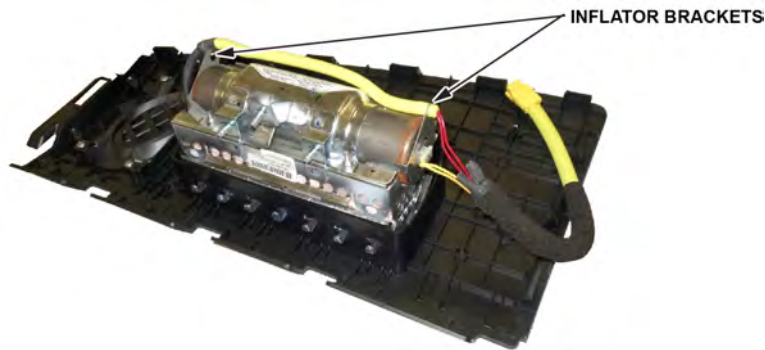
7. Remove the harness from both ends of the inflator bracket.

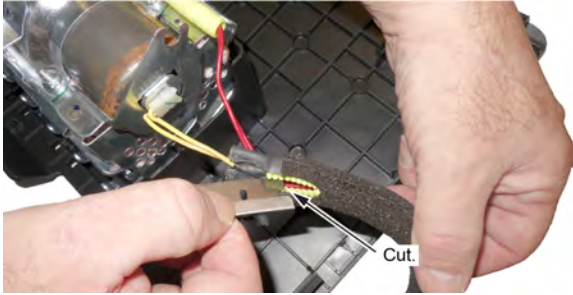
8.1. Cut about 2 inches of the corrugated tube to access the wires.

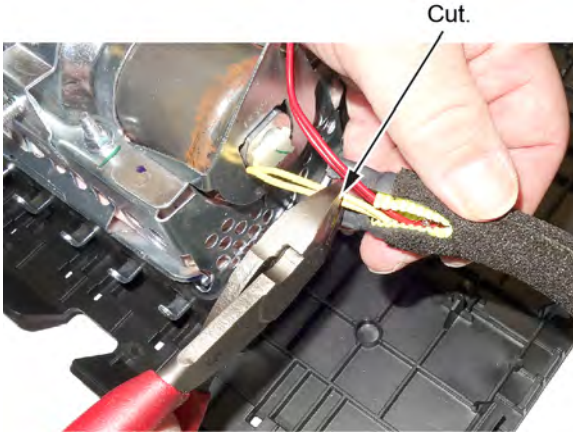
You must cut and short the yellow wires as indicated to prevent accidental deployment.

8.2. Cut the yellow wires as shown.

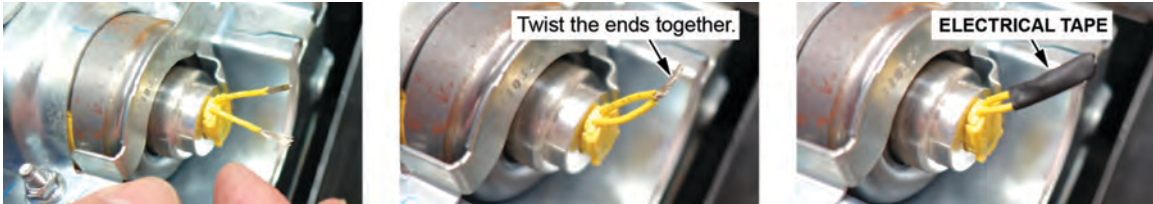
8.3. Strip away about 1 inch of the wire insulation, then twist the wires together.

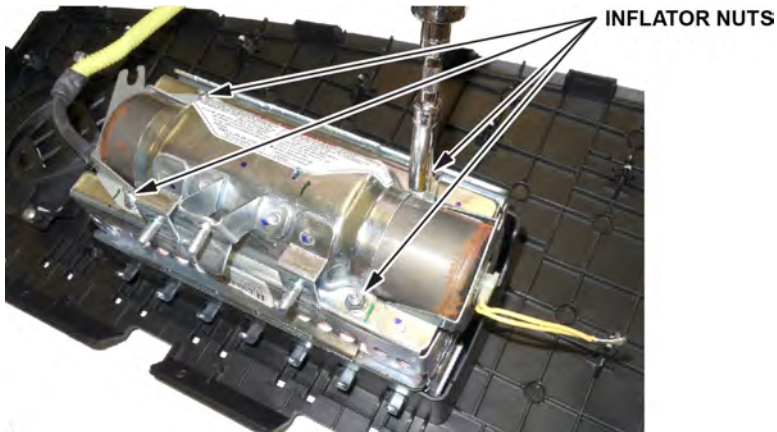
9. Remove the four inflator nuts.

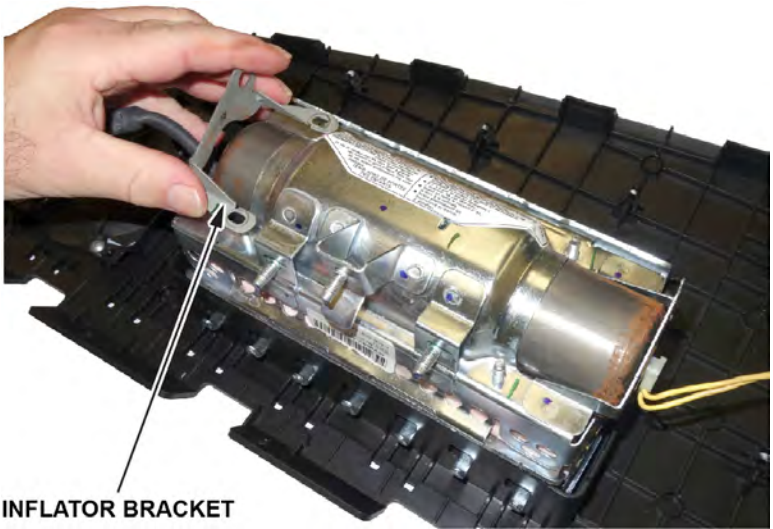
10. Remove the inflator bracket.

You can only remove one of the brackets, as the other is welded to the airbag housing.

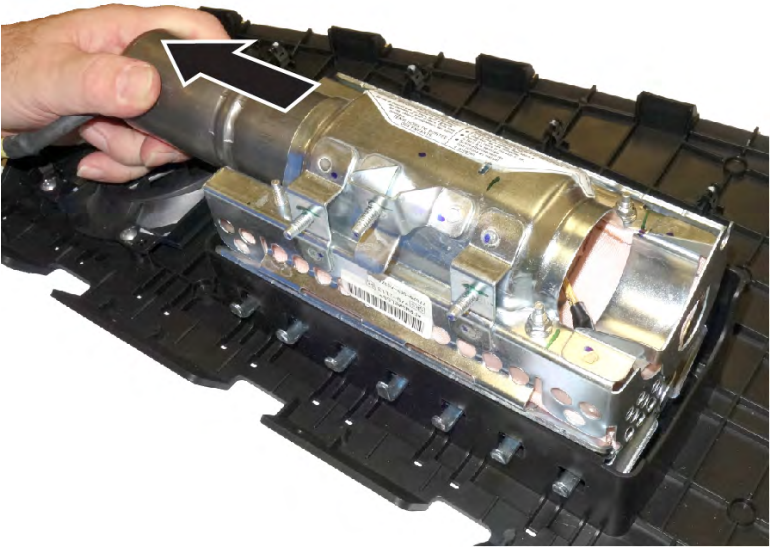
11. Remove the inflator by pushing it out.

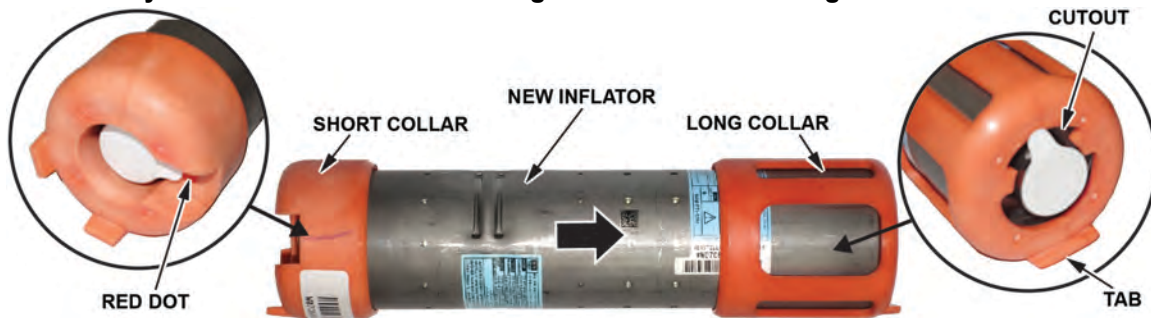
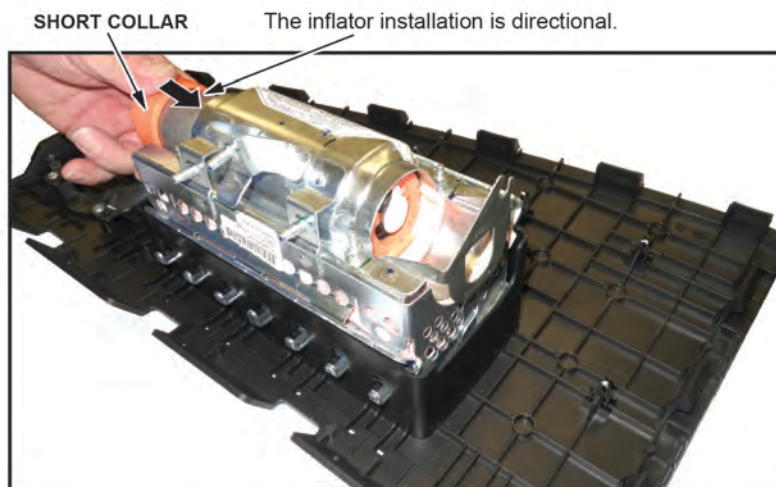
12.2. Collars on this inflator are orange. One side of the inflator has a longer collar, a tab, a plastic cutout, and a small flat spot on the connector. The other side of the inflator has a shorter collar, two tabs, and a red dot. **Make sure you insert the end with the longer collar into the airbag first.**

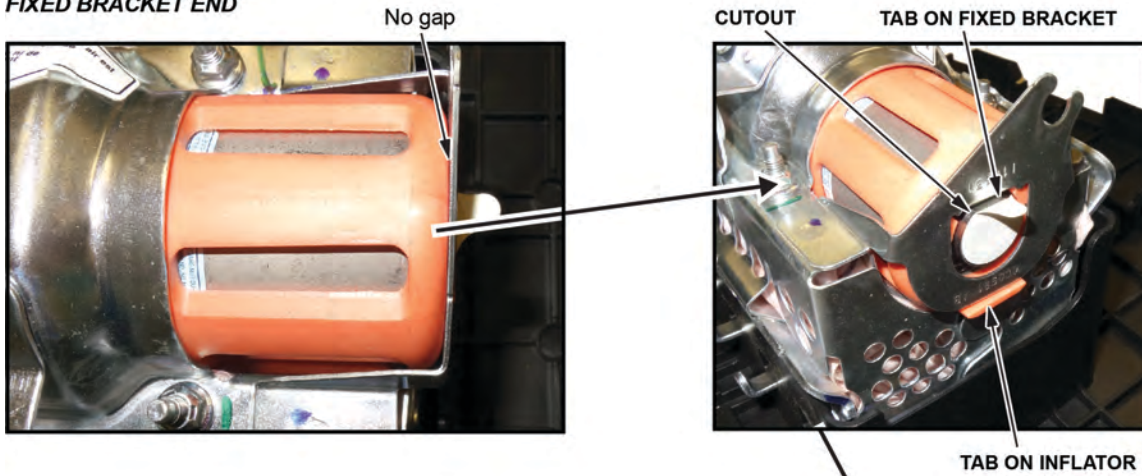
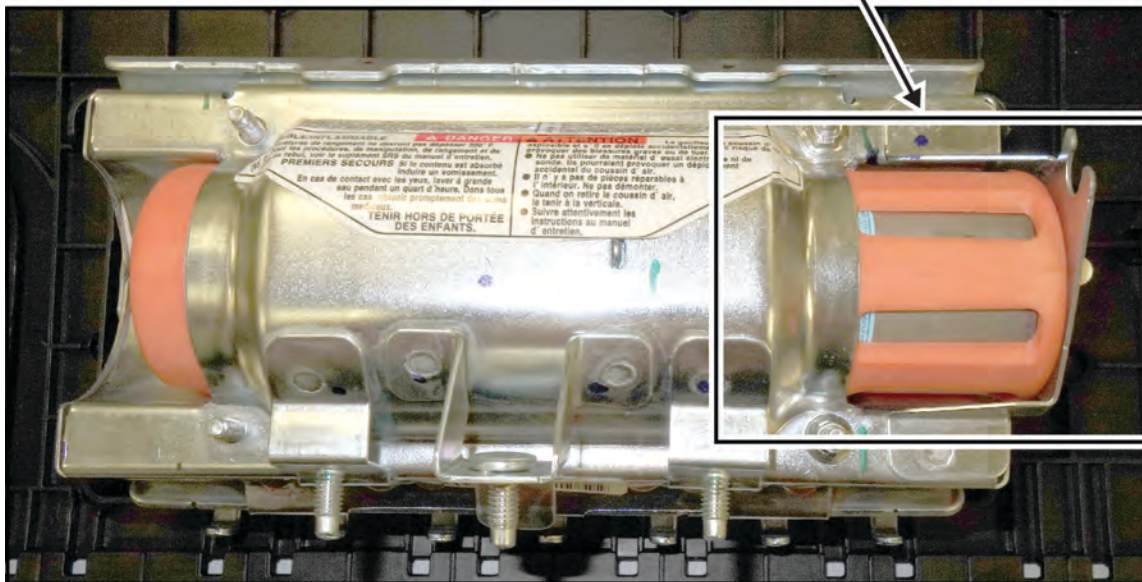
FIXED BRACKET END

12.3. Slide the inflator in until the plastic cutout and the small flat spot align with the tab on the bracket. There should be no space or gap between the inflator and bracket.

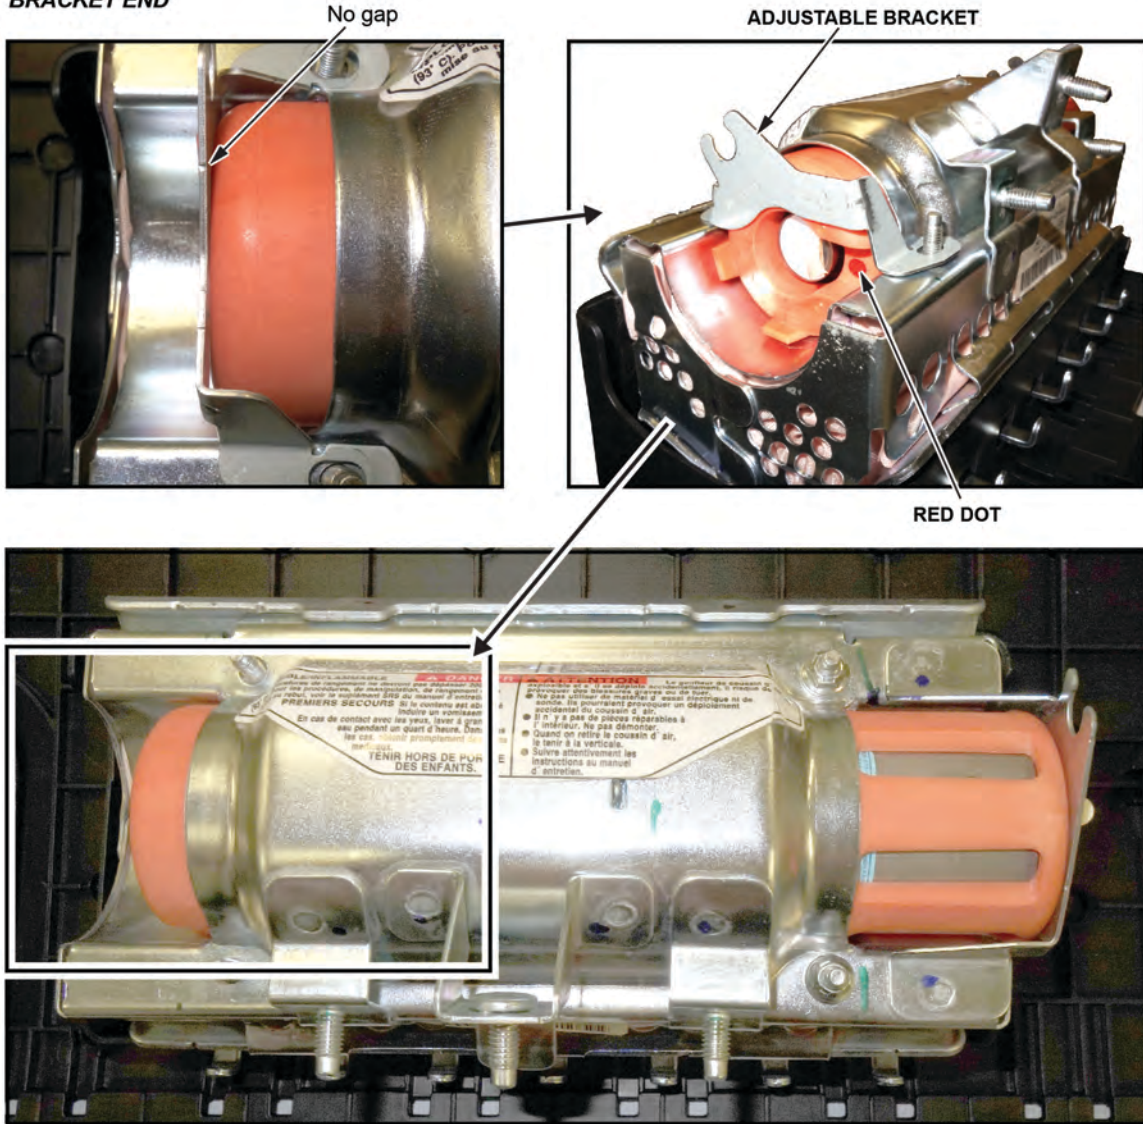
**ADJUSTABLE
BRACKET END**

12.4. Install the bracket included in the kit onto the airbag module. There should be a red dot visible on the end of the plastic connector. There should be no space or gap between the inflator and bracket.

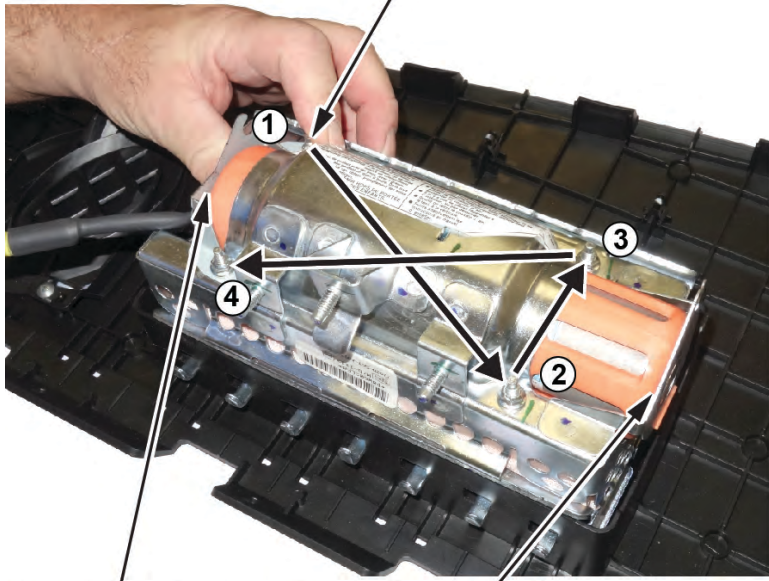
LOCK NUTS (4)
3.9 N•m (34 lb-in)

13. Install four new 5 mm locknuts and torque them in sequence to **3.9 N•m (34 lb-in)** .

Be sure there are no gaps between the inflator ends and the inflator brackets

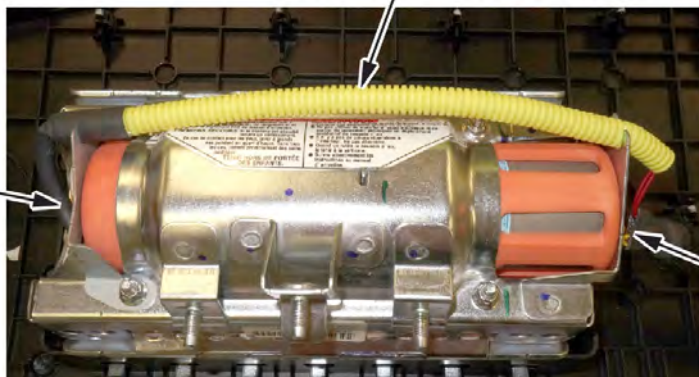
NEW INFLATOR HARNESS
Orient to the airbag as shown.

15.1. Make sure the airbag and harness are aligned as shown.

- **Make sure you have the orientation correct as shown below.** If you connect the harness incorrectly, the harness cannot be removed, and you will not be able to reinstall the airbag because the harness will be too short.
- Connect the red wire connector to the short collar side of the inflator with the red dot.

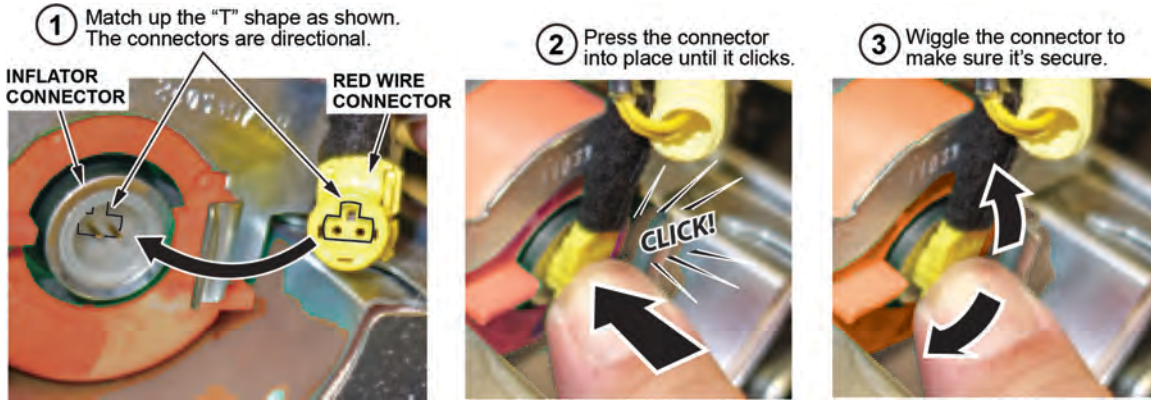
15.2. Connect the two connectors. Align the "T" shape in the inflator harness connector with the T-shaped inflator connector, then press the connector into place.

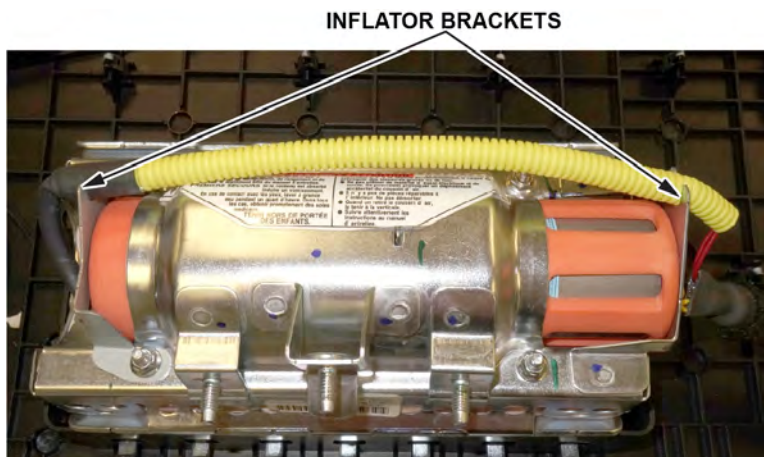
16.1. Insert the side without the shrink wrap tubing first. Insert the harness at the third "valley" in the corrugated tube.

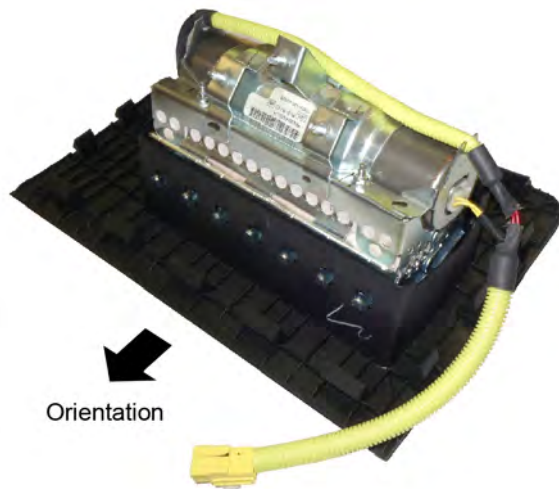
4. Place the airbag, face-down, on a clean shop towel.

The orientation of the airbag is critical because if the inflator is installed incorrectly, the harness will be too short when you reinstall the airbag.

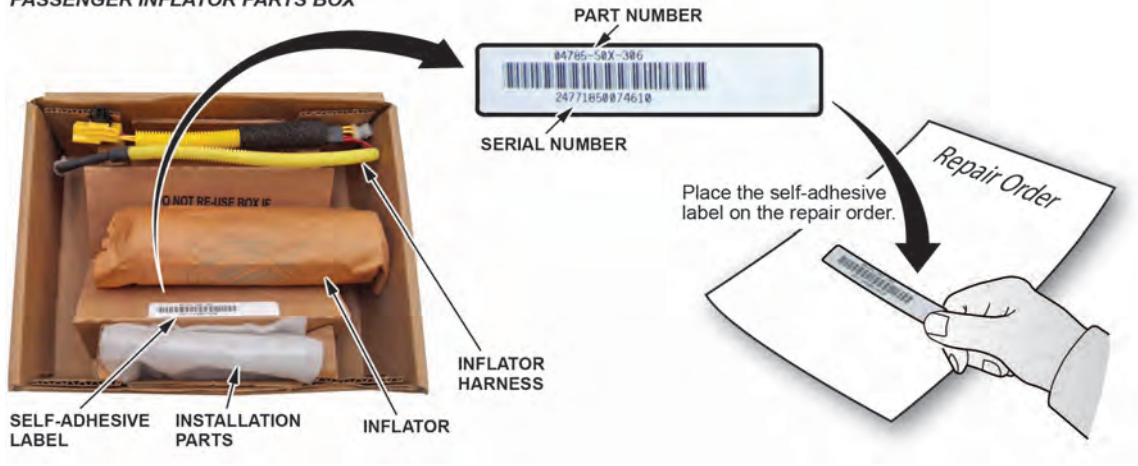
PASSENGER INFLATOR PARTS BOX

6. Peel the label located inside the inflator box from its backing and attach it to the RO. For the warranty claim to be paid, the **replacement inflator part number that you received** must be included in the warranty claim.

- The replacement part number is printed on the top part of the label and the serial number is printed on the bottom. **Make sure you attach the label to the RO and give it to the warranty clerk .**
- There may also be a colored sticker located in the kit, ignore it because it is not used.
- Not all inflator kits have a label included. In those cases, write the serial number and part number from the side of the inflator box on the RO. The part number always starts with 047.

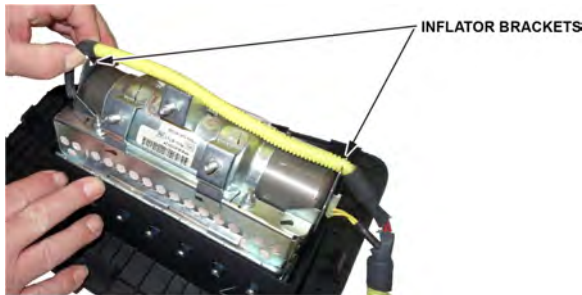
7. Remove the harness from both ends of the inflator bracket.

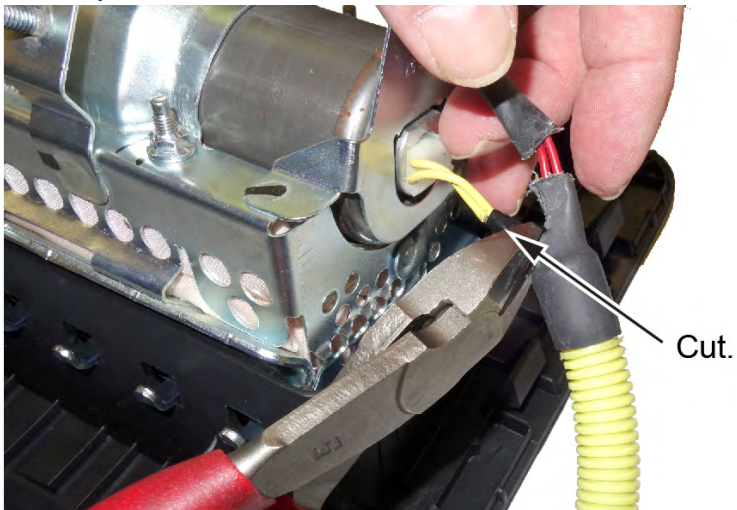
You must cut and short the yellow wires as indicated to prevent accidental deployment.

- 8.1. Cut the yellow wires as shown.

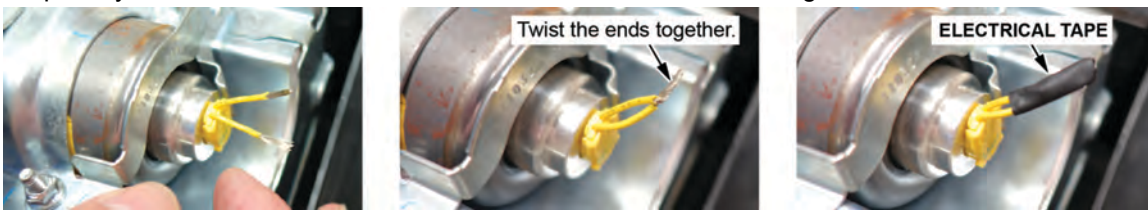
- 8.2. Strip away about 1 inch of the wire insulation, then twist the wires together.

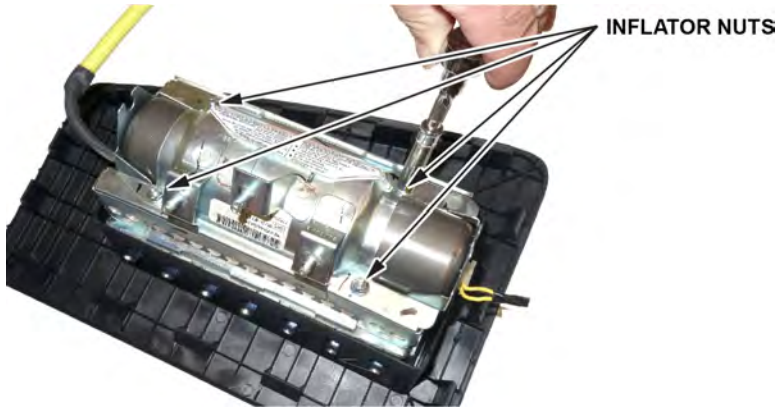
9. Remove the four inflator nuts.

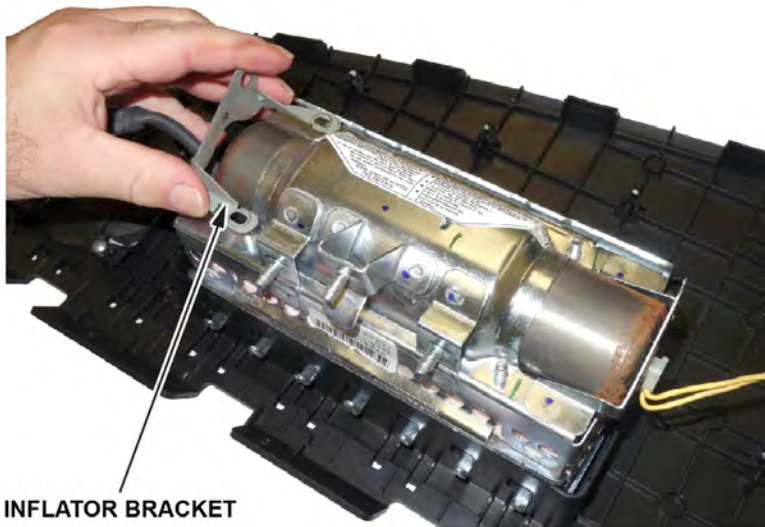
10. Remove the inflator bracket.

You can only remove one of the brackets, as the other is welded to the airbag housing.

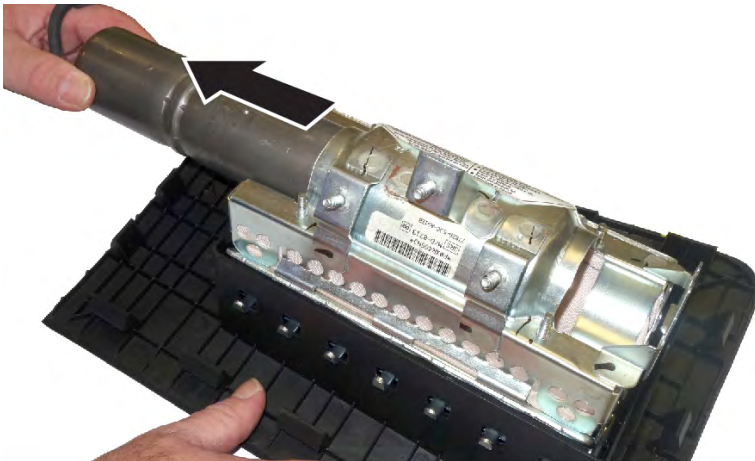
11. Remove the inflator by pushing it out.

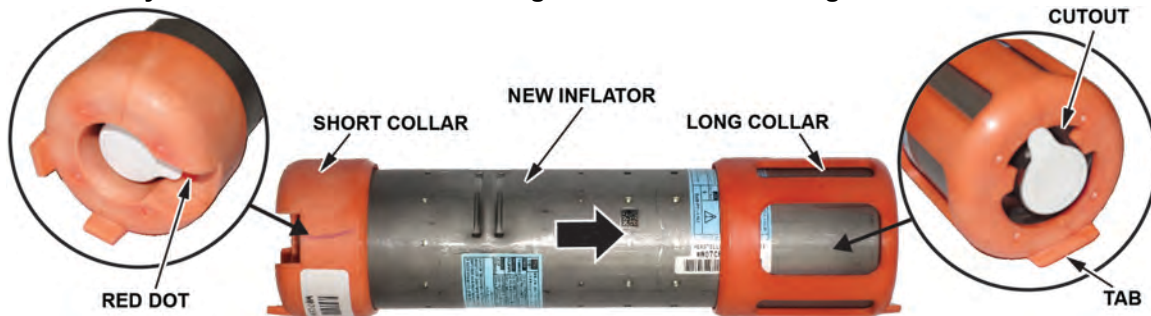
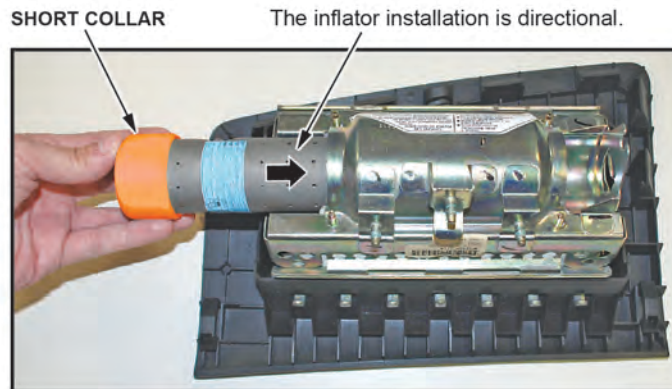
12.2. Collars on this inflator are orange. One side of the inflator has a longer collar, a tab, a plastic cutout, and a small flat spot on the connector. The other side of the inflator has a shorter collar, two tabs, and a red dot. **Make sure you insert the end with the longer collar into the airbag first.**

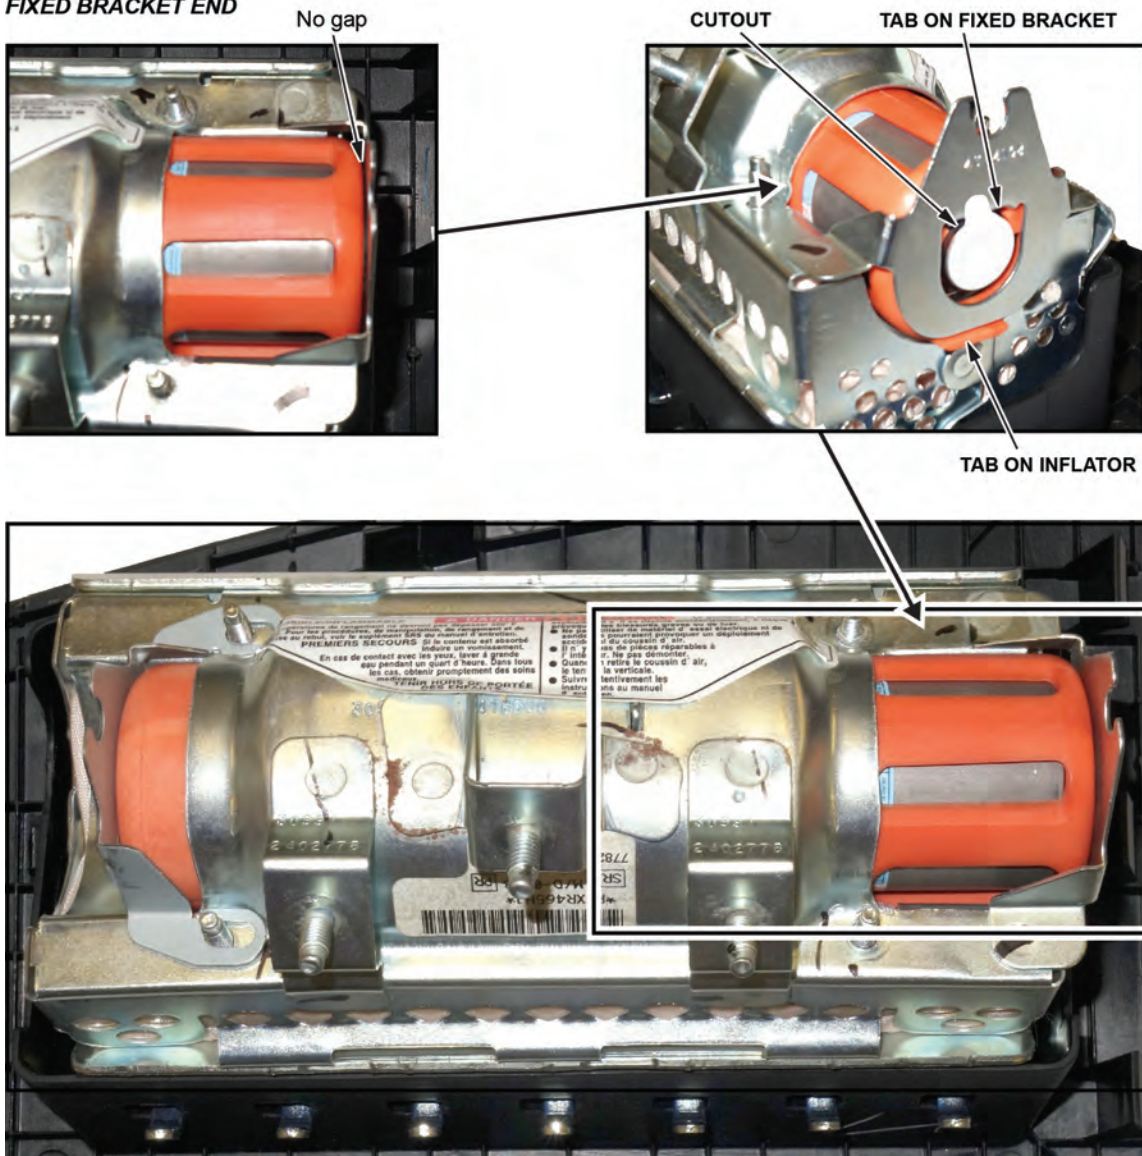
FIXED BRACKET END

12.3. Slide the inflator in until the plastic cutout and the small flat spot align with the tab on the bracket. There should be no space or gap between the inflator and bracket.

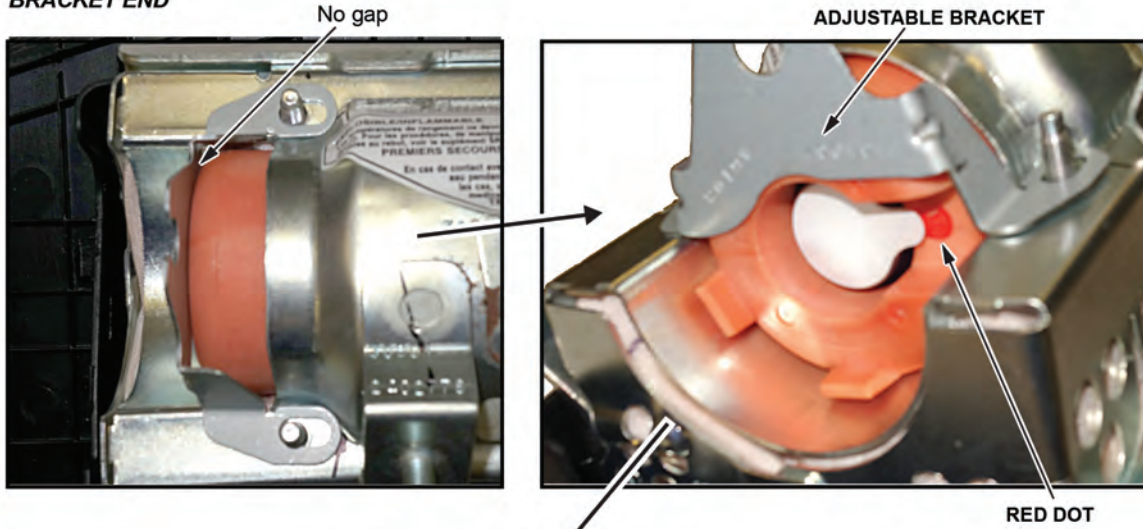
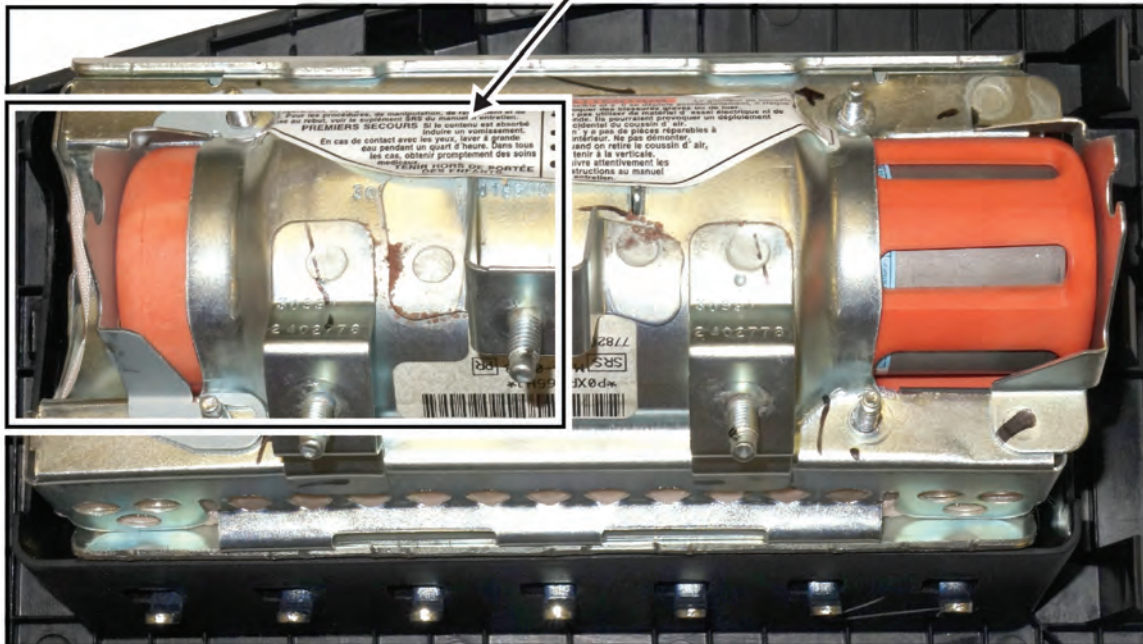
**ADJUSTABLE
BRACKET END**

12.4. Install the bracket included in the kit onto the airbag module. There should be a red dot visible on the end of the plastic connector. There should be no space or gap between the inflator and bracket.

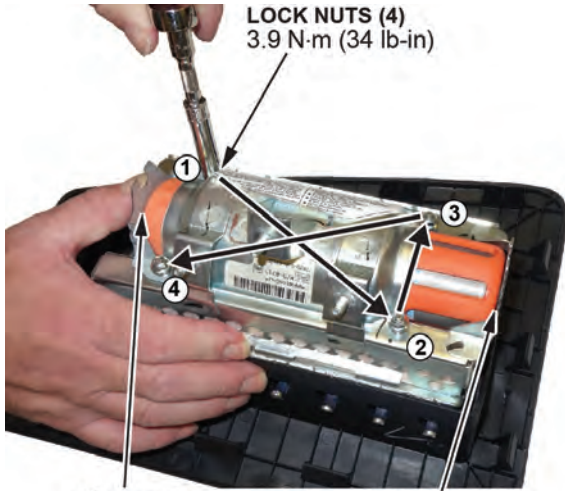
13. Install the four new 5 mm locknuts and torque them in sequence to **3.9 N•m (34 lb-in)** .

Be sure there are no gaps between the inflator ends and the inflator brackets

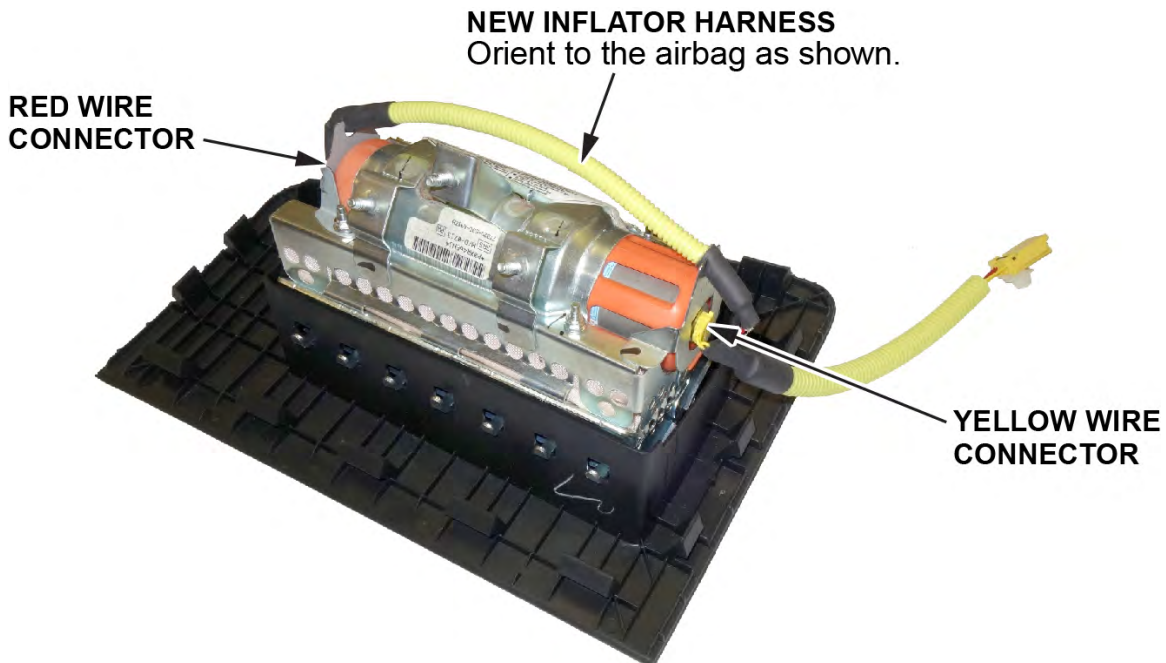
15.1. Make sure the airbag and harness are aligned as shown.

- **Make sure you have the orientation correct as shown below.** If you connect the harness incorrectly, the harness cannot be removed, and you will not be able to reinstall the airbag because the harness will be too short.
- Connect the red wire connector to the short collar side of the inflator with the red dot.

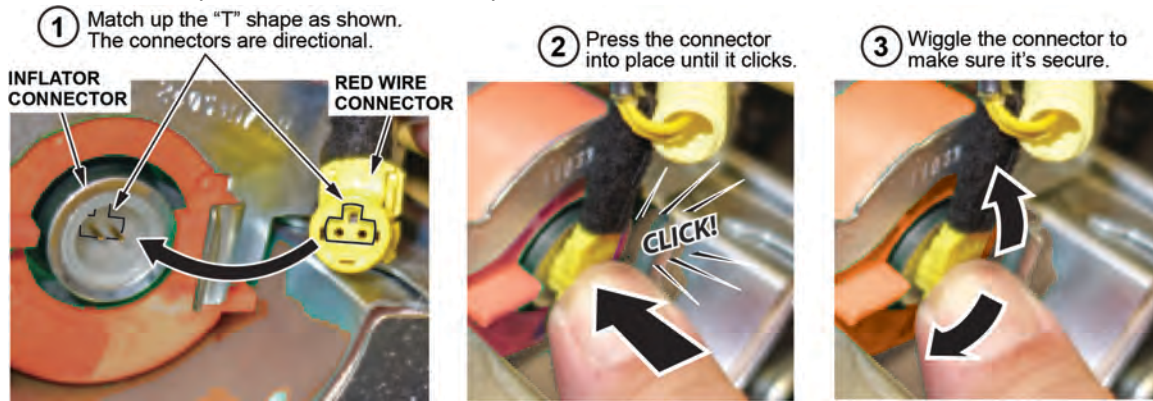
15.2. Connect the two connectors. Align the "T" shape in the inflator harness connector with the T-shaped inflator connector, then press the connector into place.

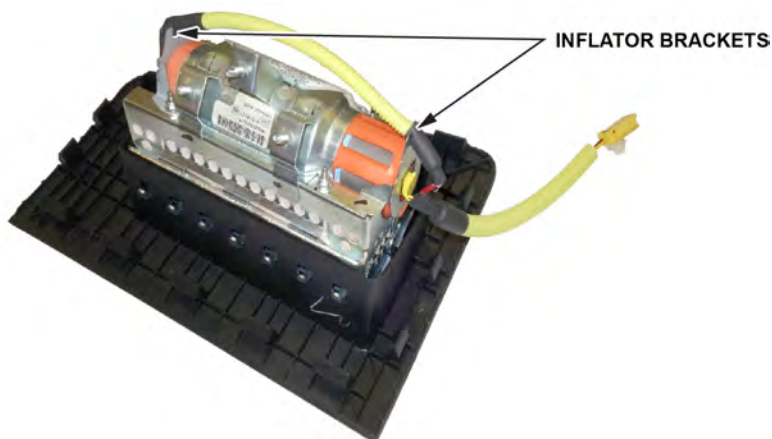
16.1. Insert the side without the shrink wrap tubing first. Insert the harness at the third "valley" in the corrugated tube.
