Safety Recall

Code: 69R6

Subject Driver Frontal Airbag Inflator (Takata)

Release Date February 1, 2018

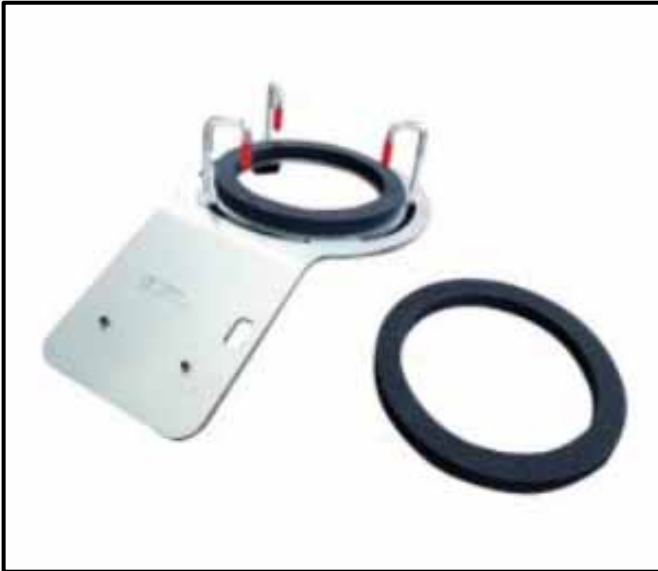
- Airbag Support - T10568

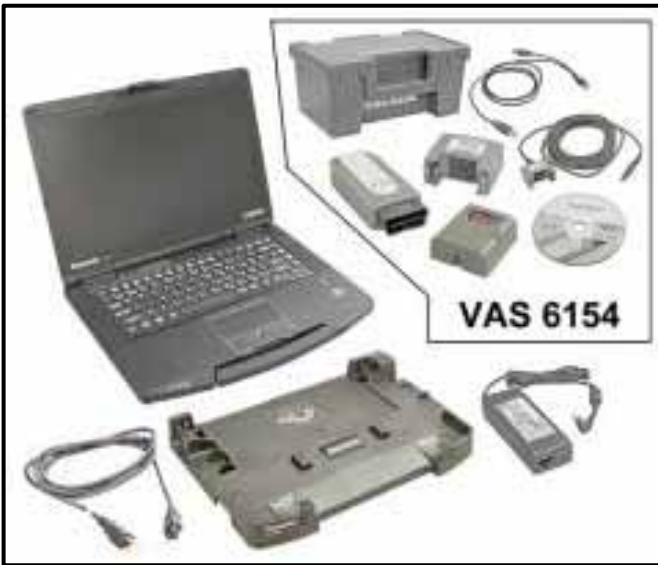
- VAS6150D - Diagnostic Tester (or equivalent)

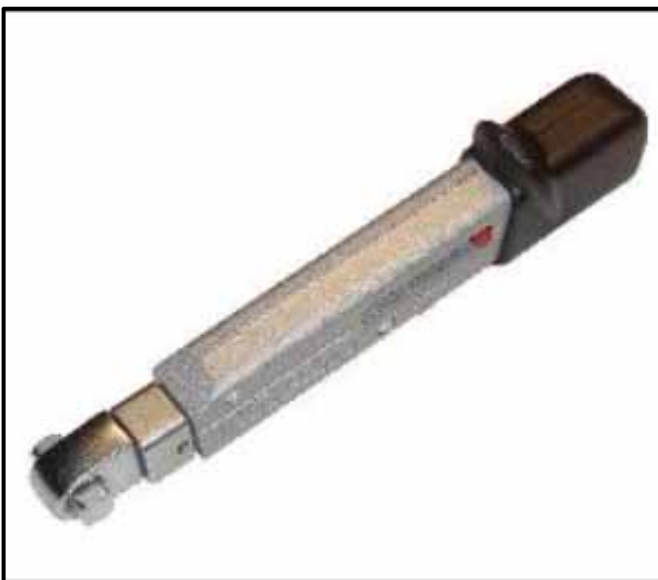
- VAG1410 – Torque Wrench (or equivalent)

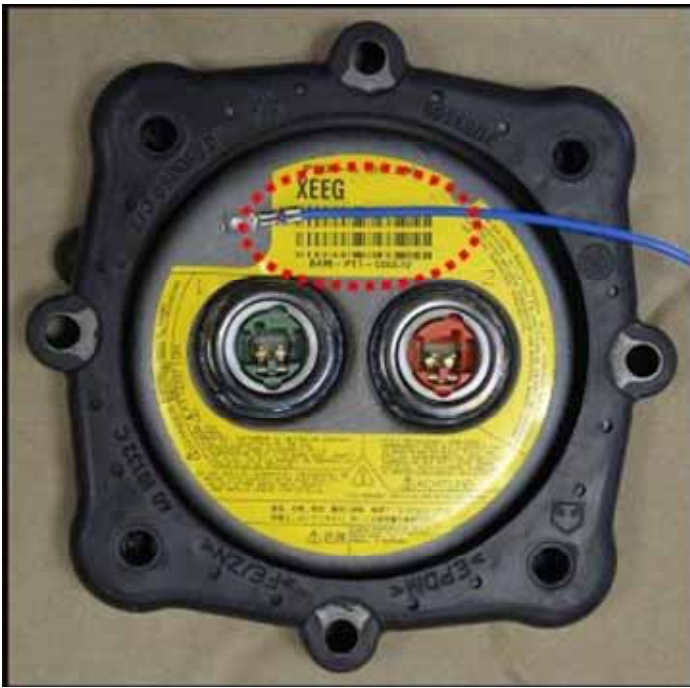
- Place the new inflator on the ESD mat.
- Scan the bar code of the new inflator at a distance of about 15 cm.

The photo is for reference only. The inflator that is installed may be either a single stage or dual stage inflator.
