# Safety Recall **Code: 69R6**

**Driver Frontal Airbag Inflator (Takata)**

March 08, 2018

U.S.A. & Canada: Certain 2009-2013 MY Audi vehicles equipped with a Takata driver frontal

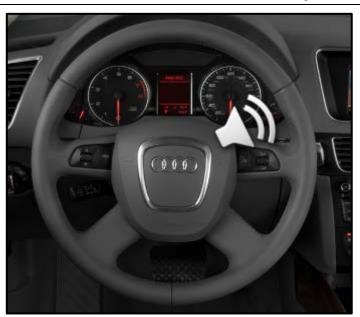
Prior to beginning repairs, verify the horn is operational.

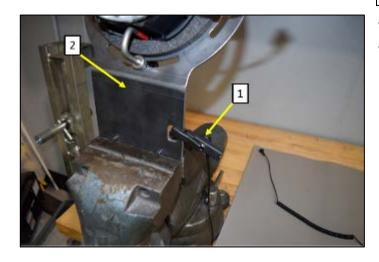
- Clamp Airbag Support T10568 <2> into the vice.
- Connect crocodile clip <1> to airbag support <2> and ESD workplace -VAS 6613-.

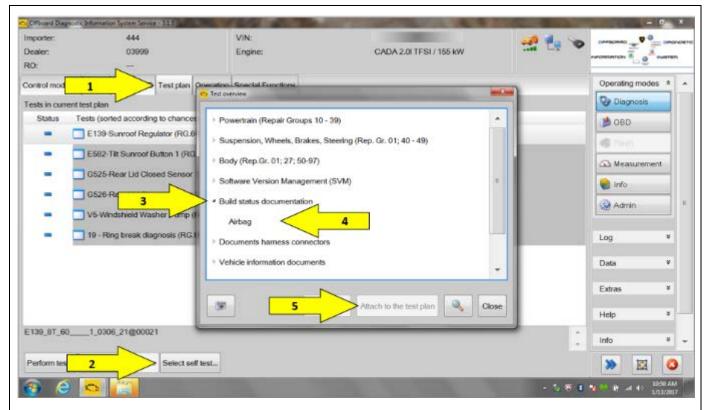
- Select the "Test plan" tab <1>.
- Select "Select self test..." <2>.
- Open the "Build status documentation" dropdown <3>.
- Highlight "Airbag" <4>.
- Select "Attach to the test plan <5>.

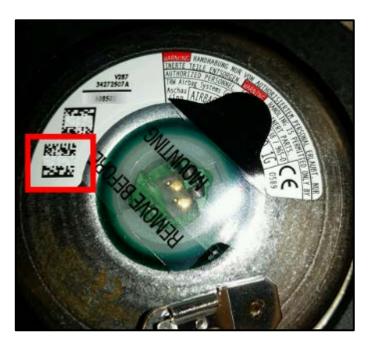
- Place the new inflator on the ESD mat.
- Scan the data matrix code of the new inflator at a distance of about 15 cm.

The photo is for reference only. The inflator that is installed may be either a single stage or dual stage inflator.

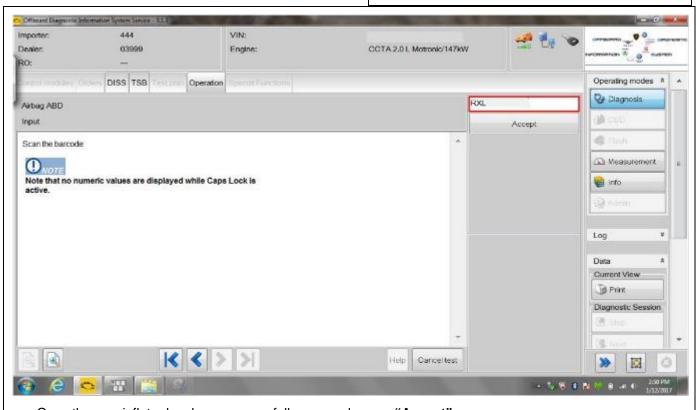
Once the new inflator has been successfully scanned, press "Accept"

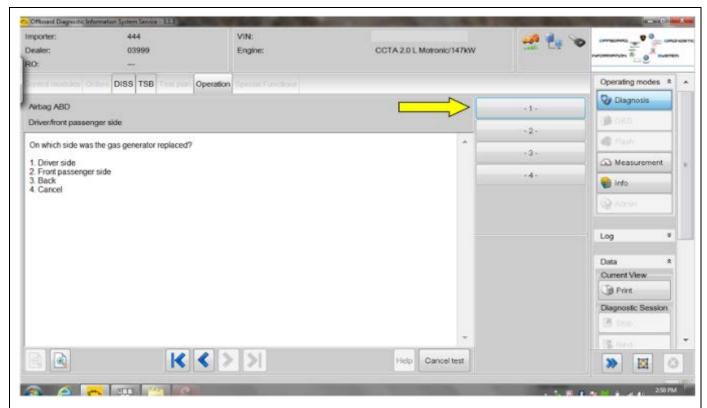
- Select option 1 indicating that the Driver side inflator was replaced.
- After selecting option 1, a valid GeKo ID will need to be entered in order to upload the new inflator identification.

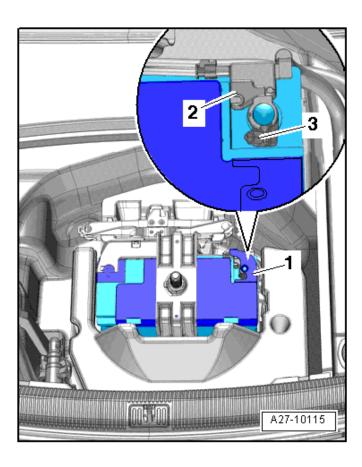
- Open the cover <1> over the battery negative terminal.
- Make sure the ignition is turned ON.
- Loosen the nut <3>.
- Remove and isolate the battery ground cable terminal <2> from the battery terminal.

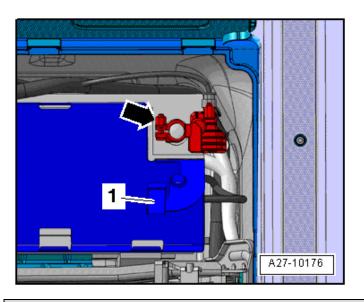
- Open the cover <1> over the battery negative terminal.
- Make sure the ignition is turned **ON**.
- Loosen the nut <arrow>.
- Remove and isolate the battery ground cable terminal from the battery pole.

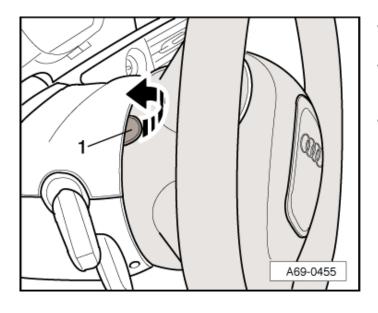
- Adjust the steering column as far down as possible.
- Turn the steering wheel so the cap <1> on the rear side of it faces upward. This is approximately the 12:00 position.
- Pry the cap off <arrow>.

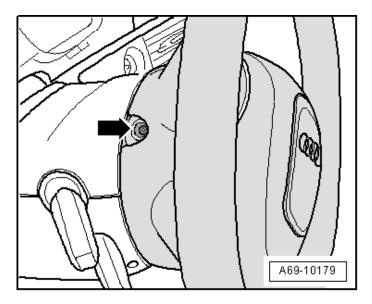
- Remove the driver airbag bolt <arrow>.
- Turn the steering wheel 180° and repeat the procedure on the opposite side.

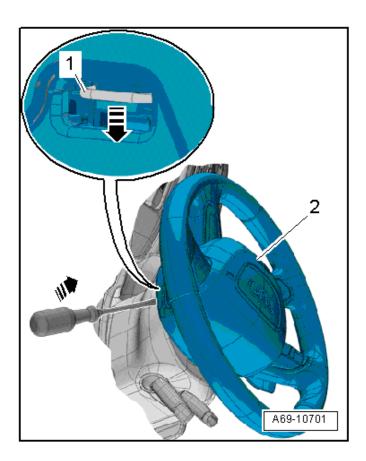
- Adjust the steering column as far down as possible.
- Turn the steering wheel so the opening on the rear side of it faces upward. This is approximately the 12:00 position.
- Release the locking bracket <1> in the direction of the arrow using a T25 TORX screwdriver, approximately 100 mm long.

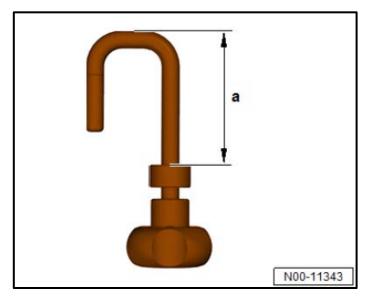
Adjust three knurled nuts of securing hooks to <dimension a> 50mm.

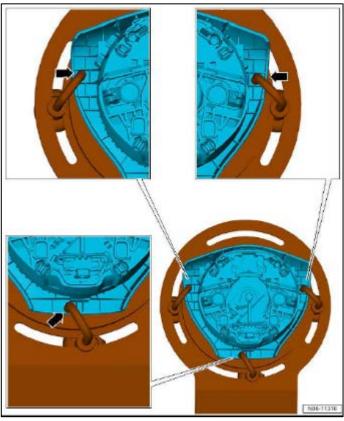
Clamp airbag centrally in airbag support. There are securing points on the sides <arrows>, parallel opposite each other and below.

The clamps must be placed in the positions shown <arrows> to prevent damage to the airbag. Damage to the airbag is not covered under this action.

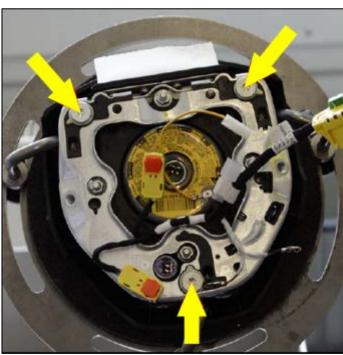
- Remove and discard the three horn ring bolts <arrows>.
- Remove the horn ring.

When removing the horn ring, take care that the springs are not lost as they are not available separately. Replacement of the airbag is required if a spring is lost and is not covered under this action.

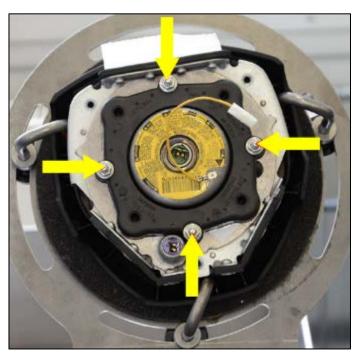
Remove and discard the four nuts <arrows>.

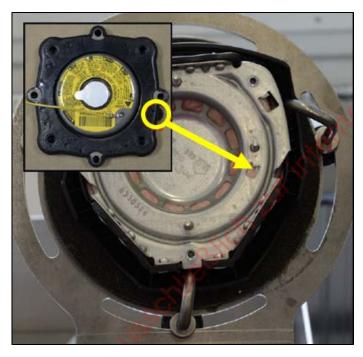
Install the new inflator onto the studs.

• Ensure the recess on the inflator lines up properly with the tab on the airbag <arrow>.

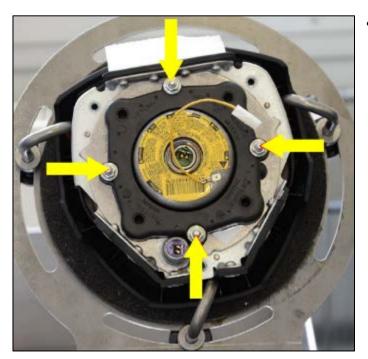
Install the new inflator and torque nuts <arrows> to 4.5 Nm

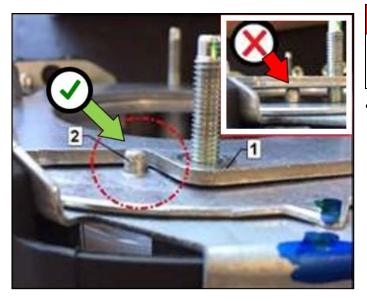
The inset illustrates the plate resting on the tab. Failure to install the plate properly could cause improper airbag operation.

Install the plate included in the kit so that the recess on the plate <1> aligns with the tab <2> on the airbag.

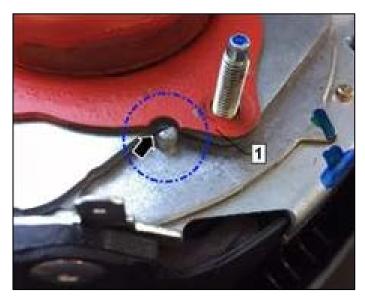
Install the new inflator onto the studs.

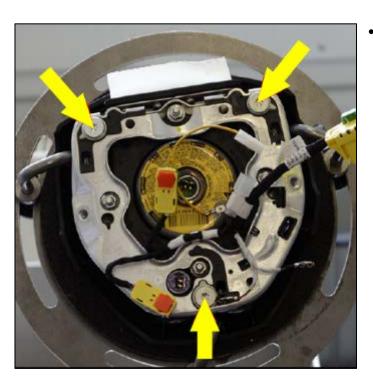
Install the horn ring and tighten the bolts <arrows> to 6 Nm.

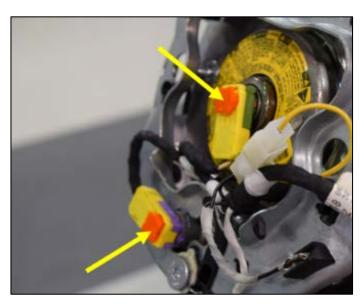
Install connectors <1, 2 and 3>.

Ensure the connector locks <arrows> are fully opened as shown when installing the connectors.

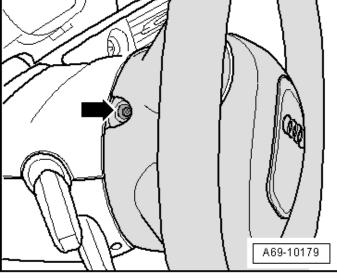
- Position the driver airbag in the steering wheel.
- Install the 2 bolts <arrow> for securing the driver airbag approximately 2 turns.
- Press horn about 3 times to achieve even gap dimension
- Torque the bolts <arrow> to 7 Nm.
- Install the bolt cover caps.

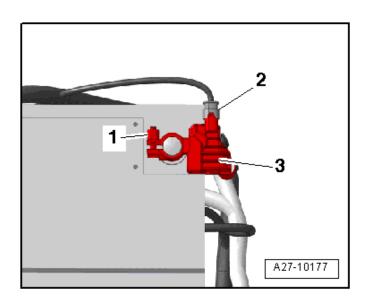
• Install battery terminal cover <1>.

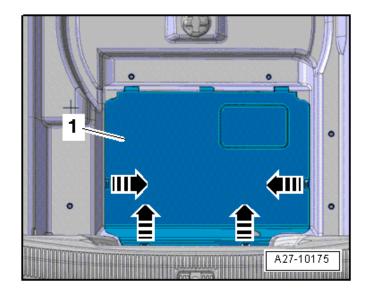
The cover is available with varying numbers of retaining clips.

Install cover <1>.

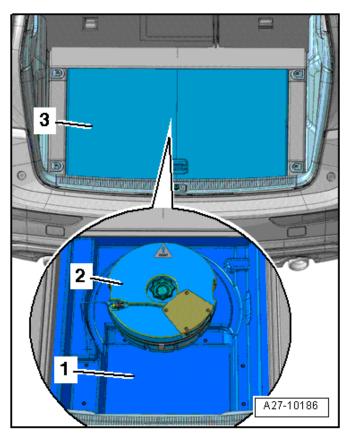
- Install the carpet <1> over the battery cover.
- If equipped, install the subwoofer <2>.
- Install the dirt tray, if applicable.
- Install the luggage compartment floor covering <3>.
- Cycle the ignition off and back on.
- Store previously recorded radio presets (if necessary).
- Set clock to local time.
- Activate the power window regulator one-touch up/down function.
- Check the DTC memories of all the control units and erase under-voltage faults if necessary.
- After completing repairs, verify the horn is operational.
