Recall #	18V-120 2018-101		
Description/Title:	29J Outlaw Seat Belt Bracket		
Affected Product Line(s):	Certain MY 2018 & 2019 29J Outlaw motorhomes		
Service Campaign # :	RC000151	Released Date:	04/02/2018
Repair Code:	TMCRC80472V	Document Date:	04/02/2018
Time Allowed:	0.67	Document Revision:	А

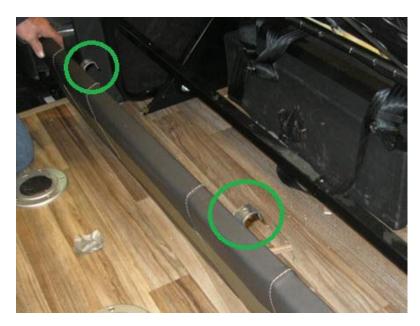
2. Remove the sofa arm rests, then lift the seat up enough to access and remove the screws securing the kickboard to the sofa frame.

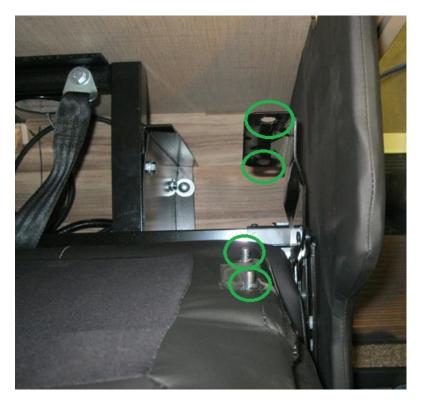
3. Remove the 4 nuts (2 per side) that secure the seat back to the sofa framing.

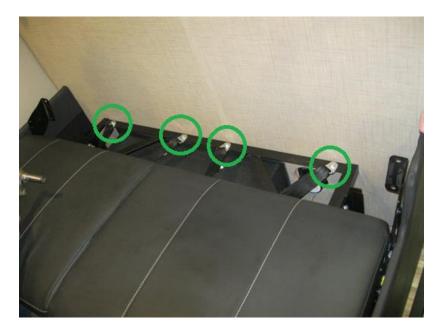
4. Remove and discard the 4 seatbelt bolts from the seatbelt bracket.

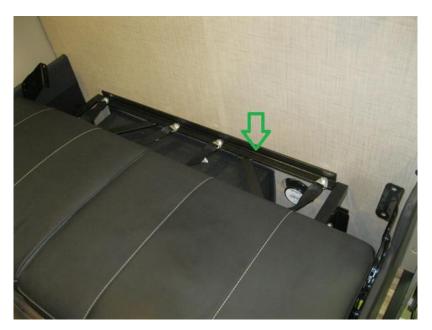
5. Add the Frame Reinforcement Angle (print TFM5493) on top of the seatbelt bracket with the bolt holes aligned. Position the vertical leg of the angle so it's against the sidewall. Reinstall the 2 seatbelts with 4 NEW 3/8"-16 x 1 ¹/₂" grade 5 bolts as specified on the assembly drawing (print TFM5491). Use the included 3/8"-16 grade 5 nuts, flat washers, and lock-washers. Torque the 4 bolts to 18-25 ft-lbs.

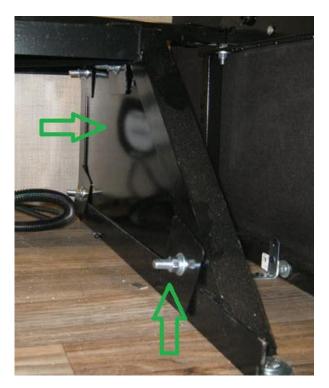
(*Rear bracket*)

6. Install the front (print TFM5492) and rear (print TFM5489) seatbelt bracket reinforcements using the bolts and reinforcement plates (print TFM5490) specified on assembly drawing (print TFM5491). The reinforcement plates will be used to clamp the front and rear brackets to the existing seat belt bar. Torque the bolts to 18-25 ft-lbs.
