PRODUCT CAMPAIGN BULLETIN

APPLICABILITY: 2012-14MY Impreza 2.0
2013MY Crosstrek
2013MY BRZ

NUMBER: WTY-84

SUBJECT: 2.0L Engine Valve Spring Fracture May Cause Engine Stall

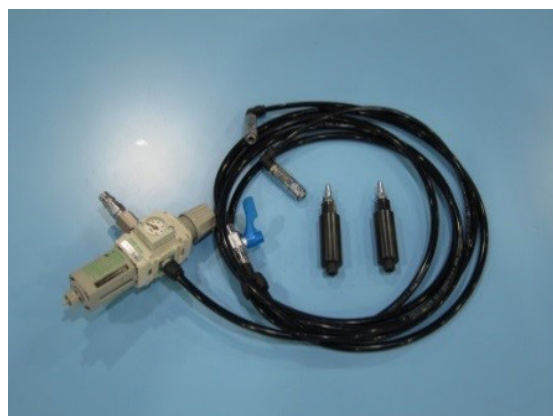
- **Air Hose Assembly**, p.n. 99850AA010 includes: air pressure regulator, 2 spark plug adapters, air hose w/ “Y” connector, 2 spark plug adaptor quick-connectors and main shut-off valve. This tool is used on both FA and FB engines.

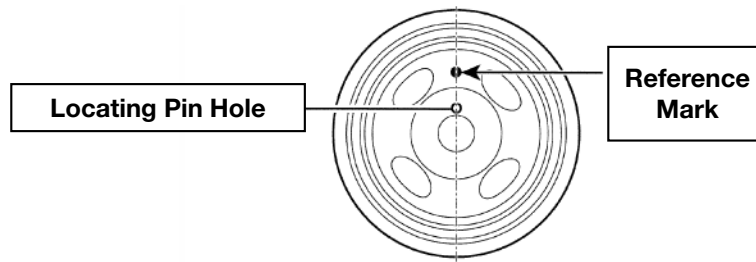
9) Apply a reference mark to the face of the removed crankshaft pulley using touch-up paint or a grease pencil adjacent to the locating pin hole as shown below.

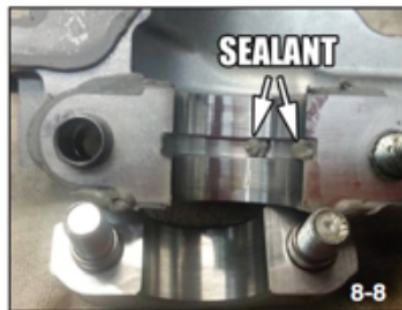
Sealant Plugging Lubrication Channel

D. **IMPORTANT:** Always keep close watch for any loose pieces of sealer, large or small as components are disassembled and remove them right away. This will help prevent them from getting into oil passages, restricting oil flow and potentially causing damage as shown here.

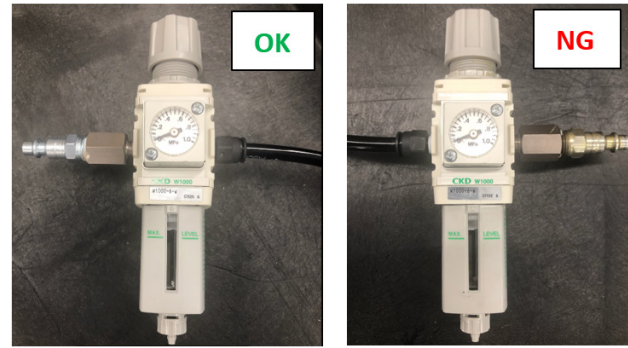
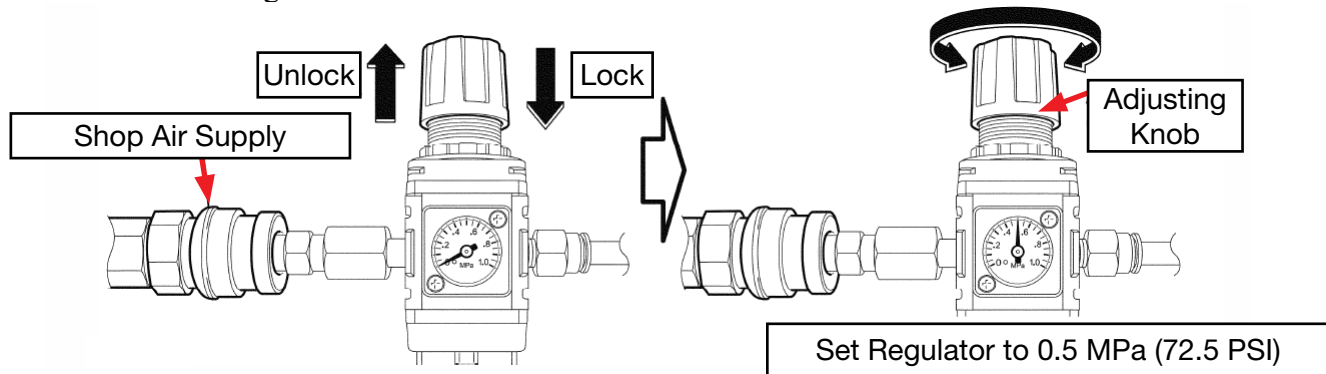
Assemble the air pressure regulator assembly as shown with the shop air supply inlet on the left and the outlet fitting to connect the plastic tubing to the right. The air pressure regulator will be ineffective otherwise. Once the tool is assembled, connect shop air, open the valve and let air flow through to make sure it is clean. Pull up on the adjustment knob, adjust to **0.5 MPa** then push the knob back down to lock the setting.

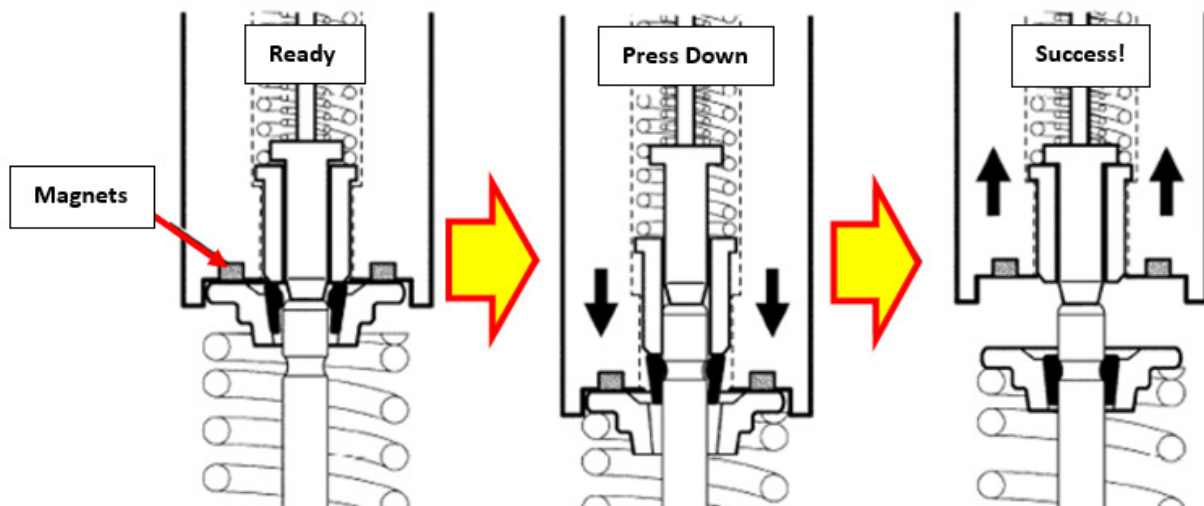
This cutaway illustration provides additional detail on how the Installer tool operates.

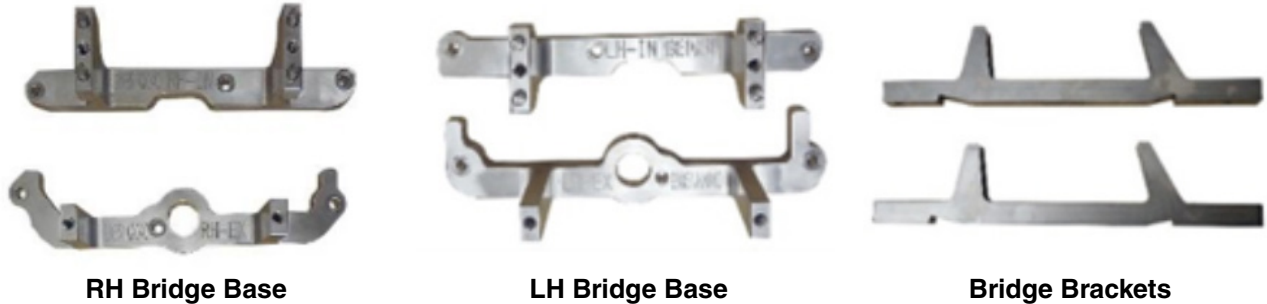
- **Bridge Base and Bracket Set**, p.n. 99850AA020 (for use on **FB engines ONLY**)

IMPORTANT REMINDER: NEVER attempt to use any of these valve spring replacement tools on a 2015MY or later 2.5L FB engine. Although the Bridge Base and Bracket set bolts to the cylinder heads normally, **the spacing between the valve stems is different**. Attempting to use any of the compressor tools or spring installers on a 2015MY or later 2.5L FB engine **WILL** damage them.

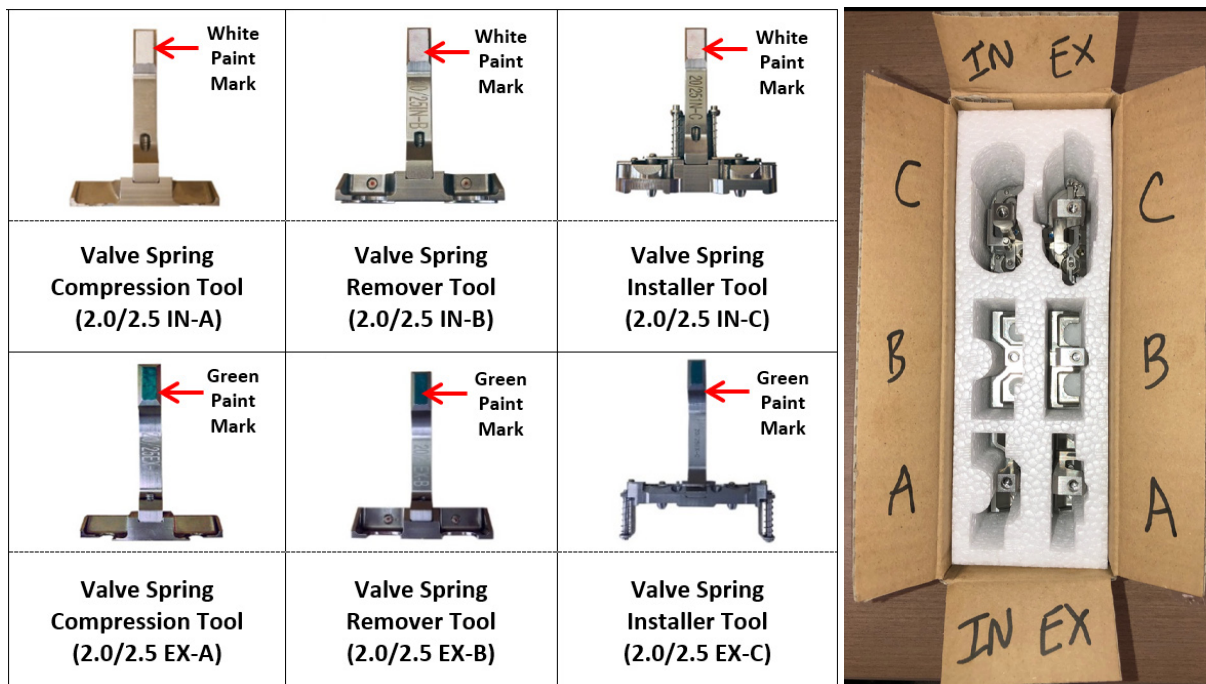
REMINDER: The tools for servicing the **INTAKE** valves have **WHITE** paint markings whereas the tools for servicing the **EXHAUST** valves have **GREEN** paint markings.

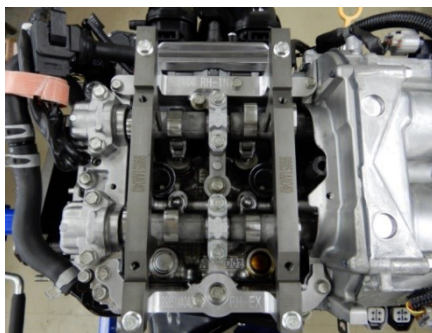
Bridge Bases and Brackets assembled on RH cylinder head.

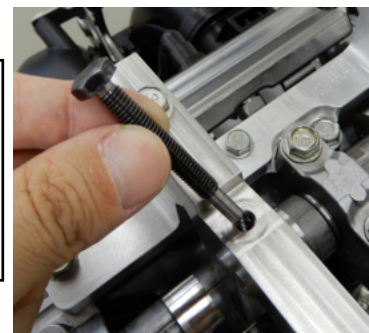
Special 6 mm Push Bolt and their locations on the bridge brackets.

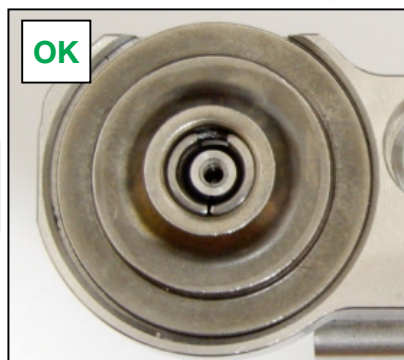
Keepers are centered.

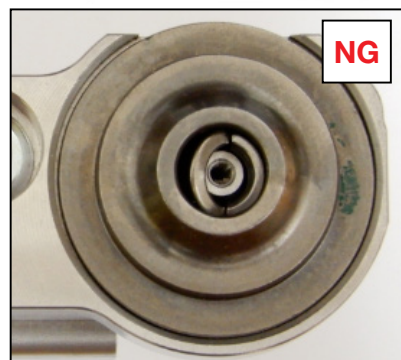
Keepers are either mis-aligned or, one is upside-down.

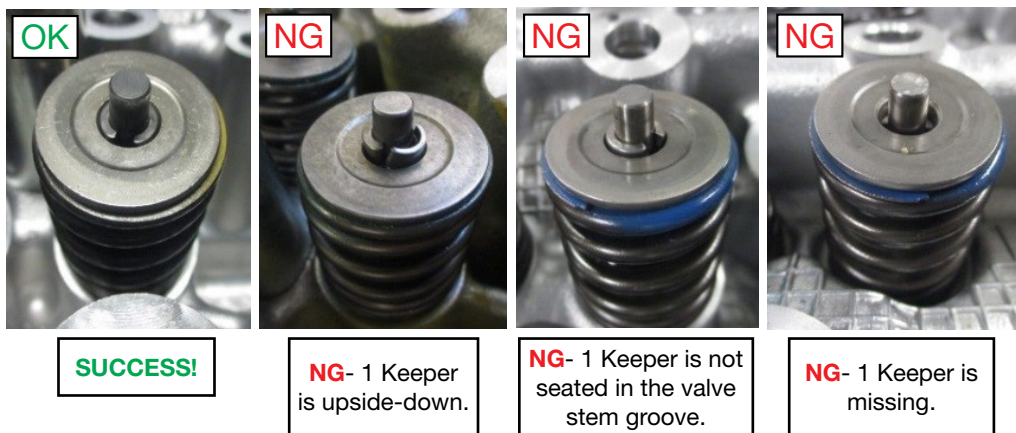
- T. Loosen the push bolt and remove the installer tool. CAREFULLY inspect both springs for successful, properly seated retainers and keepers. Use the reference photos below as a guide for confirmation.

EXTREMELY CRITICAL: If any of the NG conditions shown above exist, use the applicable spring compressor tool to remove the pair of retainers and keepers then return to Step R above and start over. If installation is successful, proceed to install the EXHAUST springs.
