## SAFETY ADVISORY # 18-339

### Raptor 353TS Outriggers

**Models Included:** 2018-2019 Raptor 353TS

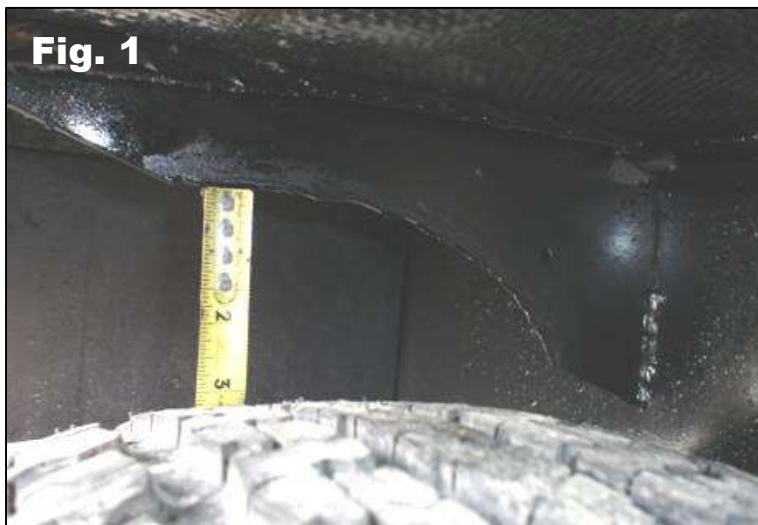
Keystone is conducting a voluntary RECALL notification campaign in accordance with the National Highway Transportation and Safety Act. It has been determined that on some 2018 and 2019 Raptor fifth wheels, the rear tires may come in contact with an outrigger. The tires and frame outriggers touching during travel may lead to an increased risk of property damage and poor vehicle handling.

Using a reciprocating saw, cut a notch in the bottom side of the outrigger located above the tires on the off door side of the unit. Cut the notch to allow 3" of clearance between the tire and the outrigger, Figure 1.

The remedy is to inspect the outriggers over the tires and cut the outriggers so that there is a 3 inch minimum clearance if needed.
