# **Recall Campaign Bulletin**

Campaign No. 2019080012, August 2019

### SUBJECT: Model C-class (205 platform), E-Class (213 platform), E-Class Coupe (238 platform), and CLS-Class (257 platform) Model Years 2018-2019 Replace Steering Rack

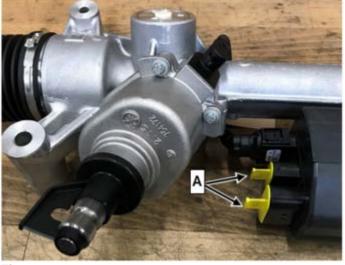
Figure 1

**i** To prevent dirt from entering the connector couplings or damage from ESD (electrostatic discharge), it is **absolutely essential** to fit the yellow dust caps **(A, Figure 1)** on the connector couplings of the steering gear to be returned. The **caps** from the **new** steering gear are to be used for this.

**i** If these dust caps are *not* fitted, it will *not* be possible to carry out an analysis. This could affect the warranty process.
