David J. Johnson
 Director
 Service Engineering Operations
 Ford Customer Service Division

September 30, 2019

SUBJECT: **Safety Recall 19S01 – Supplement #4**
 Certain 2005-2014 Mustang, 2005-2006 GT, 2007-2011 Ranger, 2006-2012 Fusion and MKZ/Zephyr, 2006-2011 Milan, and 2007-2010 Edge and MKX Vehicles
 Passenger Airbag Inflator Replacement

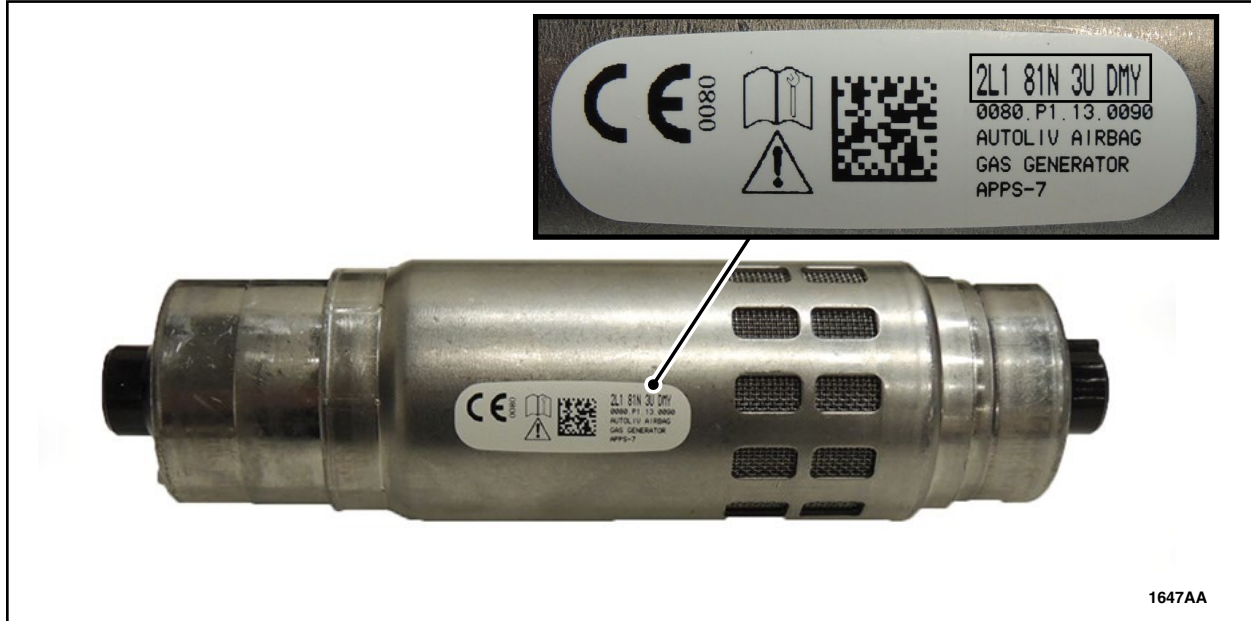
FIGURE 7

9. Record the 11 character serial number of the *new* airbag inflator on the repair order. See Figure 7.
