March 2019

Dealer Service Instructions for:

Safety Recall V06 / NHTSA 19V-021 Drag Link

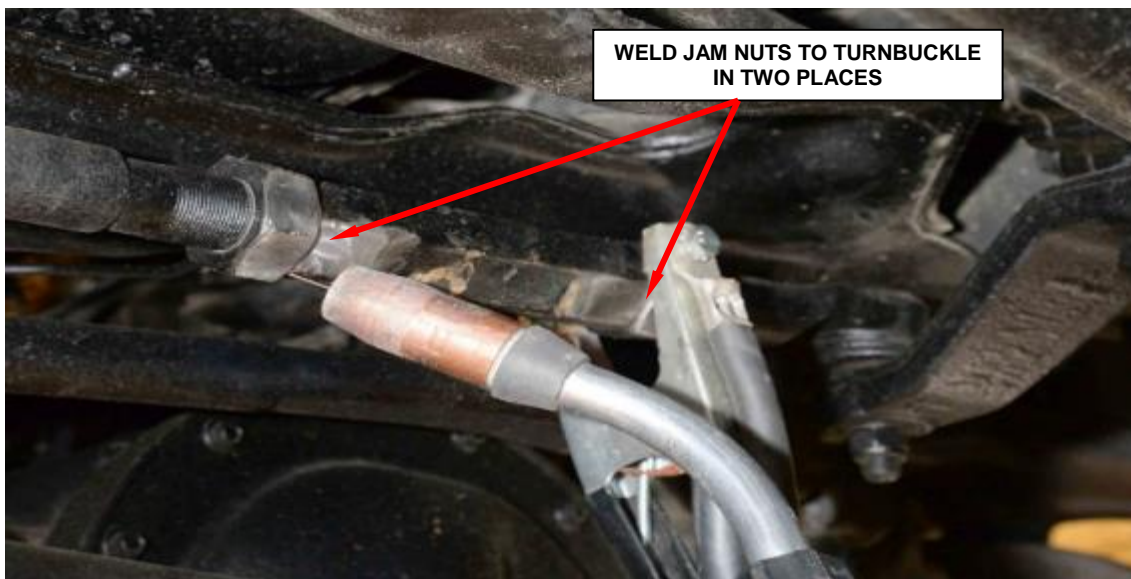
Figure 9 – Weld Both Jam Nuts to the Turnbuckle

7. Using a Lincoln Powerwave 350 Flux Cored Arc Weld (MIG) or equivalent, apply a 17mm long weld the length of one turnbuckle flat on each jam nut (Figure 9).

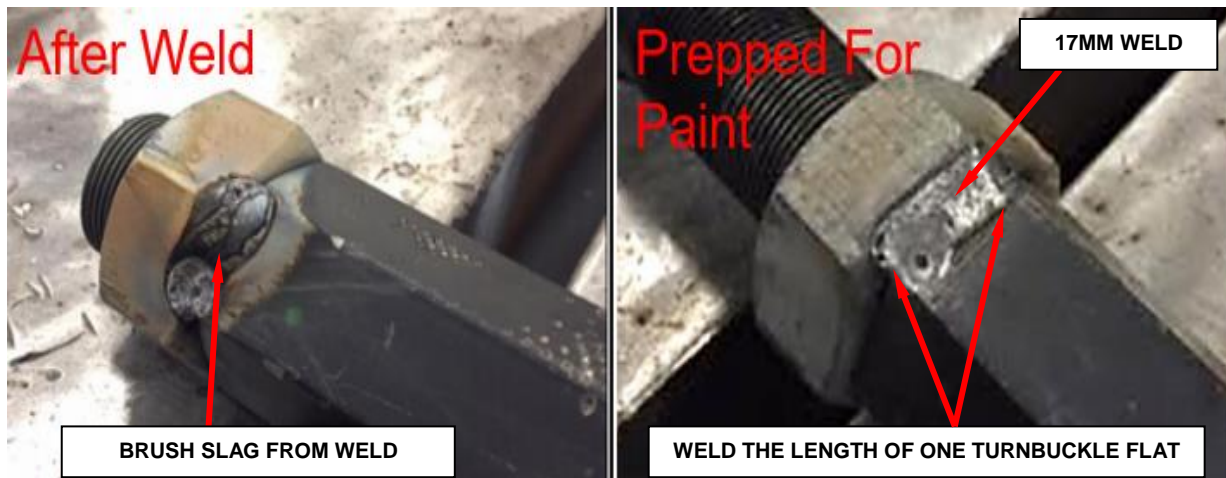
Figure 10 – Prepare areas for Paint

8. Wire brush the slag from the surface of the welds (Figure 10).
9. Allow to cool to room temperature.

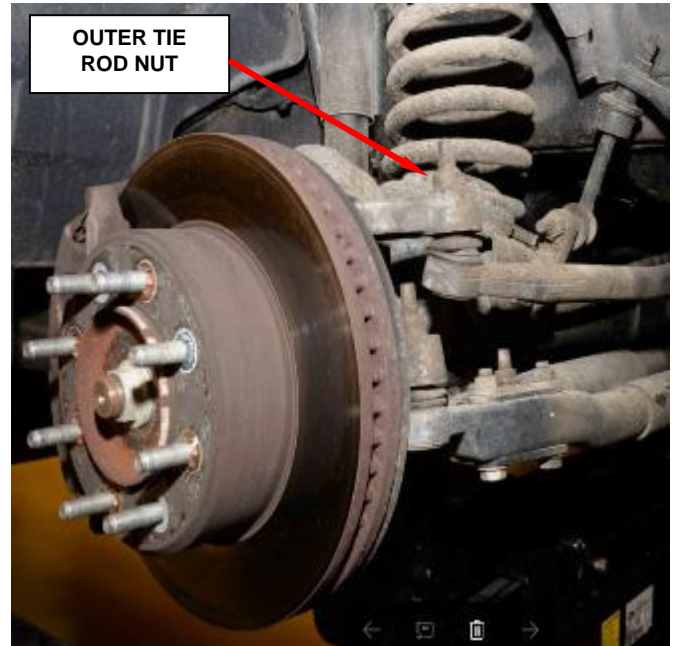
Figure 11 – Outer Tie Rod

1. Raise and support the vehicle.
2. Remove the right front tire and wheel assembly.
3. Remove and **DISCARD** the outer drag link to tie rod nut (Figure 11).
4. Remove the outer drag link tie rod from the knuckle using C-3894-A (puller shown in Figure 12).
